## Architectural Inventory Form

1. Resource number: 5AM.889
2. Temporary resource number: N/A
3. County: Adams
4. City: Brighton
5. Historic building name: Foley Farm
6. Current building name: None
7. Building address: 13210 120<sup>th</sup> Avenue, Brighton, CO
8. Owner name and address: West 80 Investors, LLC  
6551 S. Revere Parkway, Suite 265  
Englewood, CO 80111

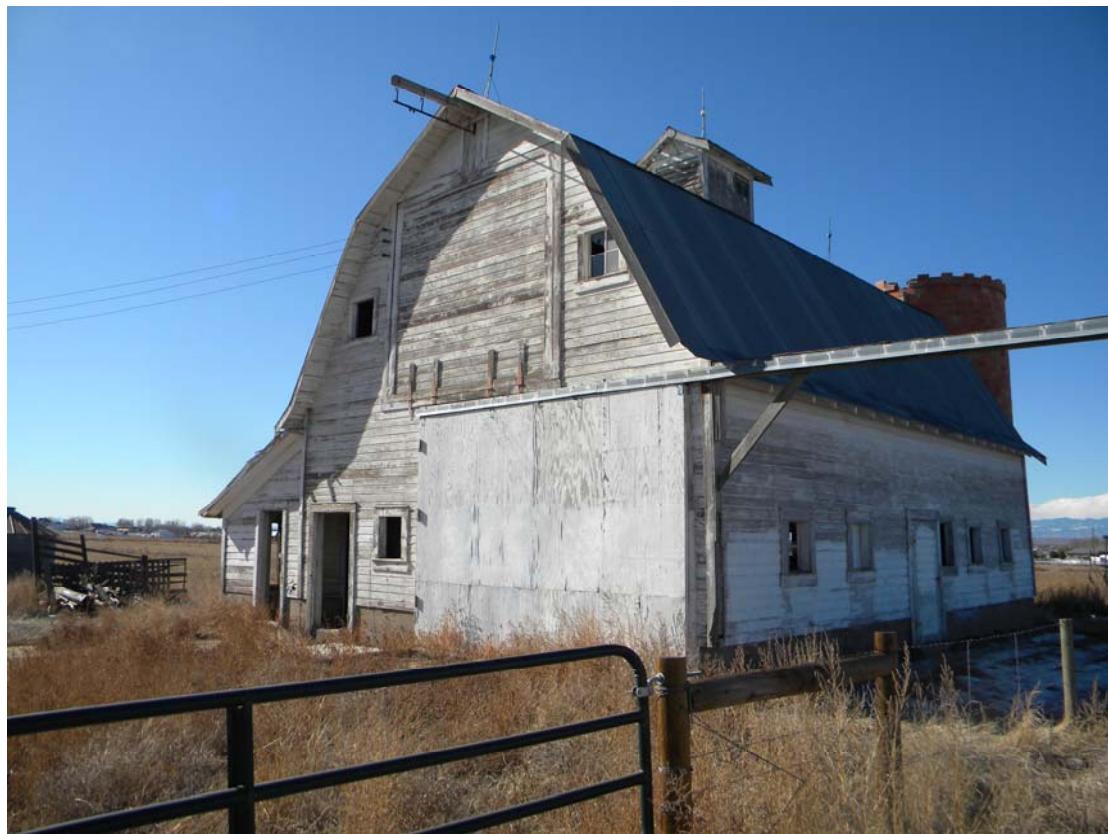
21j. General architectural description: The Foley Farm barn is a visually prominent structure located adjacent to 120<sup>th</sup> Avenue. It is a large, rectangular plan wood frame building resting on a poured concrete foundation with concrete perimeter footer walls that extend about two feet above grade. The tall building contains an upper story hayloft that is made more spacious by the building's steeply-pitched gambrel roof. A ventilation cupola covered by a diminutive gable roof rises from the center of the barn's roof. Hayloft access is provided on the building's east elevation, where a very large square hinged wooden door is installed, above which is a projecting wooden beam to support pulleys used to hoist hay bales to the barn's loft level for interior storage. The east elevation is also equipped with a very large ground level sliding door offset to the north, and the sliding rails extend beyond the north end of the barn and are supported by a timber framework embedded in the ground. The original sliding door appears to have been replaced by a relatively crude plywood-skinned door. Personnel entries are installed on east, north, and west elevations. A small room that appears to be an original design element, projects from the building's south elevation, offset to the far east end. This room extension is covered with a shed roof, and has entries on its south and east sides, and a large 4-light fixed window on its west elevation. The barn is fenestrated with a large number of nearly square window openings on all elevations, that once contained fixed 4-light windows. Many of these windows are no longer extant, but the empty window openings remain. A low wood frame wing connects the west end of the barn to a tall red tile-block solo located nearby. The barn appears to be relatively unmodified and in fair to good condition. It has lost numerous windows, and the exterior walls are badly weathered.

Barn on the Foley Farm (5AM.889), view looking southwest.

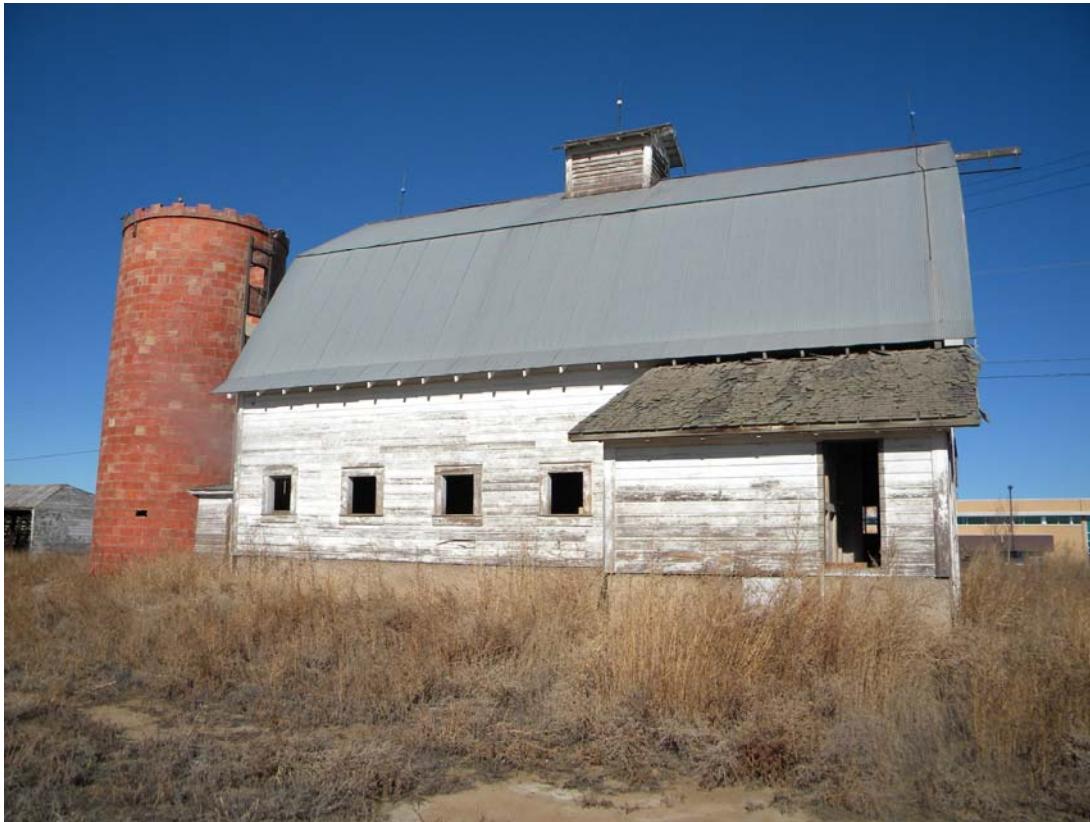
South elevation of barn on Foley Farm (5AM.588).

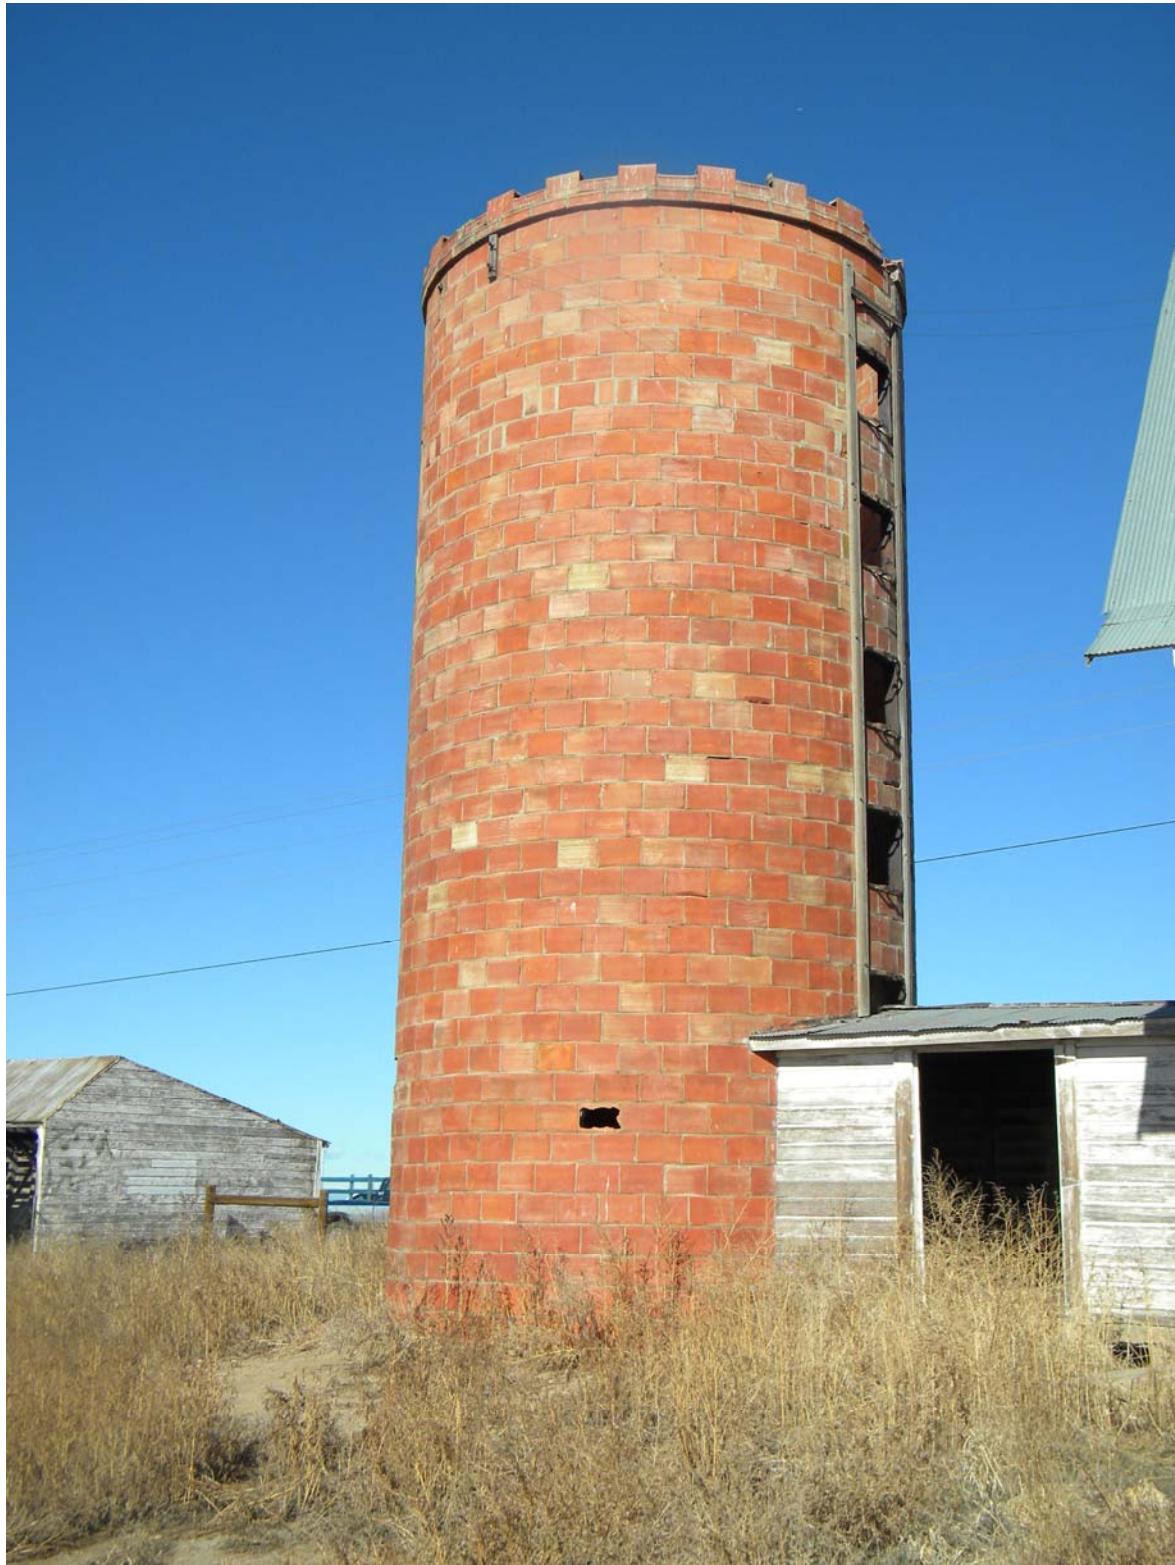
21k. General architectural description: Located a short distance beyond the west end of the barn is a tall, cylindrical red tile-block masonry silo used for storing grain. The silo is similar to many others in the region in terms of its design and size. Silos were typically used to store winter feed for livestock, and in terms of dimensions most grain silos in Colorado were approximately 20 feet in diameter and 40-60 feet tall. The Foley Farm silo is connected to the barn by means of a wood frame wing that enabled grain to be transferred from the silo through a door near its base, to feed animals kept inside the barn. The top of the silo is crenellated. The Foley Farm silo is in good condition except for damage to a small section of tile block masonry on its southwest side.

Tile block silo located near west end of barn on Foley Farm (5AM.889), view looking northwest.

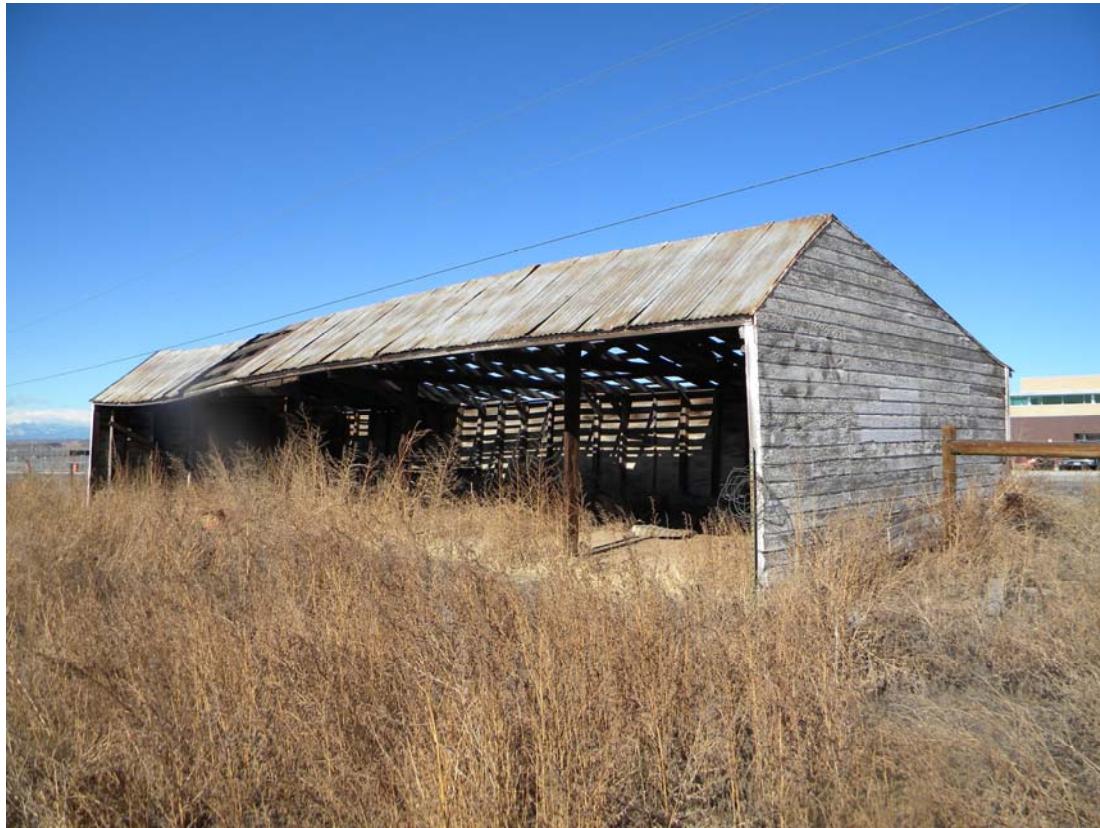
21L. General architectural description: This large agricultural outbuilding is located close to and parallel with 120<sup>th</sup> Avenue, a short distance west of the barn. It is a rectangular plan structure with an asymmetrically-sloped side gable roof. Its south side is open, and timber posts at intervals support the roof and divide the interior into four bays. The shed's exterior walls are clad with horizontal drop siding. The shed exhibits a strictly utilitarian design. The building is in fair but deteriorating condition. The roof is sagging, some panels of corrugated sheet metal roofing are no longer in place, and the painted exterior walls are quite weathered due to exposure to the elements. It is not clear if this building served historically as a machine shed (as was indicated on the site form for the Foley Farm prepared in 1995), or if it was actually used as a cattle loafing shed (as is indicated in the Adams County Assessor's property record).

Cattle or machine shed located close to 120<sup>th</sup> Avenue, Foley Farm (5AM.889), view looking northwest.

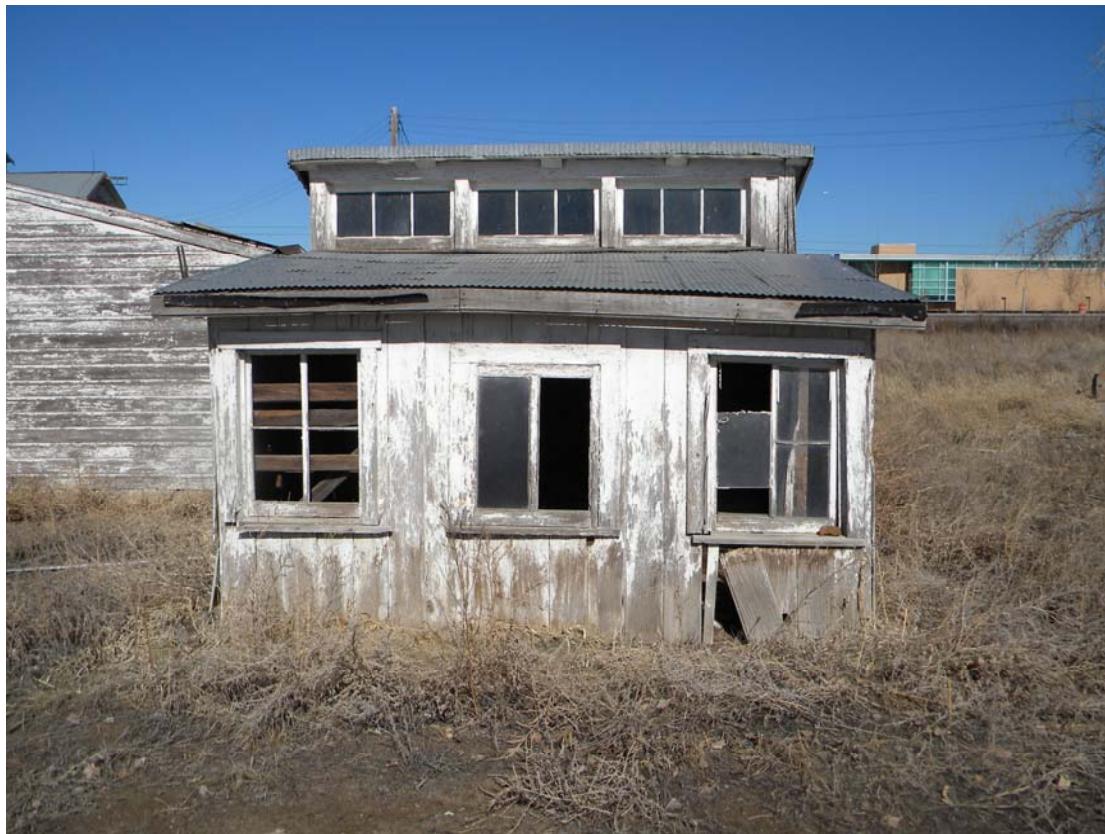
- 18f. Roof configuration: Shed roof(s)
- 19f. Primary external roof material: Corrugated sheet metal
- 20f. Special features: None
- 21f. General architectural description: This small and relatively crude wood frame structure is actually composed of two small shed-roofed sheds that have been joined together to form a larger structure. The southernmost section has a nearly flat shed roof covered with corrugated sheet metal, and walls clad with vertical board siding. A low doorway is located on the east side of this shed, and its front/south side is fenestrated with three fixed, wood sash, multi-pane windows. Attached to the north end of this small shed is a taller shed with a more steeply-pitched shed roof that slopes in the opposite direction. The northern shed section has exterior walls clad with horizontal board siding, and on the taller wall that rises above the roof of the attached southern shed is a ribbon of three horizontally-oriented 3-light fixed windows that serves as a clerestory to bring more sunlight into the building. The function of this building is not entirely clear (it may have been a chicken coop). It is in deteriorating condition, with broken windows, siding that is falling off and peeling away, and badly weathered exterior paint.

Chicken coop on the Foley farm (5AM.889), south elevation.

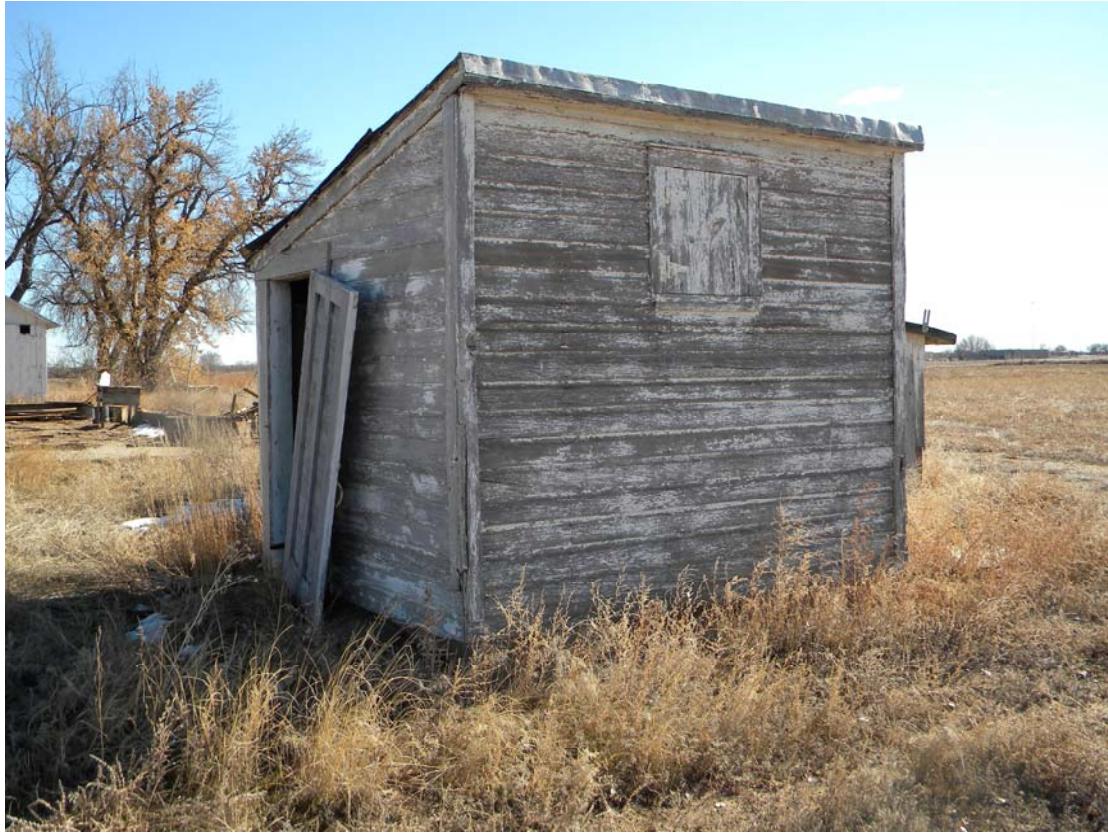
21g. General architectural description: This small utilitarian wood frame building is located adjacent to the chicken coop on the Foley Farm. The shed has a rectangular plan, a rather steeply-pitched shed roof clad with corrugated sheet metal, and exterior walls clad with horizontal drop siding. Two openings are provided on this building, including a door on the north elevation, offset to the east, which was sealed with a wooden panel door (only connected by one hinge now). Another small square opening, which was either for a window or ventilation, is located on the center of the west elevation and is sealed with a hinged wooden door or shutter. The shed is relatively intact although it has suffered from exposure to the weather.

Small wood frame shed adjacent to chicken coop on Foley Farm (5AM.889), view looking southeast.

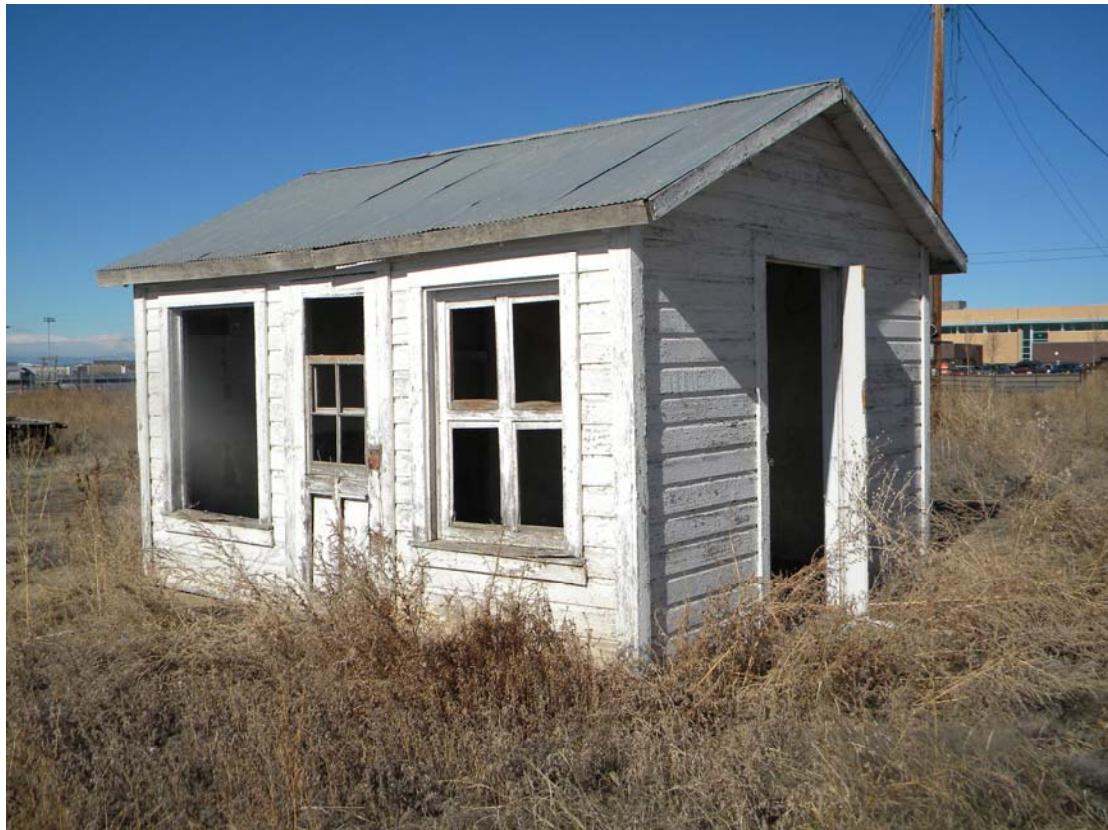
21h. General architectural description: This small wood frame building is located a short distance north of the probable chicken coop and small shed on the east side of the farm access road. The side-gabled structure has a rectangular plan and resembles a scaled-down vernacular dwelling. Its function is undetermined, but it is possible that it may represent a homestead claim shack or tenant farmhouse. The building's roof is clad with corrugated sheet metal, and its exterior walls are covered with horizontal drop siding. The building faces south, and its façade is symmetrically arranged. The main entry is centrally placed, and is equipped with a glazed and painted wooden door with 6-lights (no glass remaining). The entry is flanked by identical large window openings, only one of which still contains a window – a fixed 4-light wood sash unit. The only other opening on the building is a doorway (lacking a door) that is centered on the east elevation. The building is generally intact, except for the missing front window, missing side door, missing window and door glazing, and weathering exterior paint.

Small unidentified wood frame outbuilding on Foley Farm (5AM.889), view looking northwest.

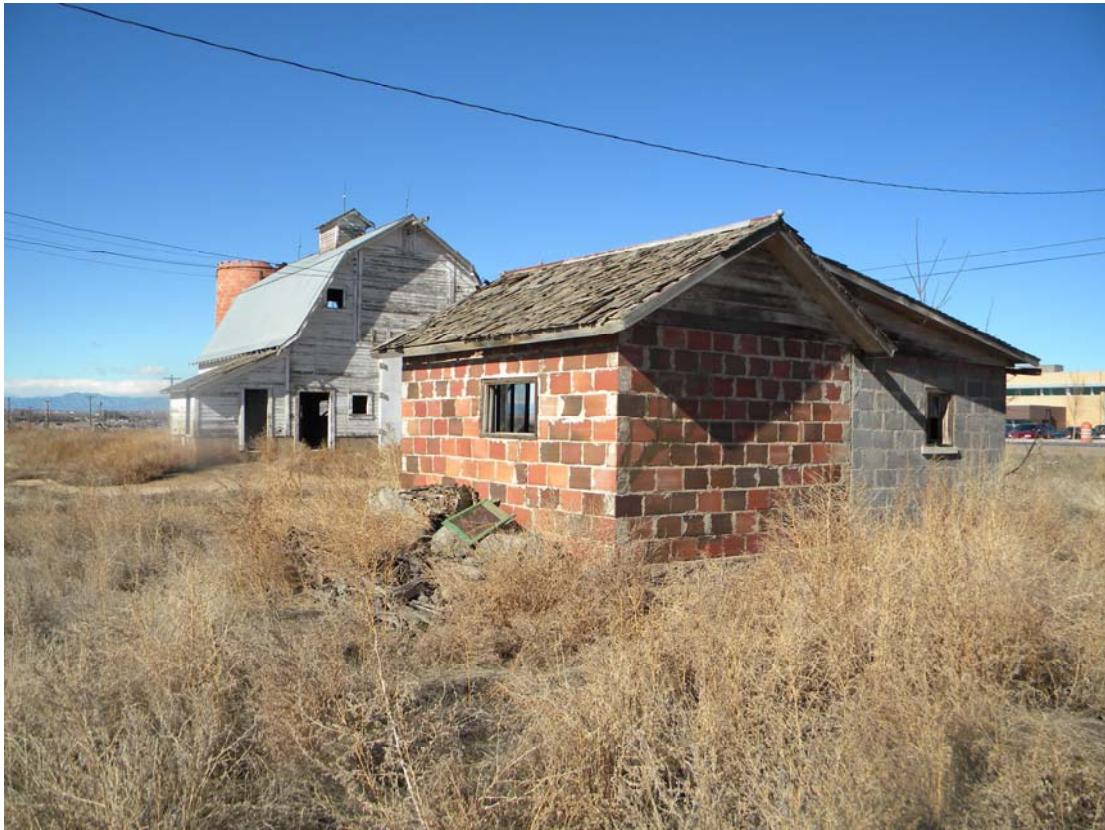
21i. General architectural description: This small masonry structure is located on the east side of the farm access road, opposite the barn and relatively close to 120<sup>th</sup> Avenue. It consists of two parts: the original front gabled section, which features walls constructed of red tile blocks, and a large grey concrete block-walled north side addition that doubled the size of the building and is covered by a very low-pitched shed roof. The façade of the original part of the building faces west, and has a centrally-placed doorway that is equipped with a louvered wooden door probably designed to permit ventilation. Horizontal drop siding is applied to the gable ends of the original portion of the building. A small rectangular window opening containing a fixed 3-light window is located on the south elevation. A similar window was located on the opposite/north elevation, and can still be seen by looking inside the building. Another entry is located on the front/west side of the concrete block-walled addition. One small fixed 4-light window is placed on both the north and west elevations of the addition. Inside the original part of the building, the walls are plastered, and there is a large rectangular cast concrete tank on the floor, which may have been used in the milk cooling and storage process. The building is in relatively good condition overall, although the exposed wooden siding and roof shingles reveal some deterioration due to weathering.

Milk house on the Foley Farm (5AM.889), a short distance east of barn,  
view looking northwest.

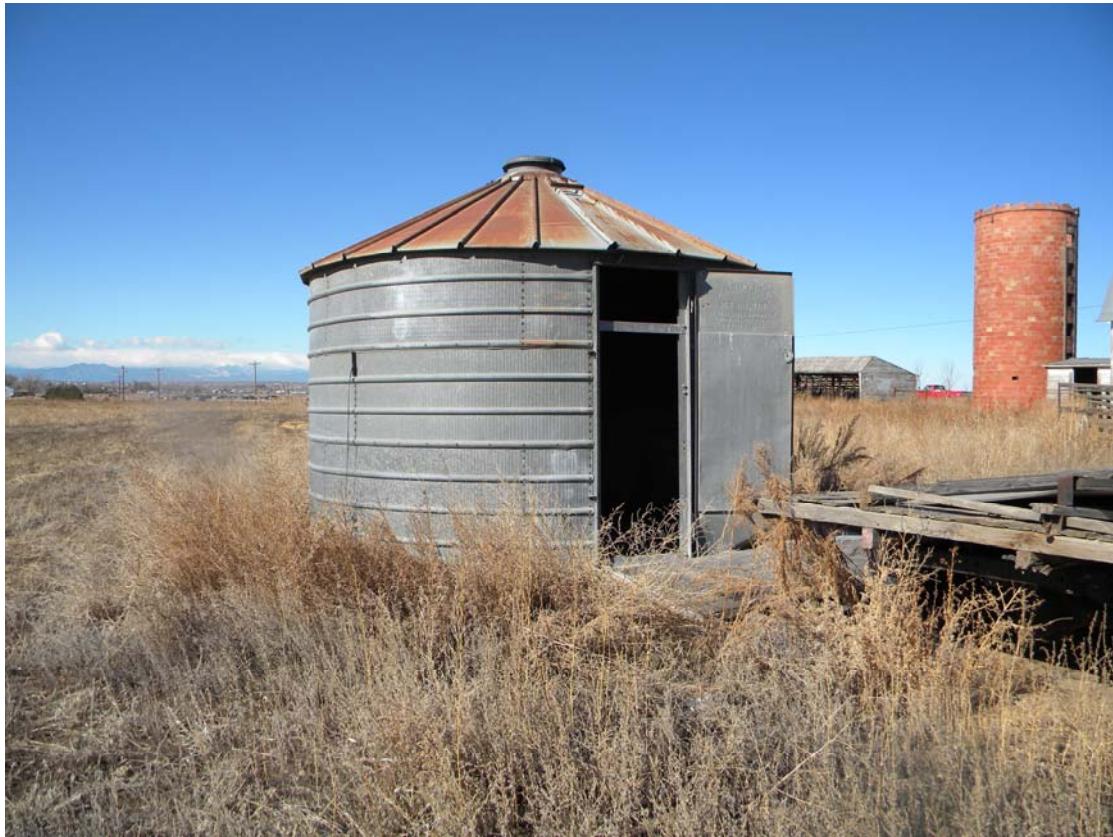
21m. General architectural description: This prefabricated grain storage bin is a squat cylindrical tank made of galvanized sheet metal, measuring perhaps 12 feet in diameter and about 8-10 feet in height. It is covered by a conical sheet metal roof with radiating stiffening ribs and a central ventilator cap. A hinged, curved sheet metal door is located on the structure's east side. Embossing on the tank's door identifies it as "Columbian Red Top Bin [Model] 531," manufactured by the Columbian Steel Tank Company of Kansas City, Missouri. The age of this grain bin is undetermined, but it presumably is of mid-twentieth century origin. The bin is in very good condition.

Prefabricated metal grain bin on the Foley Farm (5AM.889), view looking northwest.

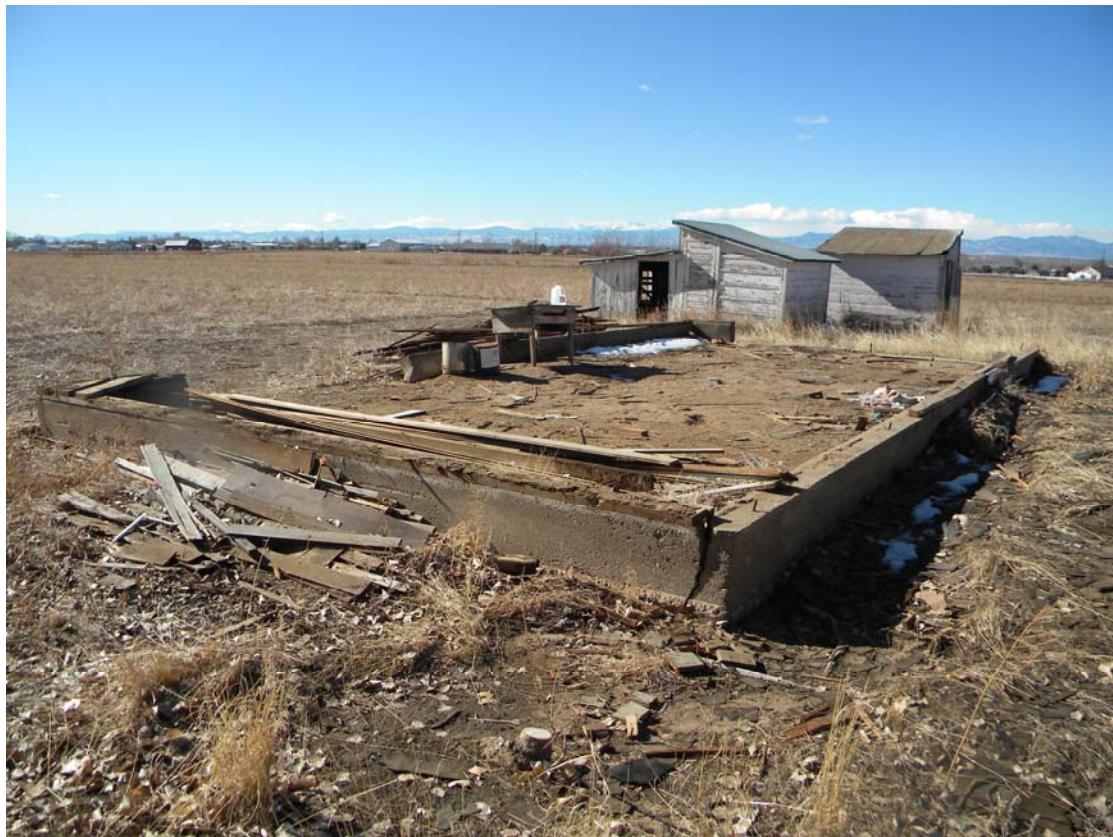
- 18e. Roof configuration: Unknown
- 19e. Primary external roof material: Unknown
- 20e. Special features: Unknown
- 21e. General architectural description: This building foundation is located on the Foley Farm a short distance west of the cluster of standing buildings containing the farmhouse. The foundation is a poured concrete slab with a low perimeter footer wall. It evidently supported a relatively large building, and piles of lumber nearby suggest that it was a wood frame, board-sided building and that it was intentionally dismantled. Its long axis is oriented east-west, and a concrete apron extends across what must have been a vehicle access opening on its west end.

Agricultural building foundation on the Foley Farm (5AM.889), view looking west-southwest.

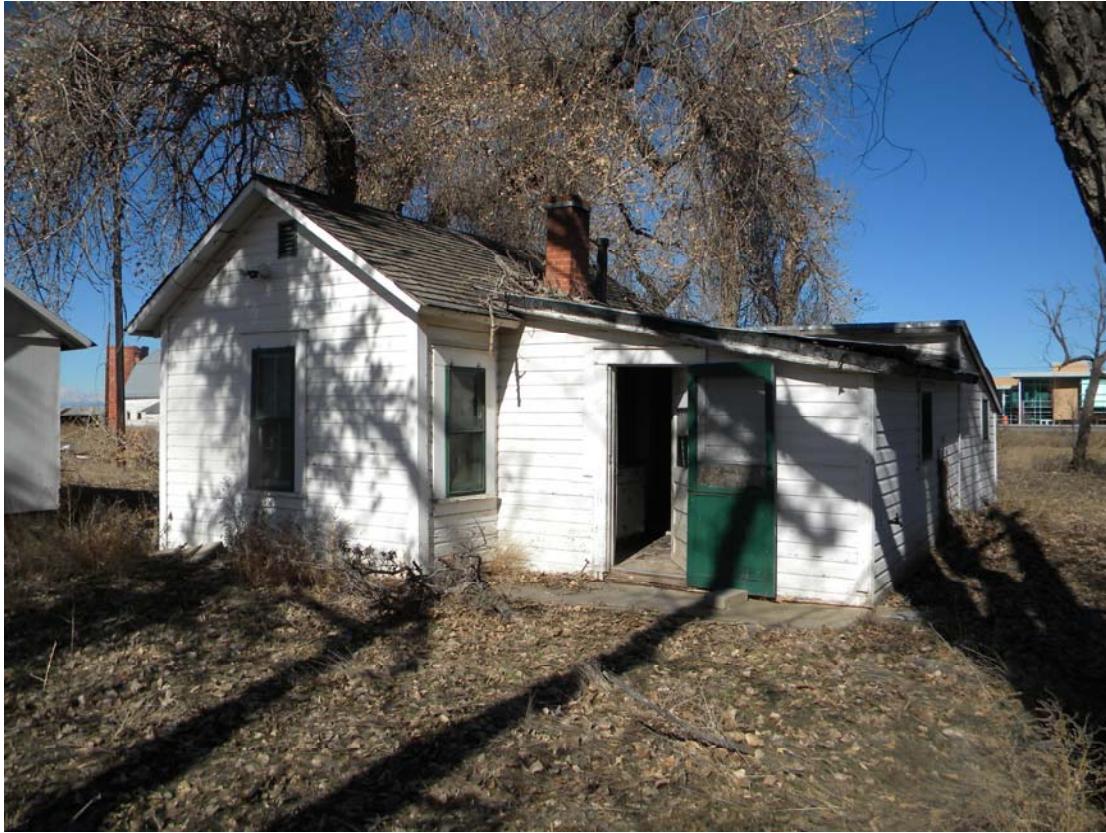
- 21a. General architectural description: This small, plain, one story wood frame house consists of the original front-gabled, rectangular plan section, with two large additions that appear to be more than 50 years old. The dwelling appears to rest on a crude stone and concrete foundation, and lacks a cellar or basement. The gable roof on the original portion of the house is moderately pitched, and rafter tails are exposed beneath the overhanging eaves. A large addition with a very low-pitched, standing-seam sheet metal-clad shed roof was evidently first built onto the east side of the gabled dwelling, and subsequently another shed-roofed addition was constructed onto the rear/north side of the gabled house and east addition. The rear addition had a more steeply pitched roof that is clad with corrugated sheet metal. The dwelling contains three entries: the original entry is on the west side of the front gabled original structure, and is equipped with a painted wood panel door framed by a wooden surround with a milled lintel molding suggestive of Colonial Revival influence. Other entries are located on the south/front side of the east addition, as well as on the west side of the rear addition. Both of these entries are also equipped with original painted wood panel doors. The original portion of the house is fenestrated mainly with tall, narrow 4/4 double-hung windows with plain board surrounds equipped with thin lintel pieces. Both of the additions are fenestrated with nearly square, 4-light fixed windows with plain board surrounds. The modest dwelling lacks ornamentation of any kind. It is generally in good condition, although the paint on the exterior siding is well-weathered, and the entry on the south side of the east addition was both ajar, and the glass pane in its door was broken as if by a projectile.

Vernacular farmhouse on the Foley Farm (5AM.889), view looking northwest.

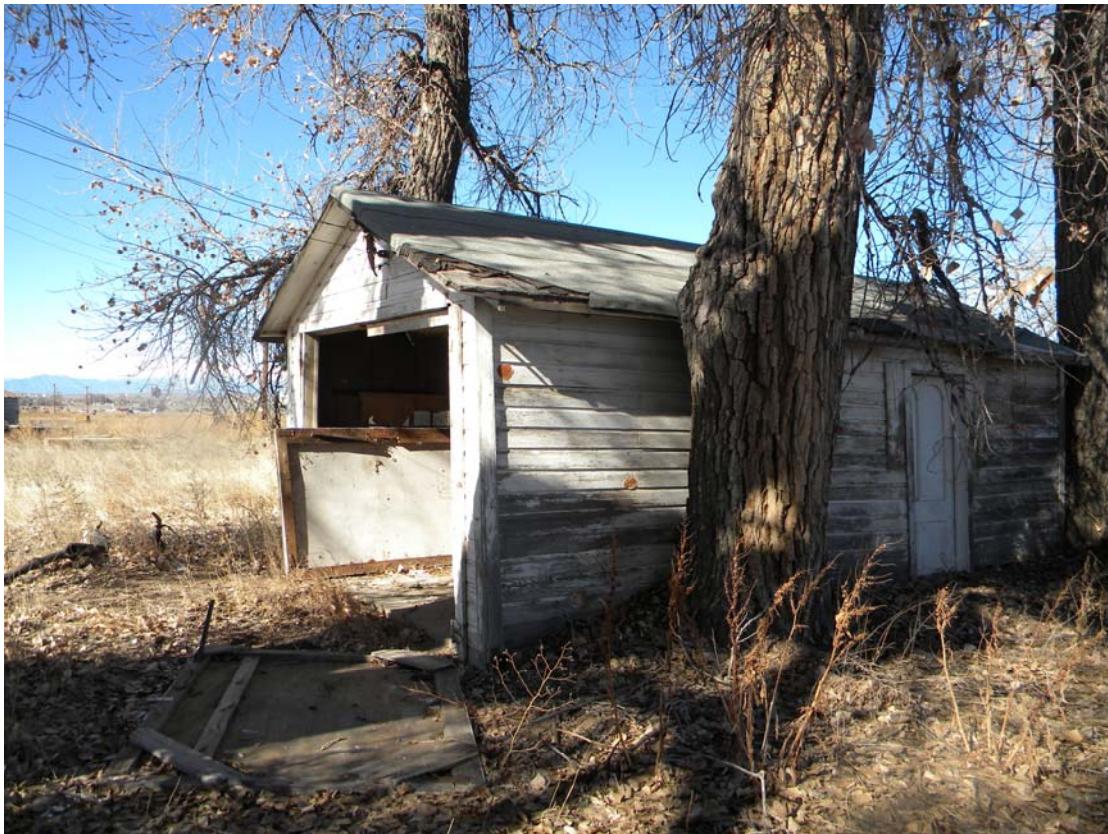
21c. General architectural description: This plain, utilitarian wood frame building is located a short distance northwest of the Foley farmhouse. It is a typical example of a detached, one car garage, exhibiting a rectangular plan, and featuring a front gable roof and drop siding applied to the exterior walls. The south-facing garage opening was originally sealed by large double hinged doors; the original doors appear to have been replaced by doors made of plywood. The building also has a personnel entry placed on the east side, offset towards the rear, that is equipped with a painted wood panel door. The garage's west elevation includes a small, double-hung wood sash window installed near the front of the building. The garage is in poor condition – its large doors have been removed and are lying on the ground, exposing the interior to the elements; its structural integrity is questionable, since the building appears to be leaning to one side as if beginning the process of collapse; and the paint on the exterior siding is weathering away, exposing much of the bare wood to the elements.

Detached wood frame garage near farmhouse, Foley Farm (5AM.889), view looking northwest.

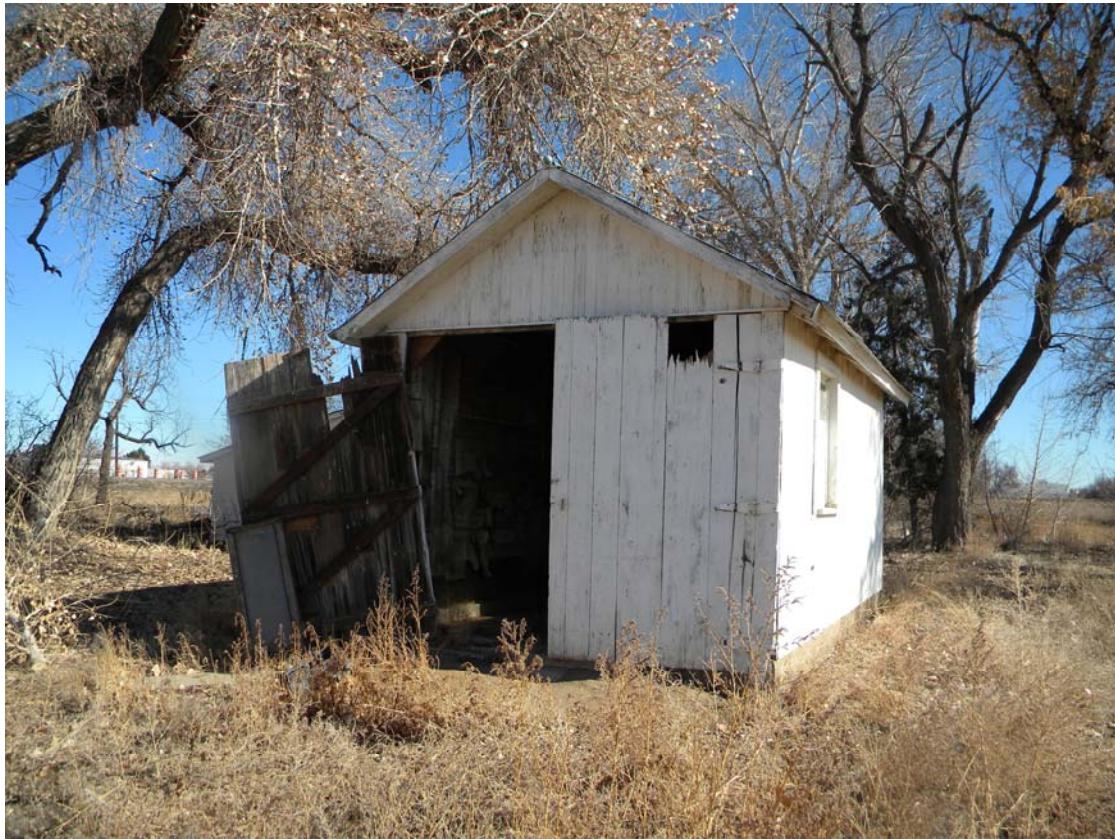
21d. General architectural description: This plain, utilitarian wood frame building is located a short distance west of the Foley farmhouse. The building rests on a concrete foundation and has a rectangular plan. It is covered by a moderately pitched gable roof, with open eaves. The vehicle access opening faces west, and is equipped with two large hinged doors made of vertical boards; both doors are damaged, and one door has a damaged hinge and was hanging open at an odd angle. A personnel entry is centered on the opposite, rear (east) end of the building, and is equipped with a narrow vertical board door attached by large strap hinges. Only one window is installed: a fixed 2/1 light window in a nearly square opening placed on the south elevation near the front of the garage. The garage appears to be relatively well-preserved, but the very good condition of the exposed concrete footer wall and exterior siding (modern wood paneling), suggest that the building is younger than many of the other farm buildings.

Detached garage or equipment shed near farmhouse, Foley Farm (5AM.889), view looking east-northeast.

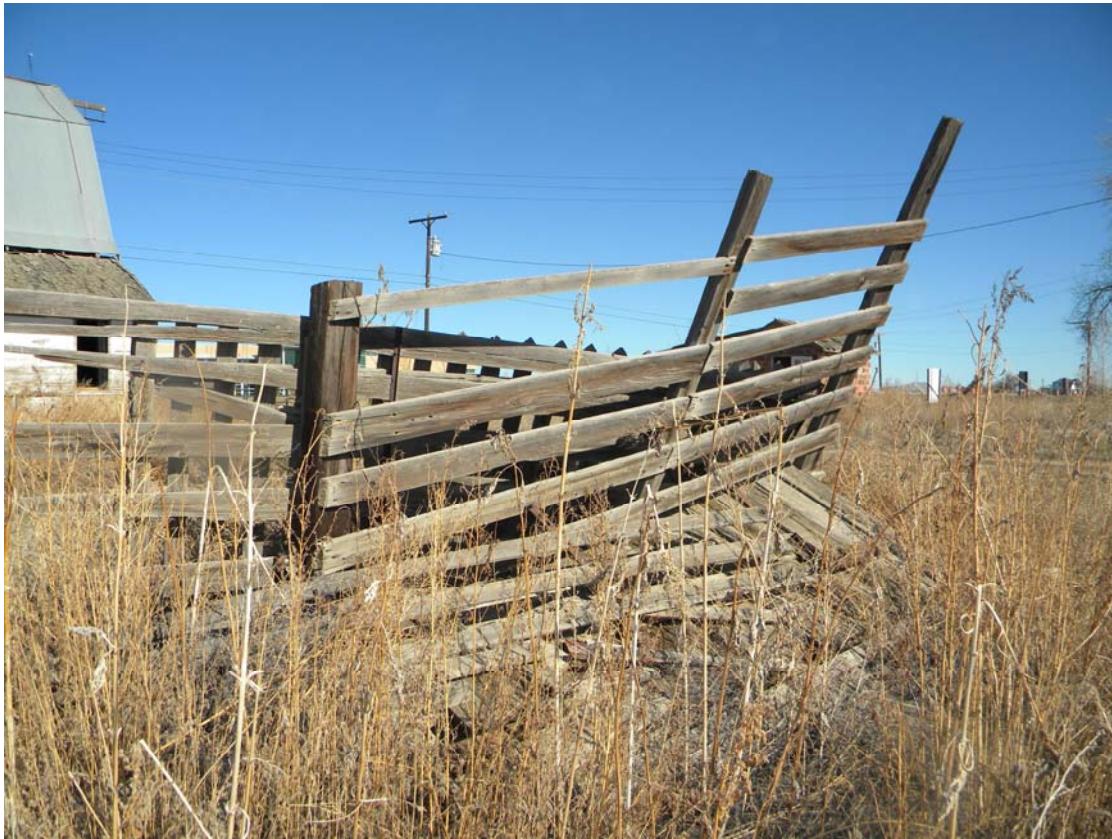
Ruins of cattle loading chute located near barn, Foley Farm (5AM.889), view looking northeast.
