COLORADO CULTURAL RESOURCE SURVEY

Architectural Inventory Form

1. Resource number: 5AM.889
2. Temporary resource number: N/A
3. County: Adams
4. City: Brighton
5. Historic building name: Foley Farm
6. Current building name: None
7. Building address: 13210 120th Avenue, Brighton, CO
8. Owner name and address: West 80 Investors, LLC
6551 S. Revere Parkway, Suite 265
Englewood, CO 80111

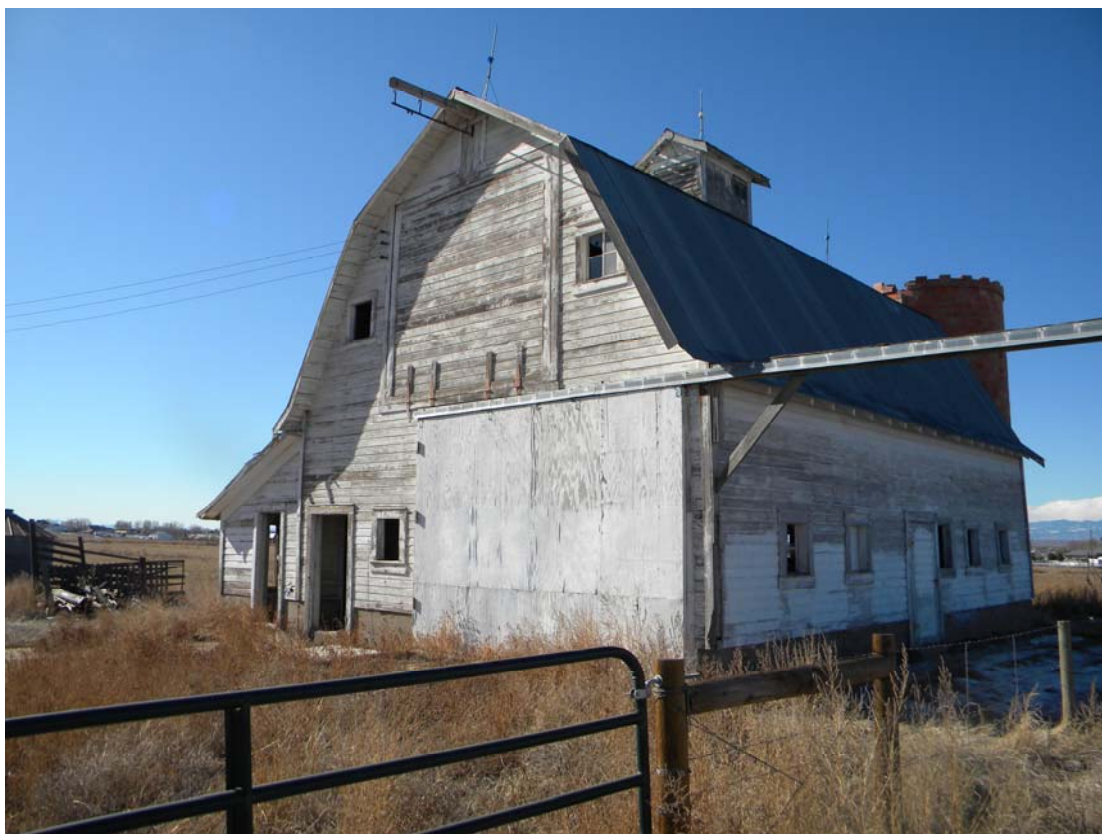
- 20j. Special features: Cupola
- 21j. General architectural description: The Foley Farm barn is a visually prominent structure located adjacent to 120th Avenue. It is a large, rectangular plan wood frame building resting on a poured concrete foundation with concrete perimeter footer walls that extend about two feet above grade. The tall building contains an upper story hayloft that is made more spacious by the building's steeply-pitched gambrel roof. A ventilation cupola covered by a diminutive gable roof rises from the center of the barn's roof. Hayloft access is provided on the building's east elevation, where a very large square hinged wooden door is installed, above which is a projecting wooden beam to support pulleys used to hoist hay bales to the barn's loft level for interior storage. The east elevation is also equipped with a very large ground level sliding door offset to the north, and the sliding rails extend beyond the north end of the barn and are supported by a timber framework embedded in the ground. The original sliding door appears to have been replaced by a relatively crude plywood-skinned door. Personnel entries are installed on east, north, and west elevations. A small room that appears to be an original design element, projects from the building's south elevation, offset to the far east end. This room extension is covered with a shed roof, and has entries on its south and east sides, and a large 4-light fixed window on its west elevation. The barn is fenestrated with a large number of nearly square window openings on all elevations, that once contained fixed 4-light windows. Many of these windows are no longer extant, but the empty window openings remain. A low wood frame wing connects the west end of the barn to a tall red tile-block solo located nearby. The barn appears to be relatively unmodified and in fair to good condition. It has lost numerous windows, and the exterior walls are badly weathered.

Barn on the Foley Farm (5AM.889), view looking southwest.

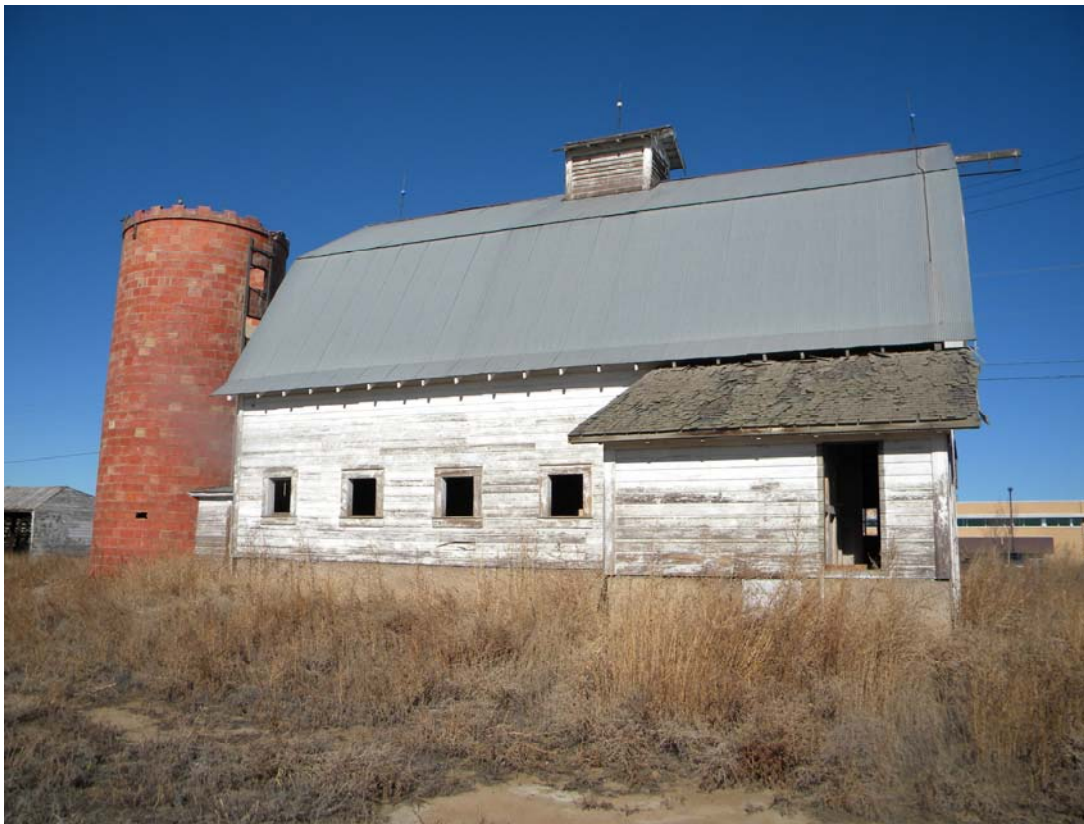
South elevation of barn on Foley Farm (5AM.588).

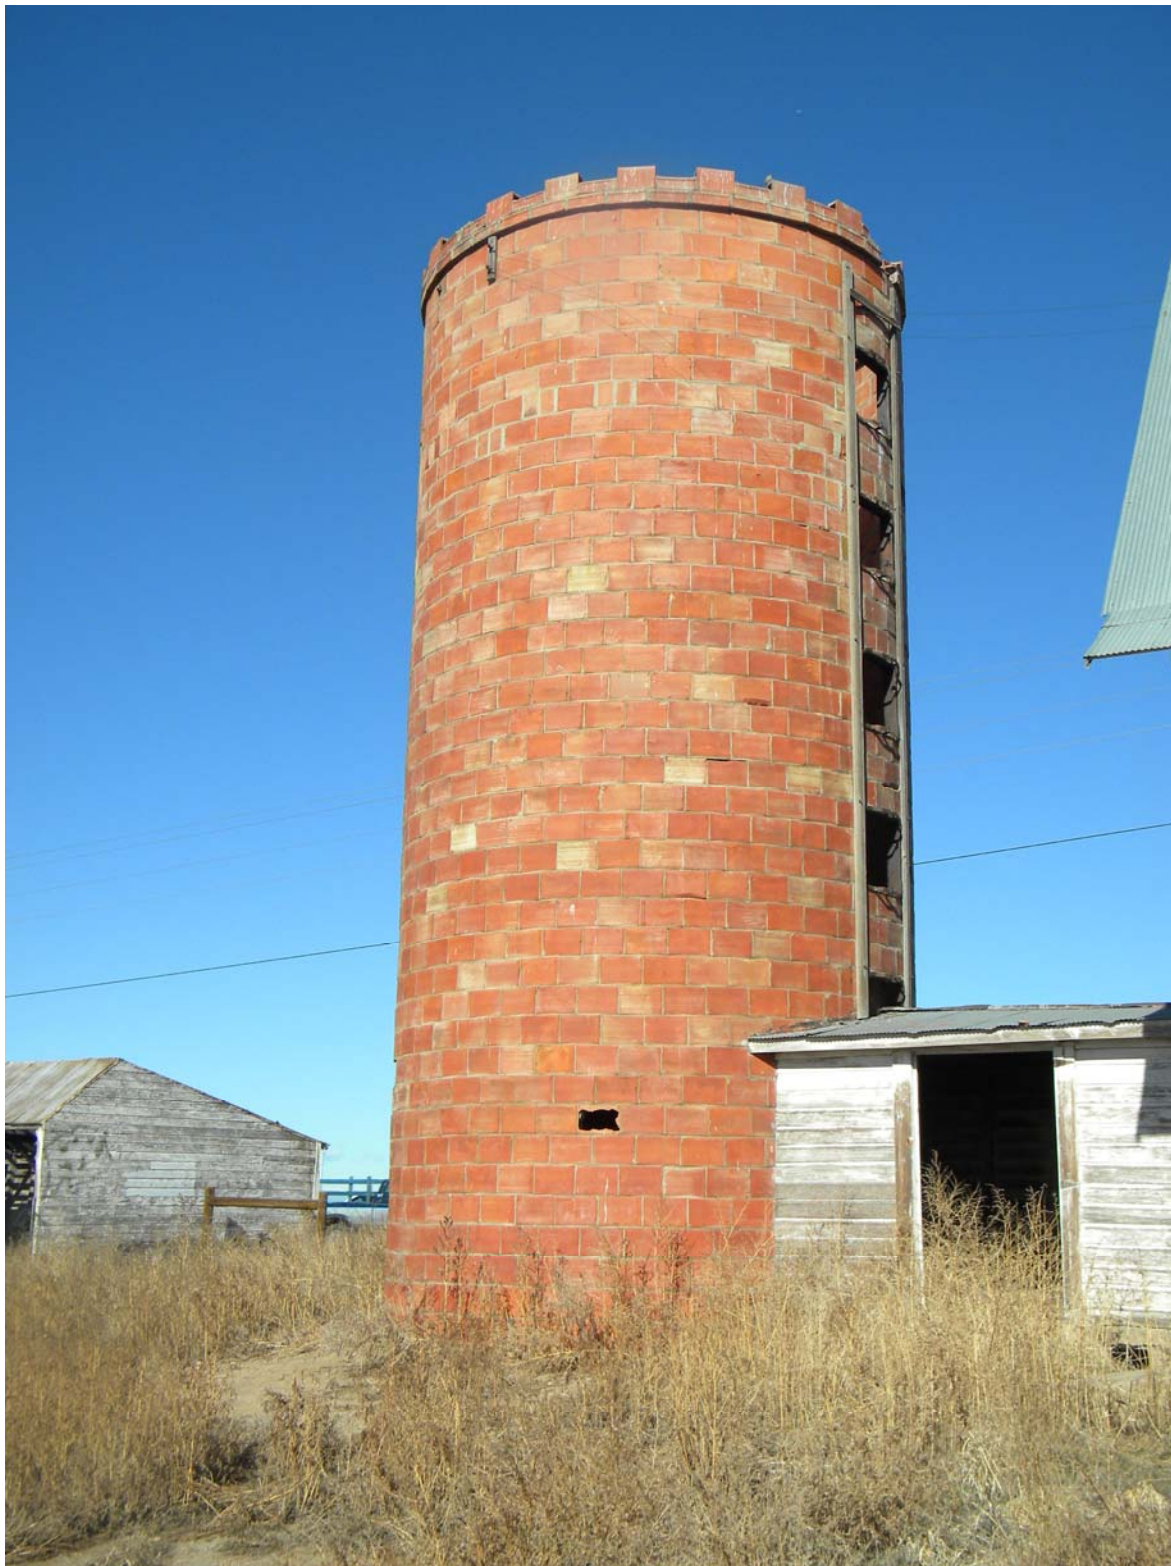
21k. General architectural description: Located a short distance beyond the west end of the barn is a tall, cylindrical red tile-block masonry silo used for storing grain. The silo is similar to many others in the region in terms of its design and size. Silos were typically used to store winter feed for livestock, and in terms of dimensions most grain silos in Colorado were approximately 20 feet in diameter and 40-60 feet tall. The Foley Farm silo is connected to the barn by means of a wood frame wing that enabled grain to be transferred from the silo through a door near its base, to feed animals kept inside the barn. The top of the silo is crenellated. The Foley Farm silo is in good condition except for damage to a small section of tile block masonry on its southwest side.

Tile block silo located near west end of barn on Foley Farm (5AM.889), view looking northwest.

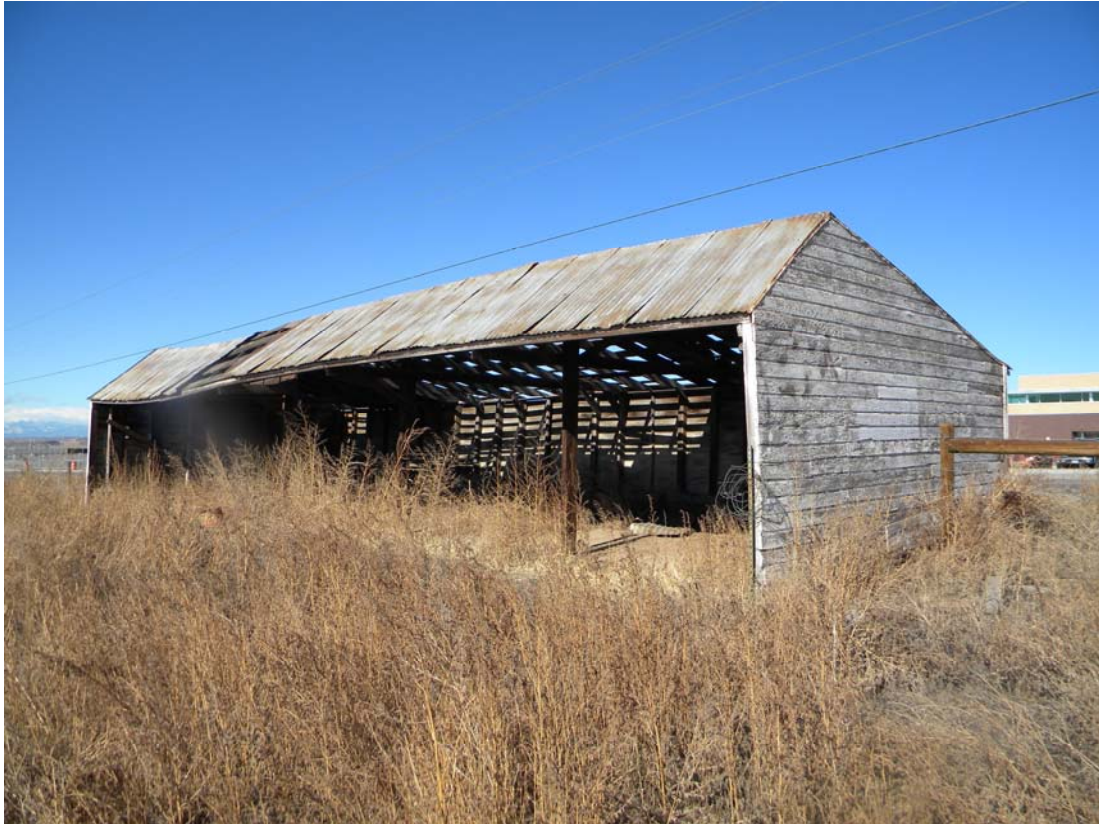
21L. General architectural description: This large agricultural outbuilding is located close to and parallel with 120th Avenue, a short distance west of the barn. It is a rectangular plan structure with an asymmetrically-sloped side gable roof. Its south side is open, and timber posts at intervals support the roof and divide the interior into four bays. The shed's exterior walls are clad with horizontal drop siding. The shed exhibits a strictly utilitarian design. The building is in fair but deteriorating condition. The roof is sagging, some panels of corrugated sheet metal roofing are no longer in place, and the painted exterior walls are quite weathered due to exposure to the elements. It is not clear if this building served historically as a machine shed (as was indicated on the site form for the Foley Farm prepared in 1995), or if it was actually used as a cattle loafing shed (as is indicated in the Adams County Assessor's property record).

Cattle or machine shed located close to 120th Avenue, Foley Farm (5AM.889), view looking northwest.

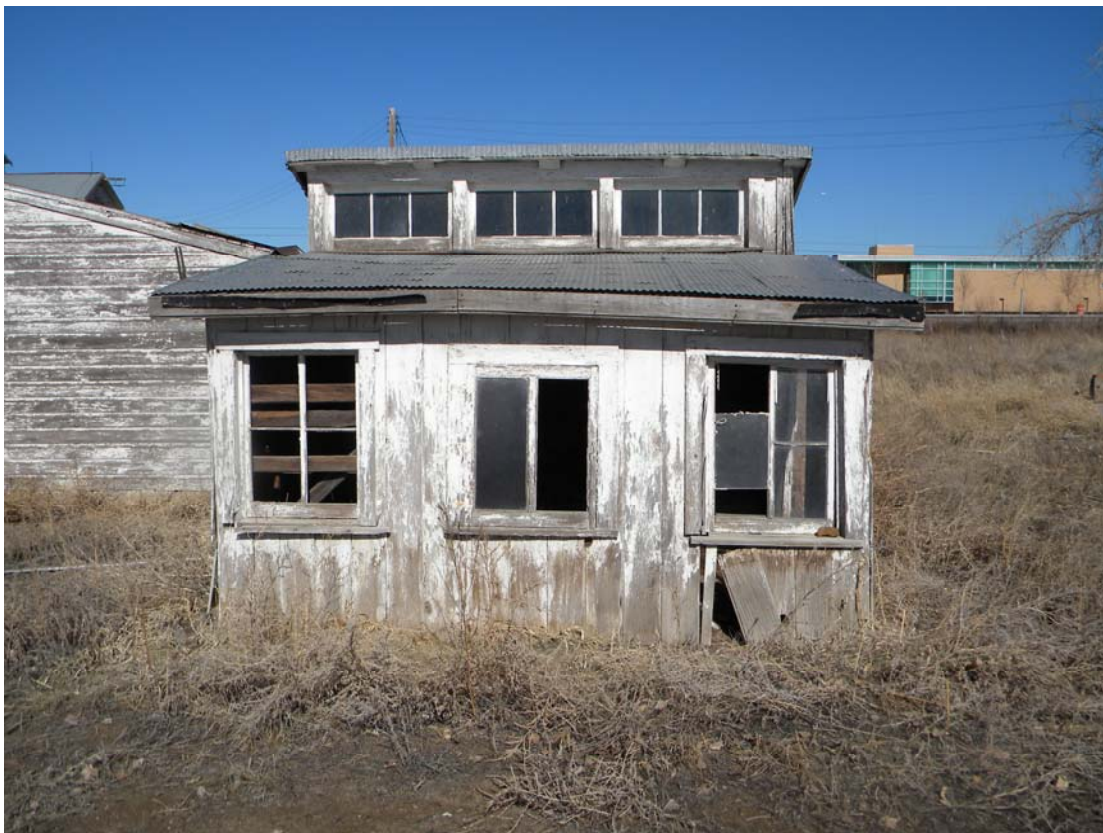
- 18f. Roof configuration: Shed roof(s)
- 19f. Primary external roof material: Corrugated sheet metal
- 20f. Special features: None
- 21f. General architectural description: This small and relatively crude wood frame structure is actually composed of two small shed-roofed sheds that have been joined together to form a larger structure. The southernmost section has a nearly flat shed roof covered with corrugated sheet metal, and walls clad with vertical board siding. A low doorway is located on the east side of this shed, and its front/south side is fenestrated with three fixed, wood sash, multi-pane windows. Attached to the north end of this small shed is a taller shed with a more steeply-pitched shed roof that slopes in the opposite direction. The northern shed section has exterior walls clad with horizontal board siding, and on the taller wall that rises above the roof of the attached southern shed is a ribbon of three horizontally-oriented 3-light fixed windows that serves as a clerestory to bring more sunlight into the building. The function of this building is not entirely clear (it may have been a chicken coop). It is in deteriorating condition, with broken windows, siding that is falling off and peeling away, and badly weathered exterior paint.

Chicken coop on the Foley farm (5AM.889), south elevation.

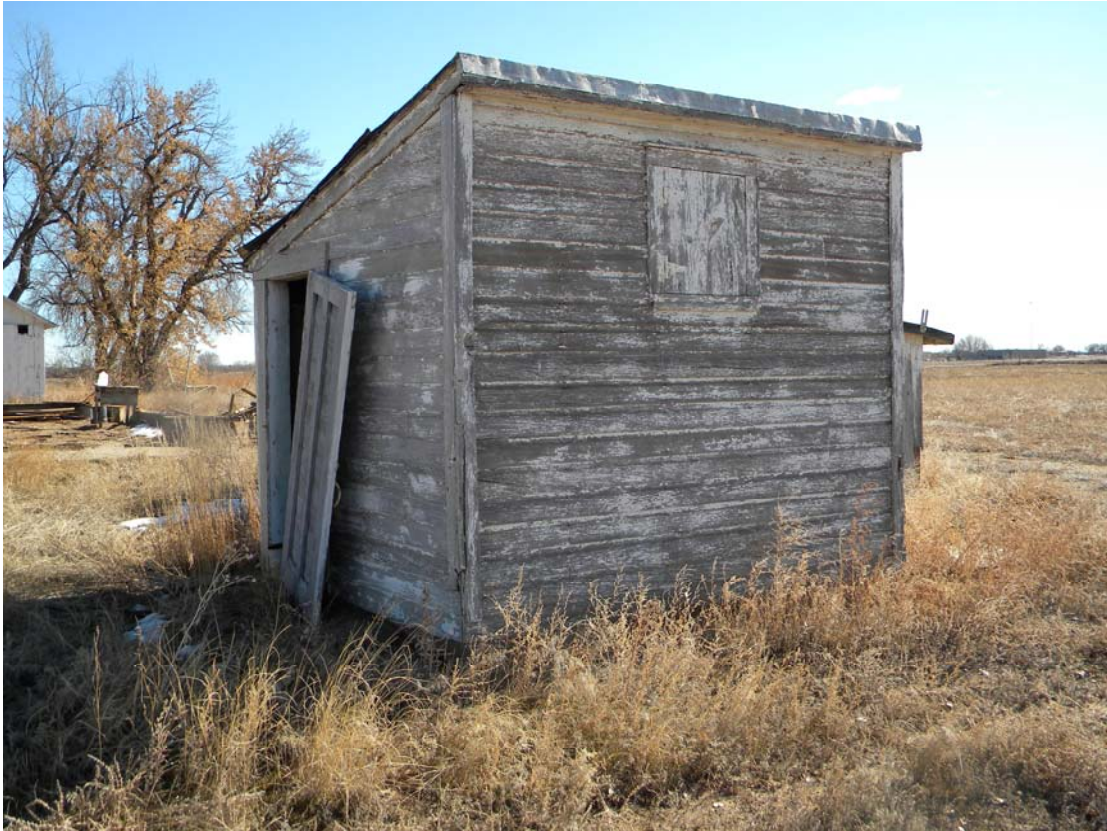
- 18g. Roof configuration: Shed roof
- 19g. Primary external roof material: Corrugated sheet metal
- 20g. Special features: None
- 21g. General architectural description: This small utilitarian wood frame building is located adjacent to the chicken coop on the Foley Farm. The shed has a rectangular plan, a rather steeply-pitched shed roof clad with corrugated sheet metal, and exterior walls clad with horizontal drop siding. Two openings are provided on this building, including a door on the north elevation, offset to the east, which was sealed with a wooden panel door (only connected by one hinge now). Another small square opening, which was either for a window or ventilation, is located on the center of the west elevation and is sealed with a hinged wooden door or shutter. The shed is relatively intact although it has suffered from exposure to the weather.

Small wood frame shed adjacent to chicken coop on Foley Farm (5AM.889), view looking southeast.

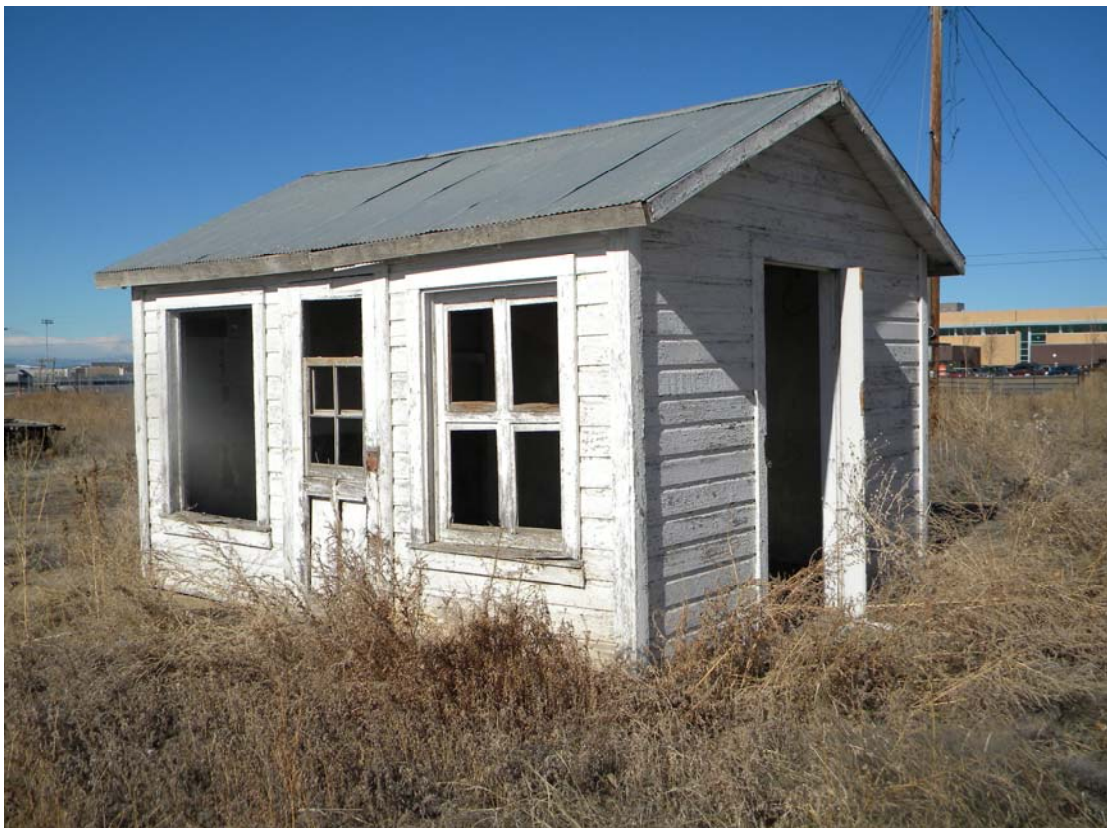
- 18h. Roof configuration: Side-gabled
- 19h. Primary external roof material: Corrugated sheet metal
- 20h. Special features: None
- 21h. General architectural description: This small wood frame building is located a short distance north of the probable chicken coop and small shed on the east side of the farm access road. The side-gabled structure has a rectangular plan and resembles a scaled-down vernacular dwelling. Its function is undetermined, but it is possible that it may represent a homestead claim shack or tenant farmhouse. The building's roof is clad with corrugated sheet metal, and its exterior walls are covered with horizontal drop siding. The building faces south, and its façade is symmetrically arranged. The main entry is centrally placed, and is equipped with a glazed and painted wooden door with 6-lights (no glass remaining). The entry is flanked by identical large window openings, only one of which still contains a window – a fixed 4-light wood sash unit. The only other opening on the building is a doorway (lacking a door) that is centered on the east elevation. The building is generally intact, except for the missing front window, missing side door, missing window and door glazing, and weathering exterior paint.

Small unidentified wood frame outbuilding on Foley Farm (5AM.889), view looking northwest.

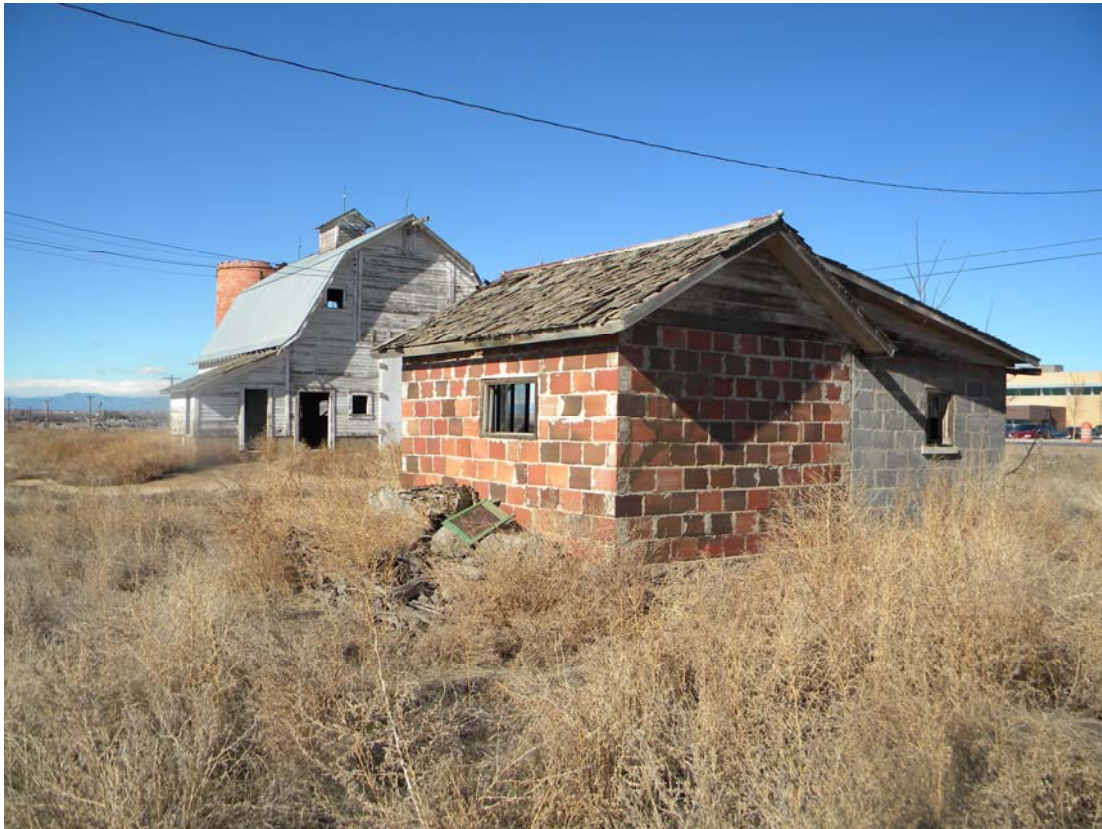
- 21i. General architectural description: This small masonry structure is located on the east side of the farm access road, opposite the barn and relatively close to 120th Avenue. It consists of two parts: the original front gabled section, which features walls constructed of red tile blocks, and a large grey concrete block-walled north side addition that doubled the size of the building and is covered by a very low-pitched shed roof. The façade of the original part of the building faces west, and has a centrally-placed doorway that is equipped with a louvered wooden door probably designed to permit ventilation. Horizontal drop siding is applied to the gable ends of the original portion of the building. A small rectangular window opening containing a fixed 3-light window is located on the south elevation. A similar window was located on the opposite/north elevation, and can still be seen by looking inside the building. Another entry is located on the front/west side of the concrete block-walled addition. One small fixed 4-light window is placed on both the north and west elevations of the addition. Inside the original part of the building, the walls are plastered, and there is a large rectangular cast concrete tank on the floor, which may have been used in the milk cooling and storage process. The building is in relatively good condition overall, although the exposed wooden siding and roof shingles reveal some deterioration due to weathering.

Milk house on the Foley Farm (5AM.889), a short distance east of barn, view looking northwest.

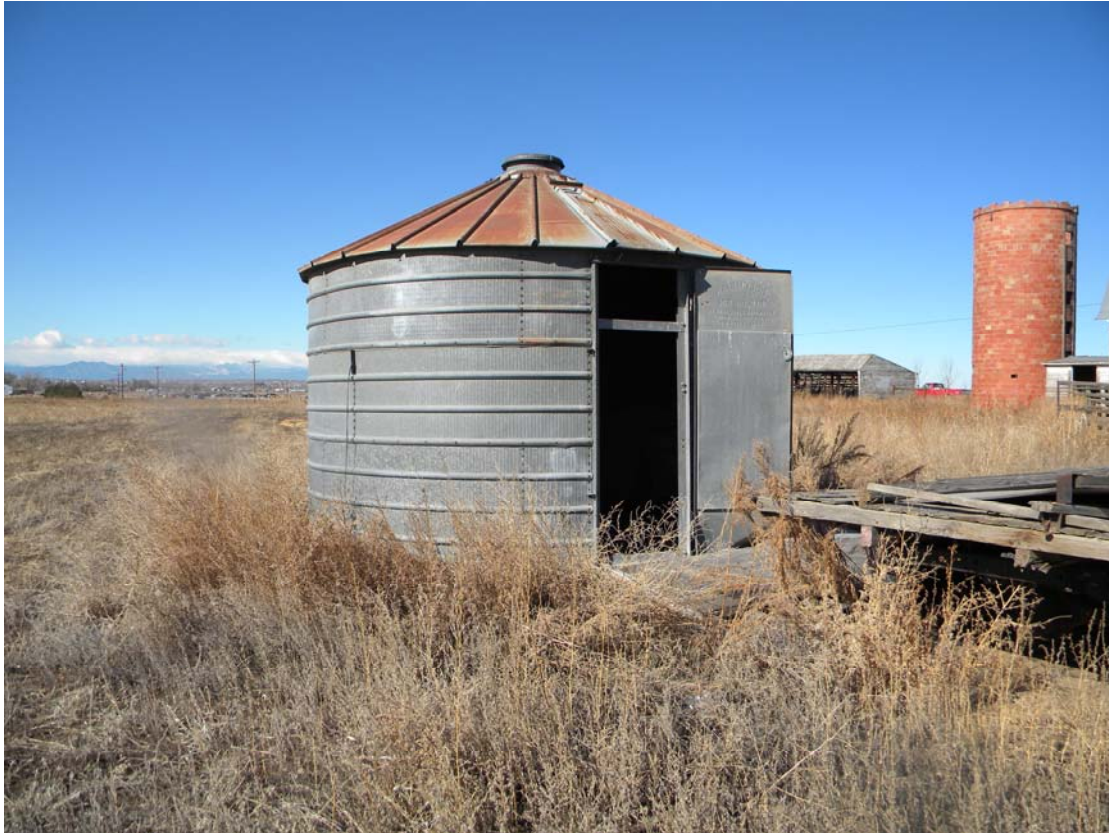
- 21m. General architectural description: This prefabricated grain storage bin is a squat cylindrical tank made of galvanized sheet metal, measuring perhaps 12 feet in diameter and about 8-10 feet in height. It is covered by a conical sheet metal roof with radiating stiffening ribs and a central ventilator cap. A hinged, curved sheet metal door is located on the structure's east side. Embossing on the tank's door identifies it as "Columbian Red Top Bin [Model] 531," manufactured by the Columbian Steel Tank Company of Kansas City, Missouri. The age of this grain bin is undetermined, but it presumably is of mid-twentieth century origin. The bin is in very good condition.

Prefabricated metal grain bin on the Foley Farm (5AM.889), view looking northwest.

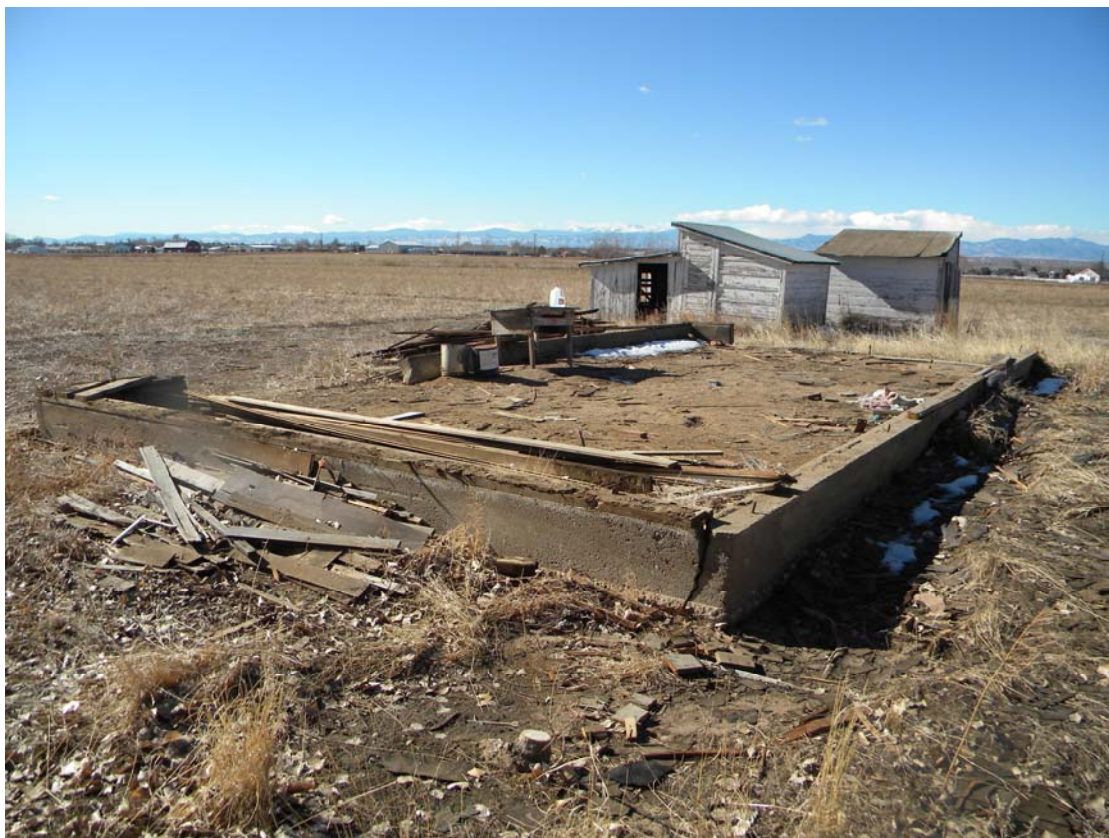
- 18e. Roof configuration: Unknown
- 19e. Primary external roof material: Unknown
- 20e. Special features: Unknown
- 21e. General architectural description: This building foundation is located on the Foley Farm a short distance west of the cluster of standing buildings containing the farmhouse. The foundation is a poured concrete slab with a low perimeter footer wall. It evidently supported a relatively large building, and piles of lumber nearby suggest that it was a wood frame, board-sided building and that it was intentionally dismantled. Its long axis is oriented east-west, and a concrete apron extends across what must have been a vehicle access opening on its west end.

Agricultural building foundation on the Foley Farm (5AM.889), view looking west-southwest.

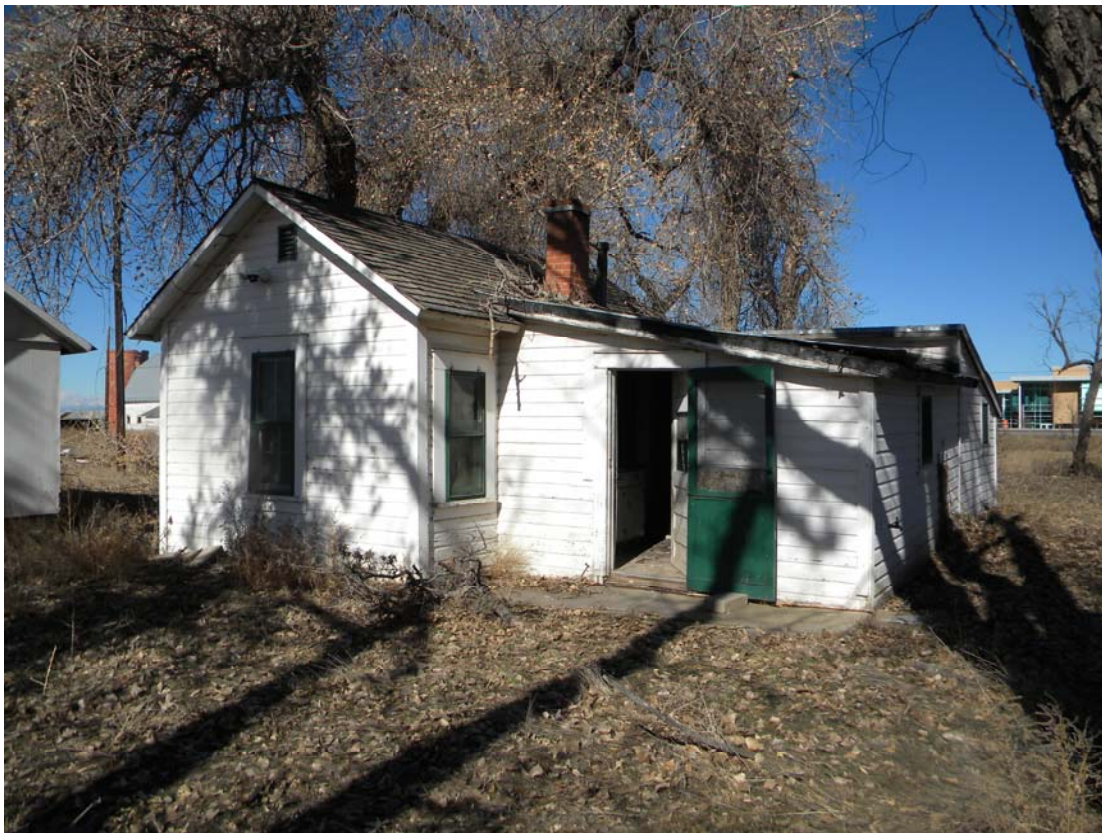
- 21a. General architectural description: This small, plain, one story wood frame house consists of the original front-gabled, rectangular plan section, with two large additions that appear to be more than 50 years old. The dwelling appears to rest on a crude stone and concrete foundation, and lacks a cellar or basement. The gable roof on the original portion of the house is moderately pitched, and rafter tails are exposed beneath the overhanging eaves. A large addition with a very low-pitched, standing-seam sheet metal-clad shed roof was evidently first built onto the east side of the gabled dwelling, and subsequently another shed-roofed addition was constructed onto the rear/north side of the gabled house and east addition. The rear addition had a more steeply pitched roof that is clad with corrugated sheet metal. The dwelling contains three entries: the original entry is on the west side of the front gabled original structure, and is equipped with a painted wood panel door framed by a wooden surround with a milled lintel molding suggestive of Colonial Revival influence. Other entries are located on the south/front side of the east addition, as well as on the west side of the rear addition. Both of these entries are also equipped with original painted wood panel doors. The original portion of the house is fenestrated mainly with tall, narrow 4/4 double-hung windows with plain board surrounds equipped with thin lintel pieces. Both of the additions are fenestrated with nearly square, 4-light fixed windows with plain board surrounds. The modest dwelling lacks ornamentation of any kind. It is generally in good condition, although the paint on the exterior siding is well-weathered, and the entry on the south side of the east addition was both ajar, and the glass pane in its door was broken as if by a projectile.

Vernacular farmhouse on the Foley Farm (5AM.889), view looking northwest.

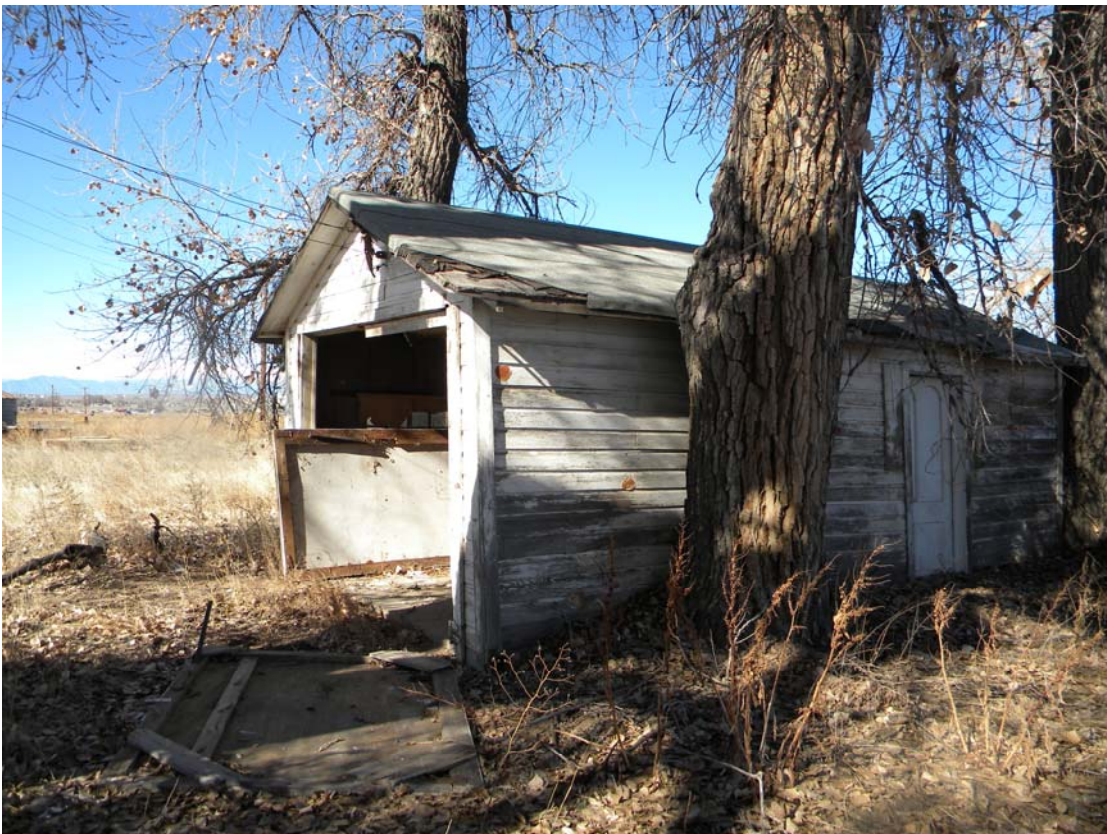
- 21c. General architectural description: This plain, utilitarian wood frame building is located a short distance northwest of the Foley farmhouse. It is a typical example of a detached, one car garage, exhibiting a rectangular plan, and featuring a front gable roof and drop siding applied to the exterior walls. The south-facing garage opening was originally sealed by large double hinged doors; the original doors appear to have been replaced by doors made of plywood. The building also has a personnel entry placed on the east side, offset towards the rear, that is equipped with a painted wood panel door. The garage's west elevation includes a small, double-hung wood sash window installed near the front of the building. The garage is in poor condition – its large doors have been removed and are lying on the ground, exposing the interior to the elements; its structural integrity is questionable, since the building appears to be leaning to one side as if beginning the process of collapse; and the paint on the exterior siding is weathering away, exposing much of the bare wood to the elements.

Detached wood frame garage near farmhouse, Foley Farm (5AM.889), view looking northwest.

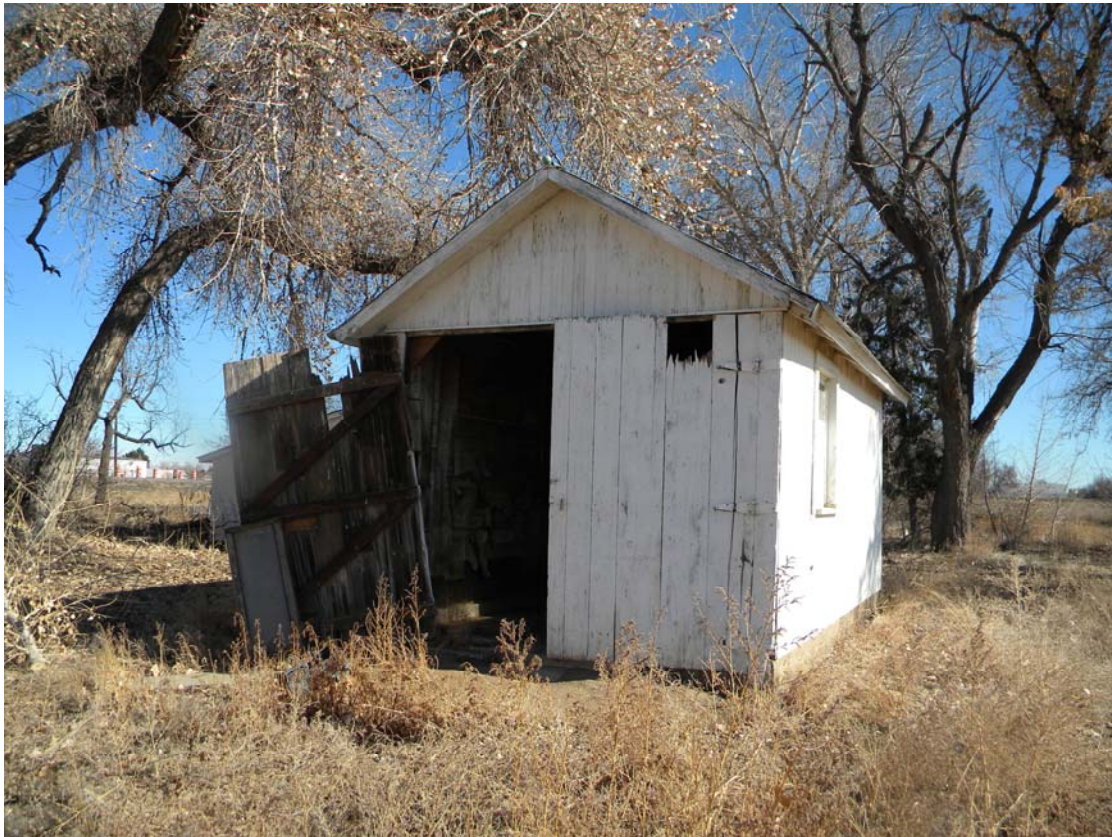
- 18d. Roof configuration: Front-gable roof
- 19d. Primary external roof material: Corrugated sheet metal
- 20d. Special features: None
- 21d. General architectural description: This plain, utilitarian wood frame building is located a short distance west of the Foley farmhouse. The building rests on a concrete foundation and has a rectangular plan. It is covered by a moderately pitched gable roof, with open eaves. The vehicle access opening faces west, and is equipped with two large hinged doors made of vertical boards; both doors are damaged, and one door has a damaged hinge and was hanging open at an odd angle. A personnel entry is centered on the opposite, rear (east) end of the building, and is equipped with a narrow vertical board door attached by large strap hinges. Only one window is installed: a fixed 2/1 light window in a nearly square opening placed on the south elevation near the front of the garage. The garage appears to be relatively well-preserved, but the very good condition of the exposed concrete footer wall and exterior siding (modern wood paneling), suggest that the building is younger than many of the other farm buildings.

Detached garage or equipment shed near farmhouse, Foley Farm (5AM.889), view looking east-northeast.

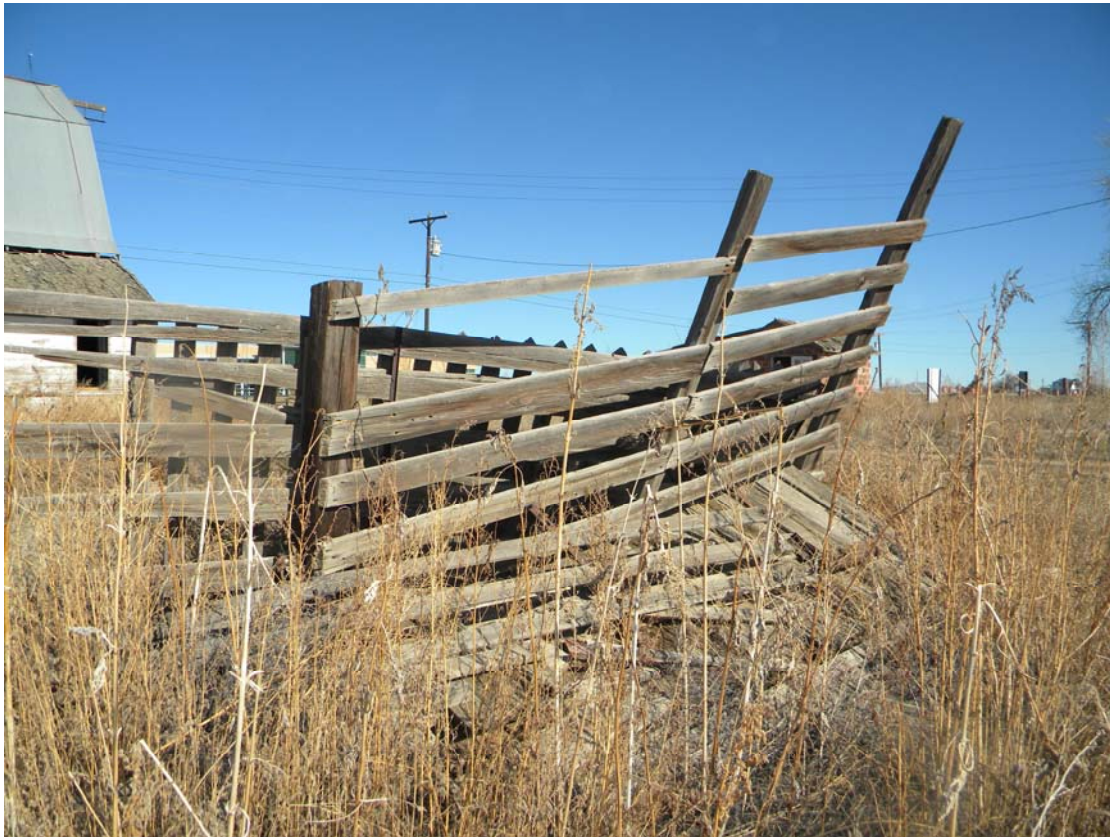
Ruins of cattle loading chute located near barn, Foley Farm (5AM.889), view looking northeast.
