Supportive, Sustainable Infrastructure

Brighton Guardrail Inspection Report City of Brighton, CO

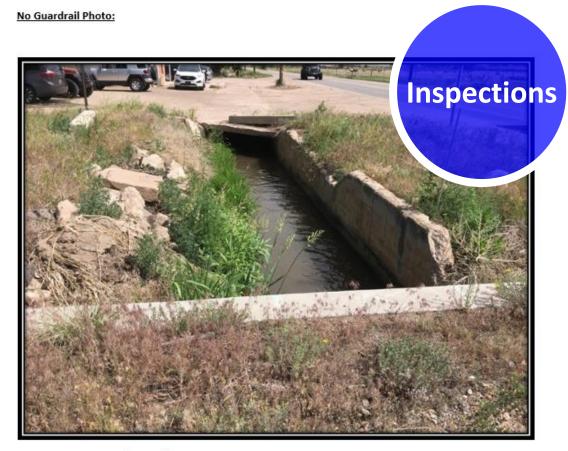
FIGURE 13: VIEWING NORTH ON THE WESTBOUND SIDE OF THE DITCH

No guardrail is in place; slab is about 22 feet. Priority 1

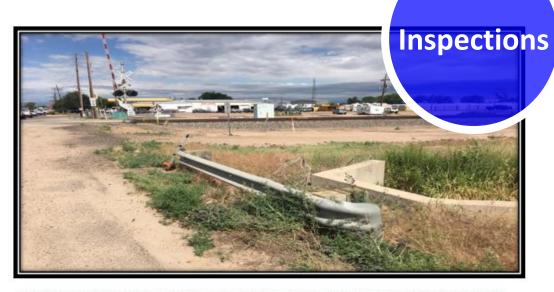
FIGURE 22: VIEWING GUARDRAIL FROM THE EAST IN THE WESTBOUND DIRECTION APPROACHING MAIN STREET (CR27)

Minor westbound damage but guardrail remains operational. Priority 5
