Pre-Demolition Asbestos Building Inspection

575 Bush St.

Brighton, CO 80601

Prepared for The City of Brighton

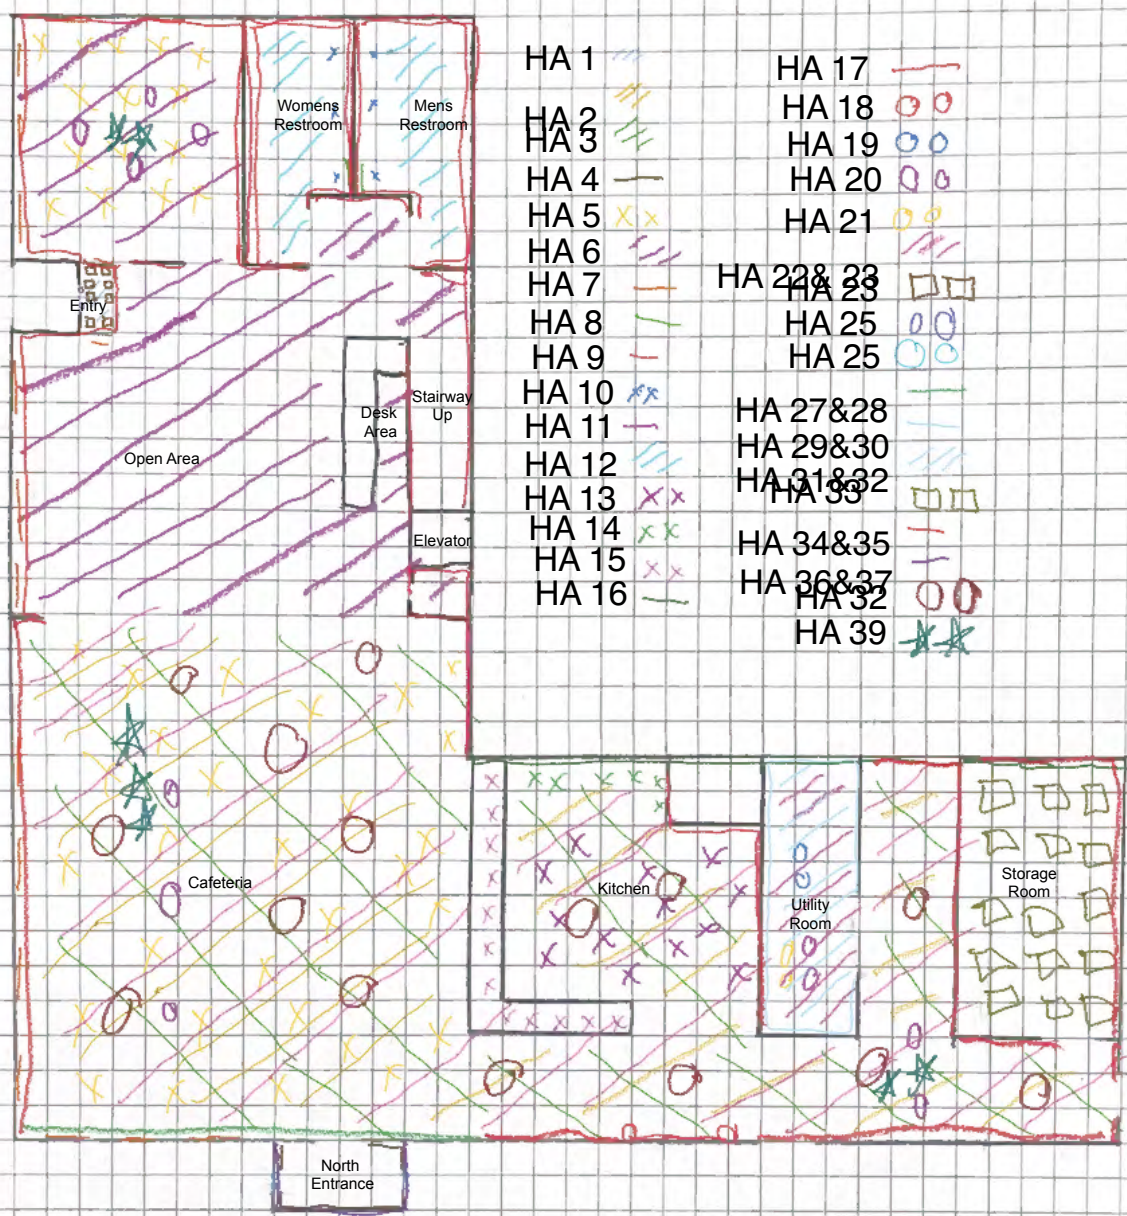
575 Bush St.
 Brighton, CO 80601
 1970's Addition 1st Floor

| HA 1 | HA 17 |

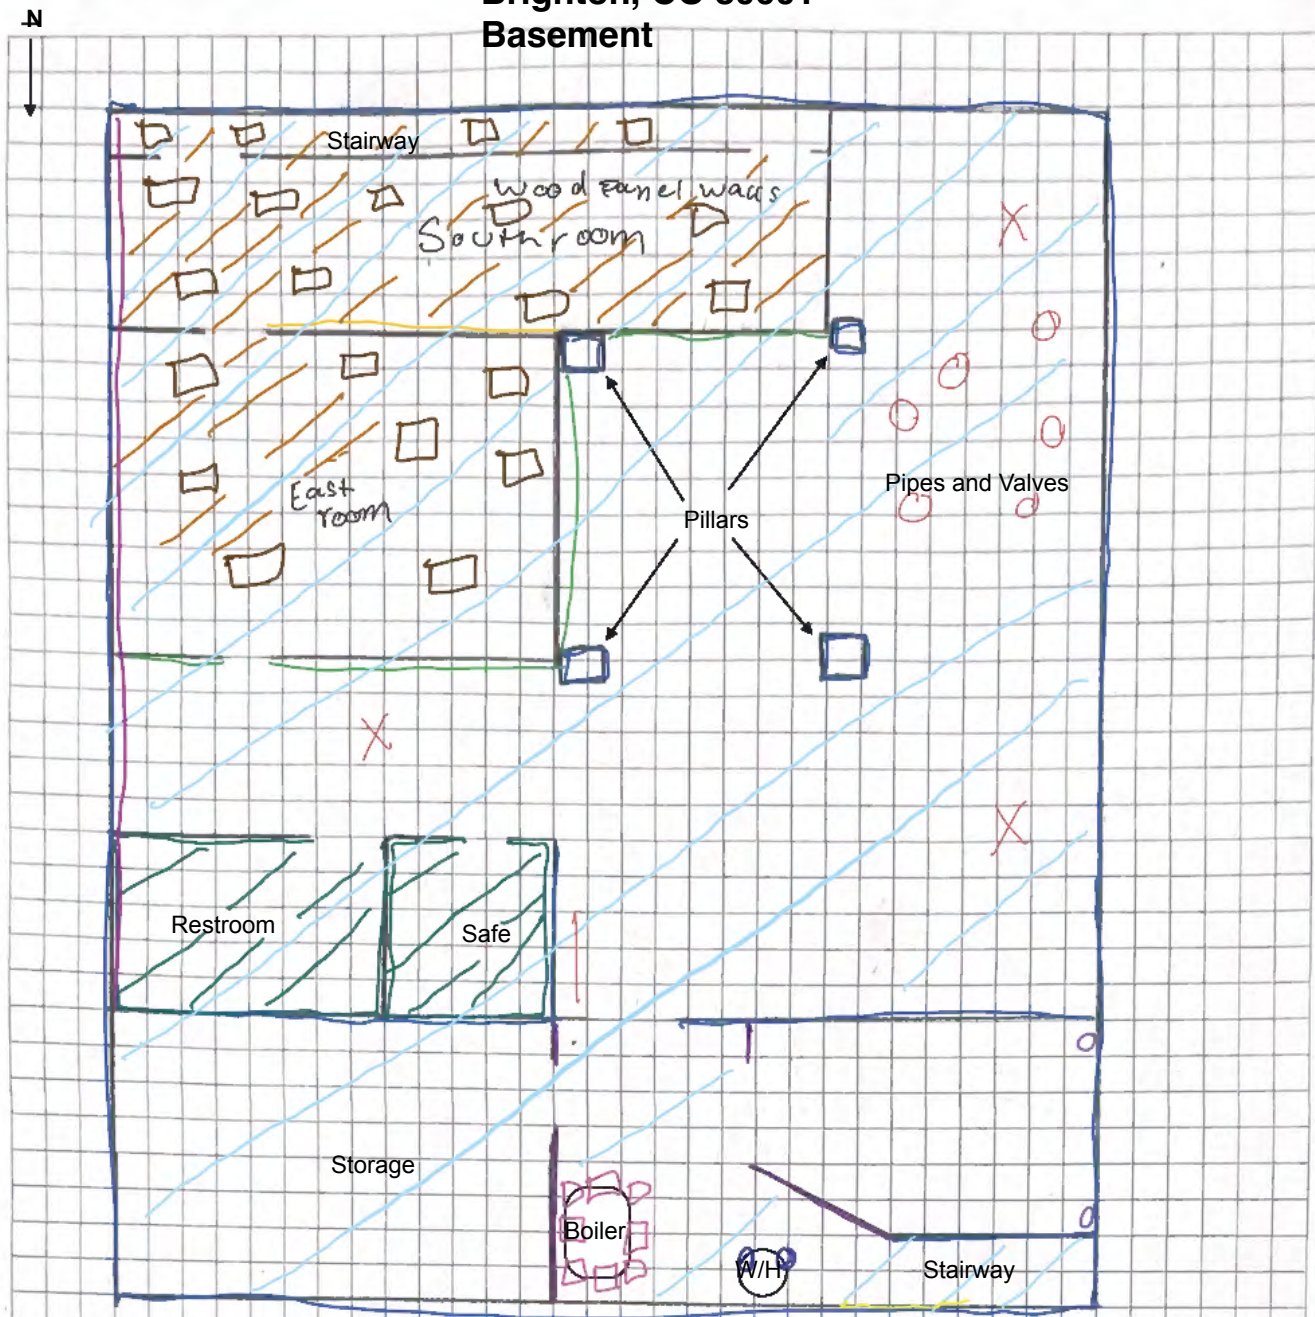
575 Bush St
 Brighton, CO 80601
 Basement

HA 97 Assumed Asbestos containing
 HA 98 Assumed Asbestos containing
 HA 99 Assumed Asbestos containing

- HA 59
- HA 60&61
- HA 62&63
- HA 64&65
- HA 66
- HA 67
- HA 68
- HA 69 Asbestos containing
- HA 70
- HA 71
- HA 72
- HA 73
- HA 74
- HA 75

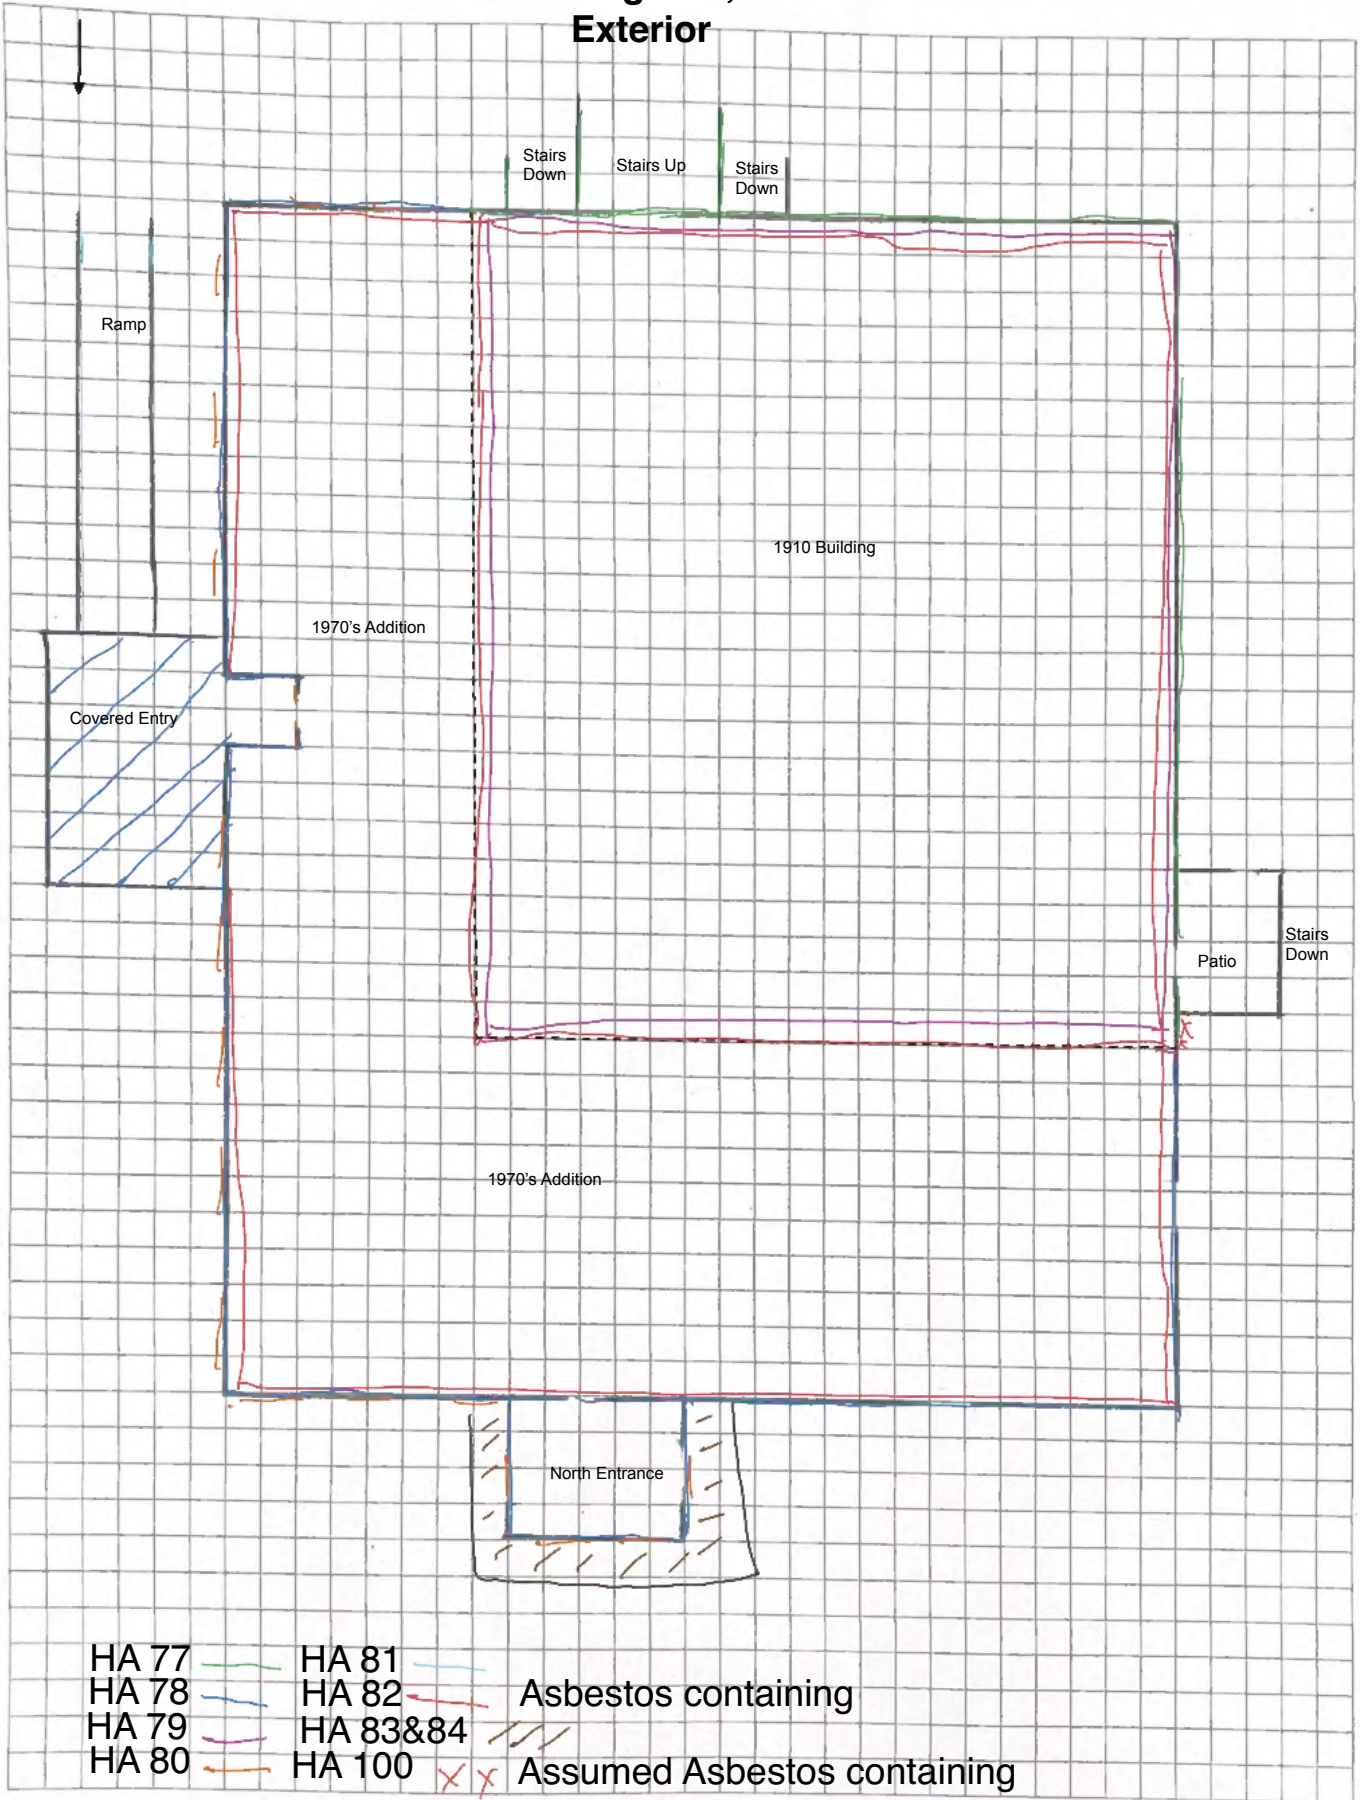
575 Bush St.
Brighton, CO 80601
Exterior

| HA 80 | — | HA 100 | X X | Assumed Asbestos containing |

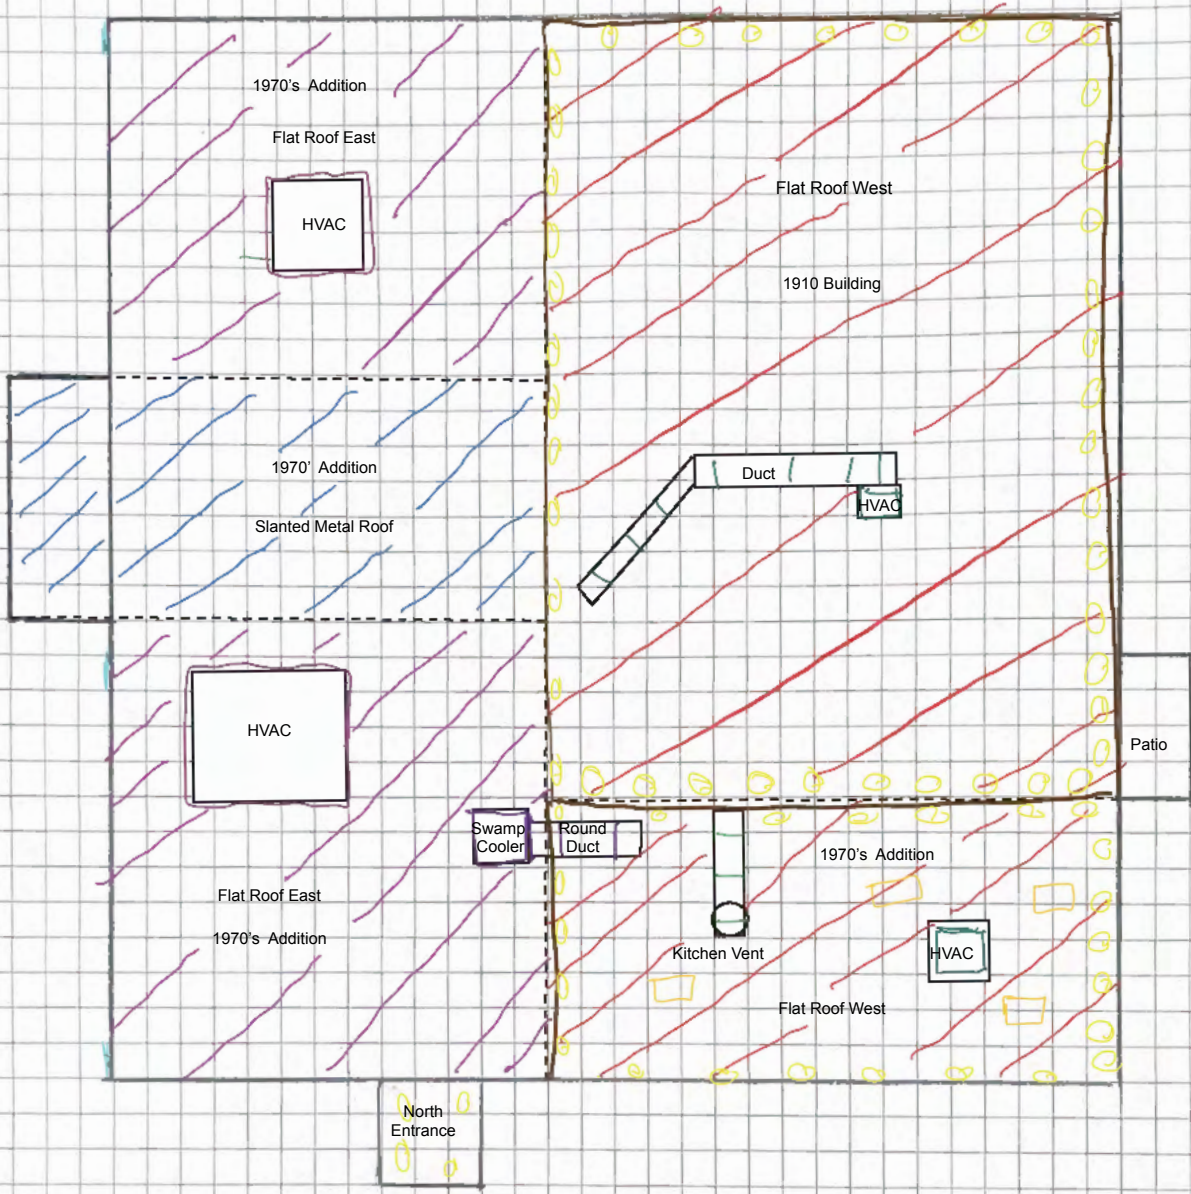
575 Bush St.
Brighton, CO 80601
Roof

- HA 85 Asbestos containing
- HA 86
- HA 87
- HA 88
- HA 89
- HA 90
- HA 91

- HA 92
- HA 93
- HA 94
- HA 95
- HA 96
