# OLD BRIGHTON SENIOR CENTER

575 Bush Street  
Brighton, Colorado

## IMPROVEMENT ASSESSMENT

Revised Draft April 24, 2013

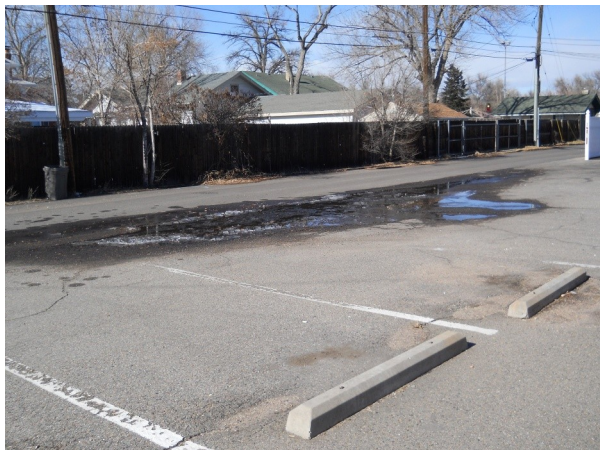
The parking lot is in fair to poor condition. The existing asphalt is cracked and alligating, and is reaching the end of its useful life. There is ponding at the northwest corner of the lot.

Ponding in parking lot

- Overlay the existing asphalt surface. Rotomilling the existing prior to the overlay is recommended to avoid building up the asphalt and impacting the minimal site drainage.

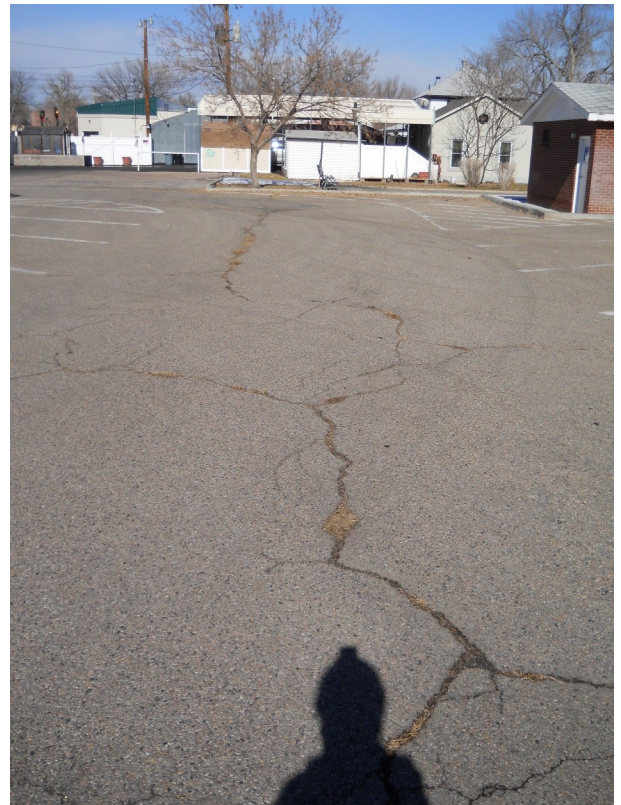
Cracked pavement at parking lot

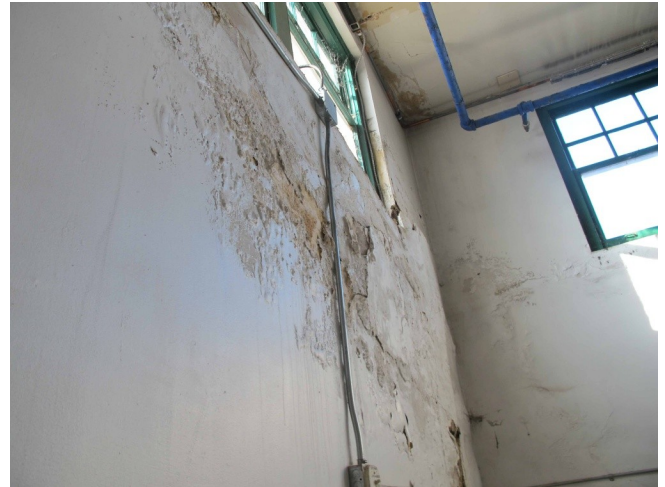
The foundations do not display any evidence of movement and appear to be functioning as intended. There is a non-breathable coating and a cement parge coat applied to the inside face of the foundation wall that is severely deteriorated. Sections of the parge coat are delaminating along the west and south elevations. The east elevation was not observable due to applied finishes. The non-breathable coating applied to the walls is trapping water in the concrete which is leading to the observed damage and deterioration.

Deterioration of parge coat at interior face of foundation walls

- Remove the coatings applied to the concrete walls and the parge coats. Once all coverings are removed, the foundation walls should be inspected for damage or deterioration. If damaged concrete is encountered, it should be removed and patched. The inside face of the exterior walls should be coated with a breathable coating.

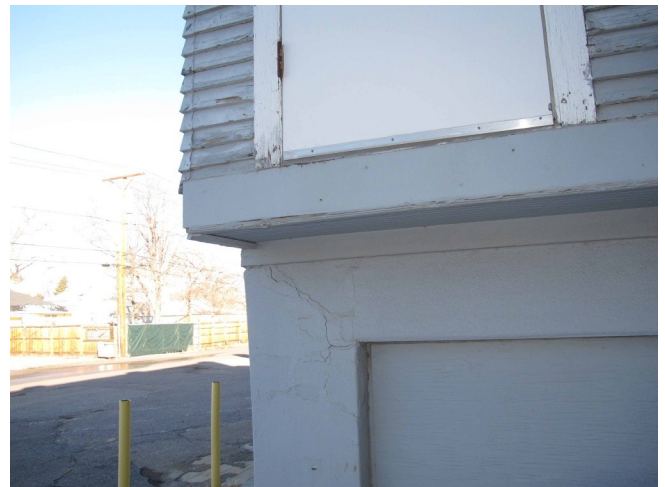
Cracking was observed at concrete framing under the west balcony. Cracks appear to be due to the restraint of the shrinkage of the concrete beam by the short concrete column. However, deterioration due to moisture intrusion appears to be enlarging the cracks.

Cracking at concrete framing under the west balcony

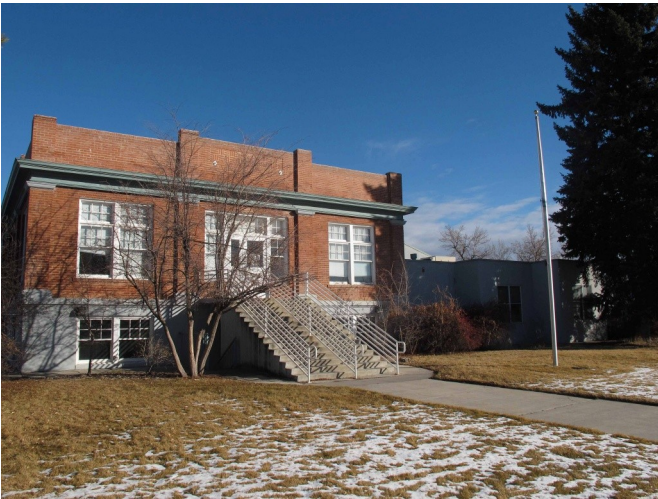
The lack of positive drainage away from the building is allowing water to build up adjacent to the structure which can lead to foundation issues or permeate into the building as noted above. Also, there are no drains observed at the base of the exterior stairs to the basement located on the south and west walls. Ponding was observed adjacent to the east side of the building around the downspouts.

Site lacks positive drainage away from the building

- Remove all landscaping and irrigation systems located within 5 feet of the structure.
- Install drains at below grade stairs.
- Replace apron at east side of 1986 addition to slope away from building.
- Installation of below-grade waterproofing and a perimeter drainage system should be considered.

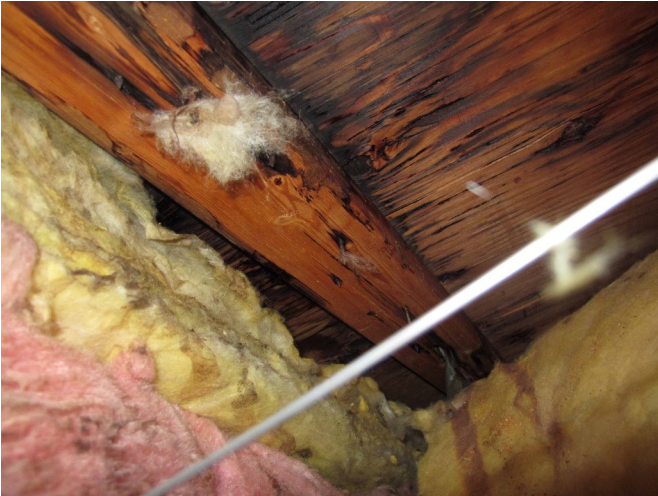
Roof deck deterioration where leaks in the roofing have occurred

The noted damage is associated with ongoing deterioration and lack of maintenance and has not impacted the structural stability of the building at this point; however, if repairs are not performed the deterioration will continue to intensify and could lead to structural issues.

- Patch delaminated and deteriorated concrete at the south entry stair.
- Repoint deteriorated mortar joints around the entire exterior of the structure. The majority of deterioration was observed on the south and west walls of the original building.
- Remove and replace deteriorated sections of roof deck. When deck is removed the structural framing should be inspected for deterioration that could affect the structural stability of the framing.
- Apply a traffic coating to the south stairs.

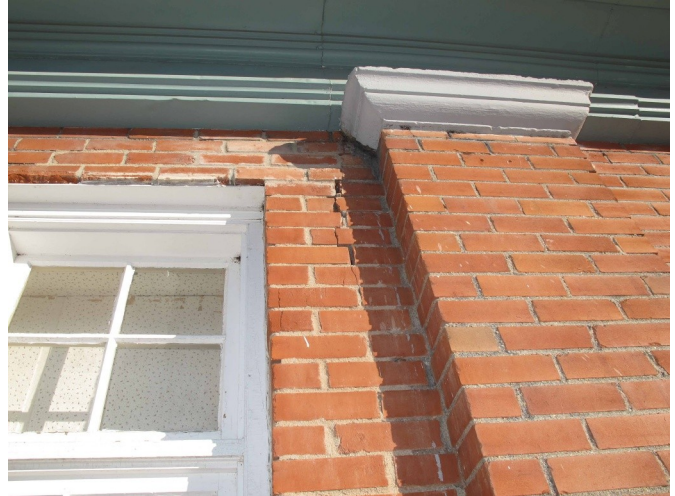
Deterioration of mortar joints

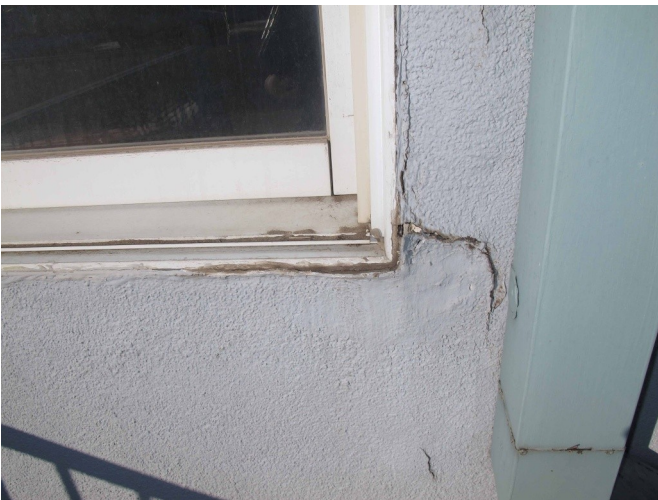
Cracking in the EIFS at the 1986 addition

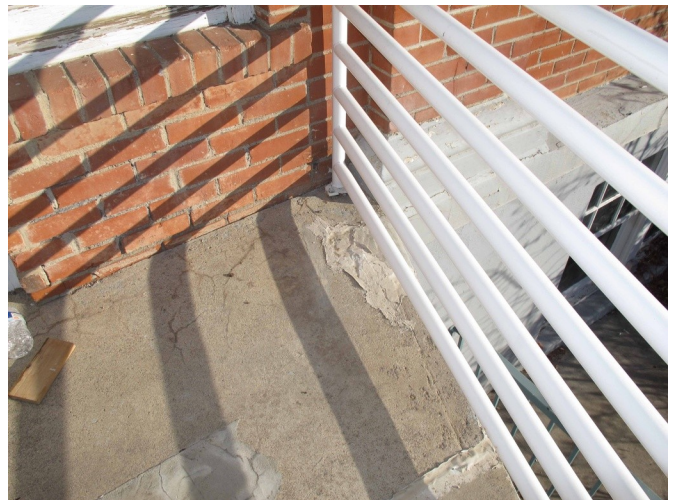
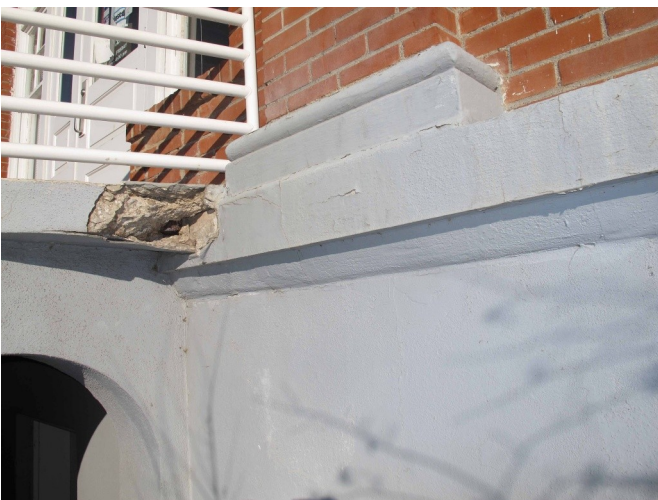
Concrete deterioration and cracking at the south entry stair landing

The concrete stair at the south entry is in poor condition. In particular, the concrete landing is cracked and concrete has spalled off at the east side of the landing, as well as at the underside of the landing.

- Patch delaminated and deteriorated concrete at the south entry stair.
- Install traffic coating on south stairs.
- Repair deteriorated wood and repaint west porch.
- Replace roof on west porch
- Repair EIFS at east entry porch.
- Replace coating on ramp at east entry.
- Repaint handrails on ramp.
- Replace flashing at top of north vestibule roof.

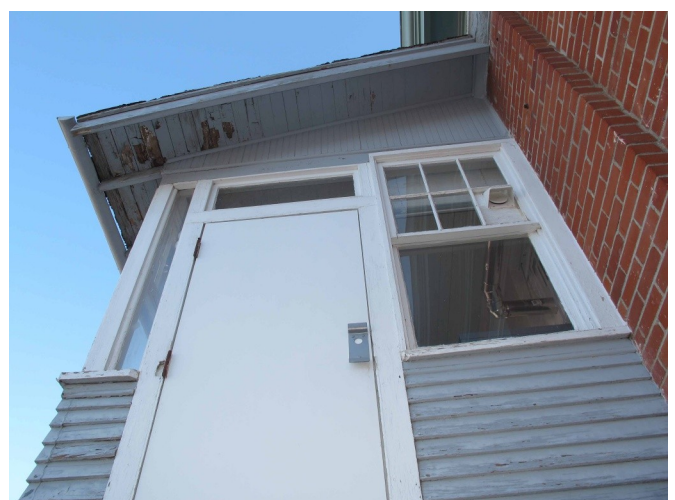
Wood deterioration at balcony roof

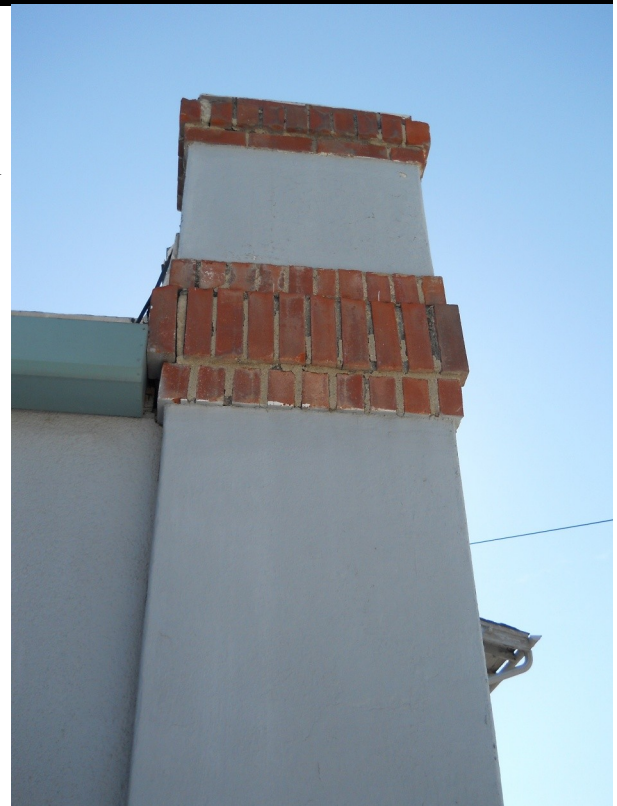
The stucco at the single story north wing is cracked in several places, and the wash on the coping is cracked.

Deteriorated mortar joints and stucco at north wing

- Repoint masonry on existing building and replace missing or damaged brick. Care should be taken to ensure that new mortar is compatible with historic masonry.
- Repair parging and repaint with a breathable coating.
- Reseal joints on sheet metal cornice and repaint.
- Repair stucco on one-story wing and repaint.
- Repair EIFS cracks on 1986 addition, and replace sealant at windows.
- Repaint sheet metal coping.

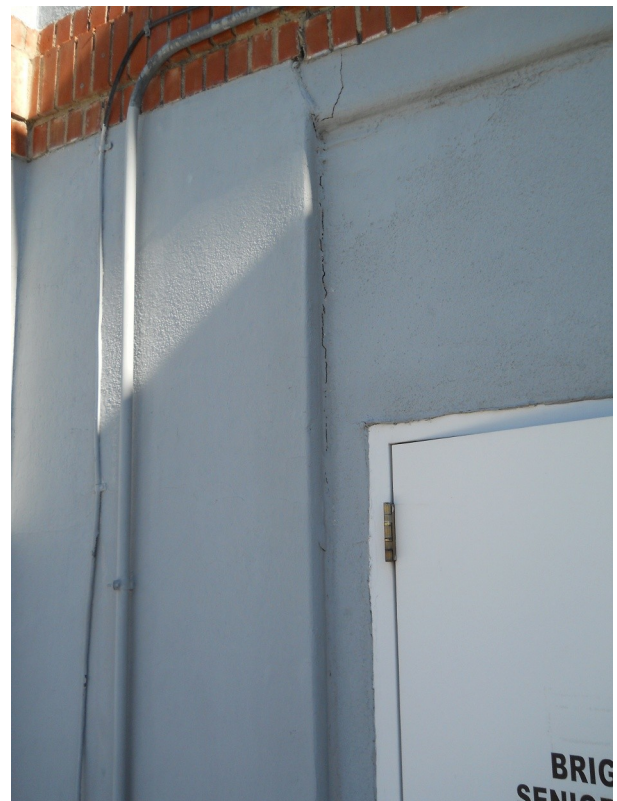
Deteriorated stucco at north wing

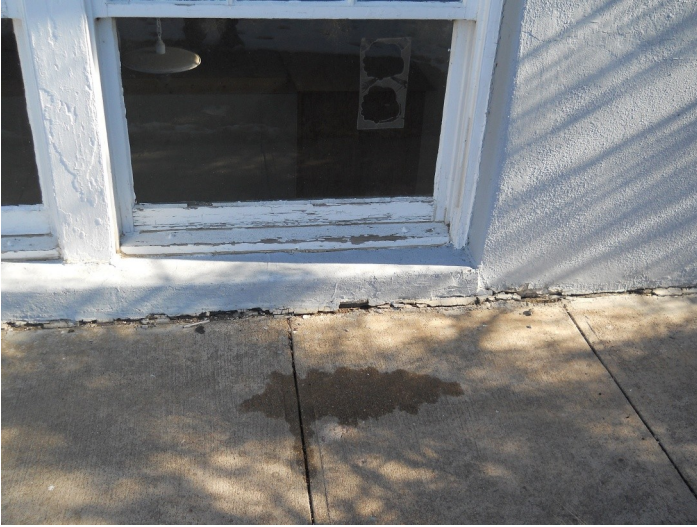
Portions of the parging are in poor condition, especially where it meets the adjacent sidewalk. The paint on the parging coat is peeling in some areas.

Deteriorated parking at grade

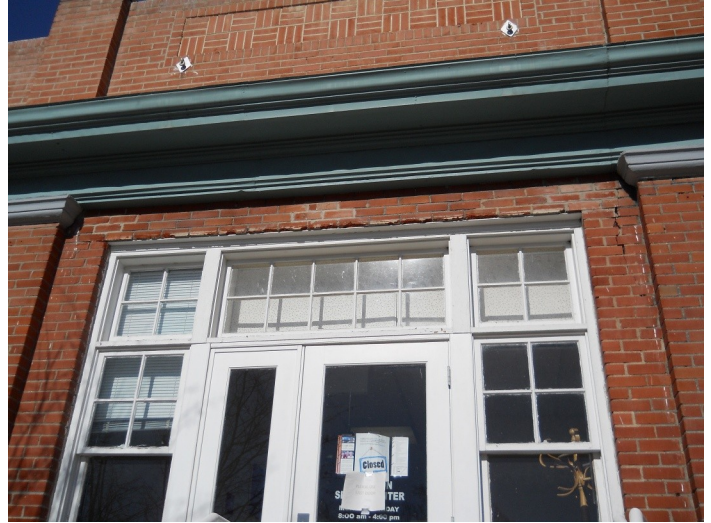
The brick on the original building needs repointing. In particular there are cracked bricks in the header of the south entry and adjacent to the pilaster east of the entry. The brick is deteriorated at the chimneys on the original building.

Damaged brick at south entry

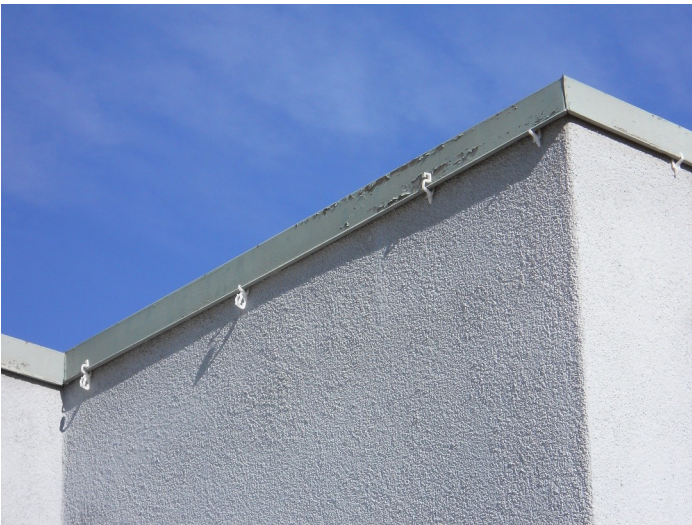
The paint is failing on the sheet metal coping at the 1986 addition, and the metal is beginning to corrode.

Failing paint at metal coping

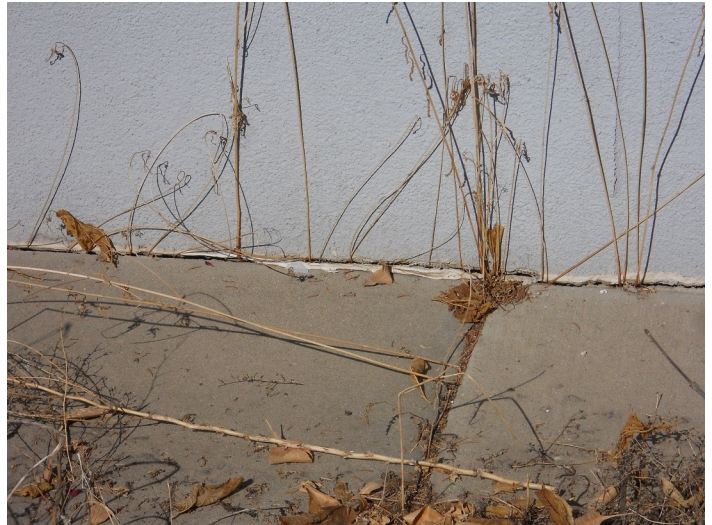
Deteriorated sealant joint at grade

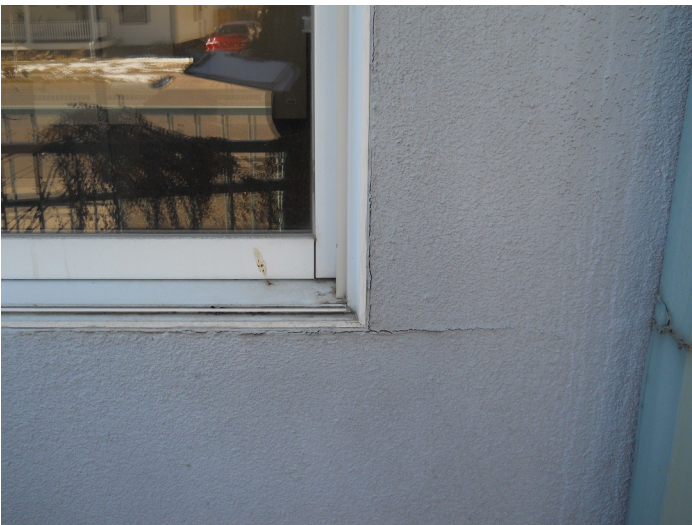
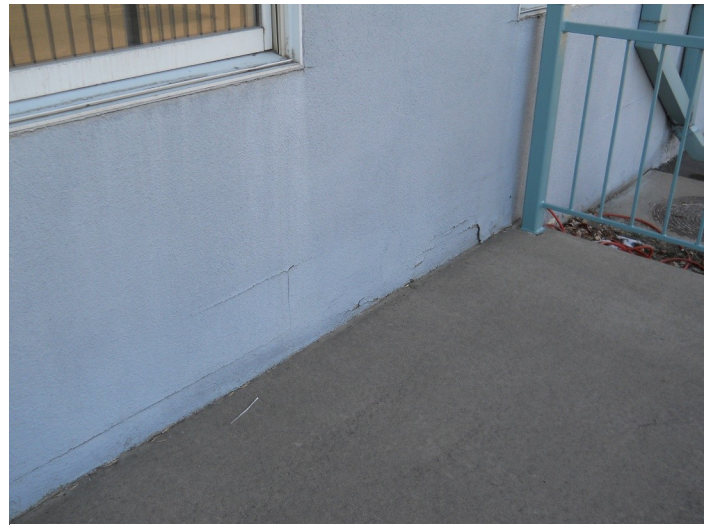
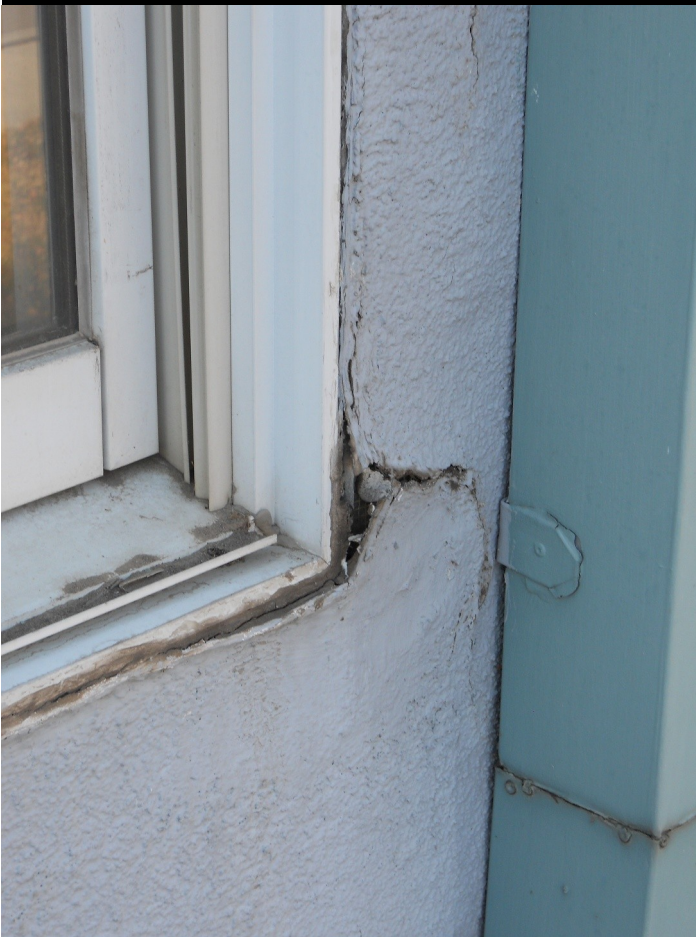
The EIFS on the 1986 addition is cracked in numerous places, especially around the windows. In addition the joint at the base of the wall is in poor condition.

Cracks in EIFS at 1986 addition

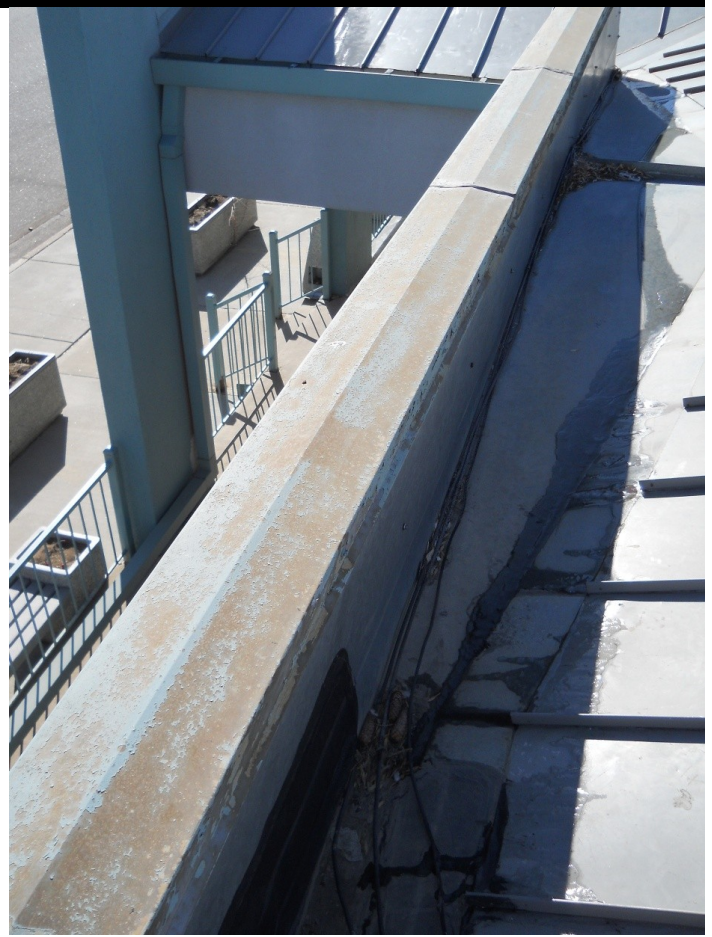
Corrosion at sheet metal coping

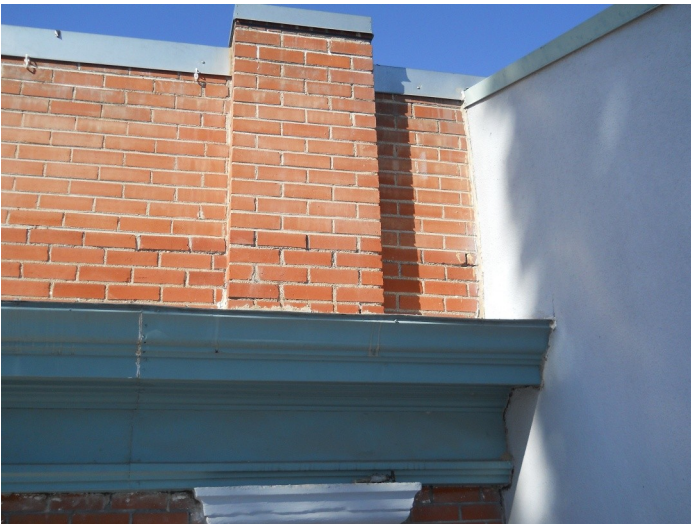
Deteriorated mortar at original building

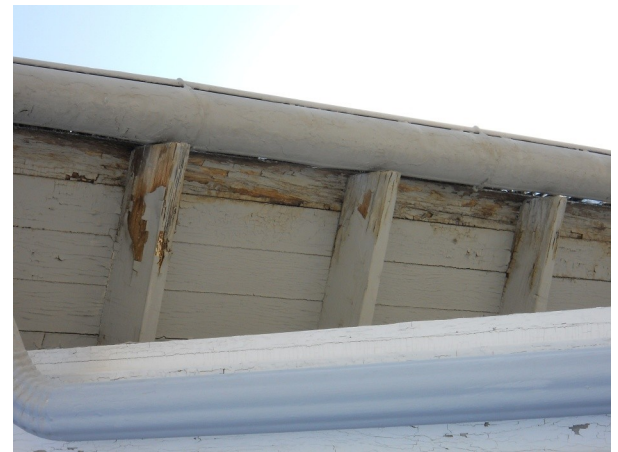
The wood porch at the west elevation is in poor condition, with failing paint and deteriorated wood siding and exposed sheathing at the soffit. The asphalt shingle roof is in poor condition. The EIFS at the east entry is cracked. An elastomeric coating was applied to the curbs of the ramp and this is failing as well. The handrails at the ramp need to be repainted.

Deteriorated sheathing and rafters at west porch

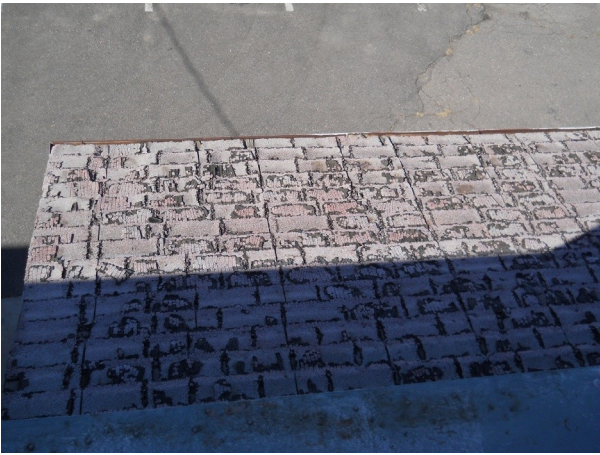
Asphalt shingle roof at west porch

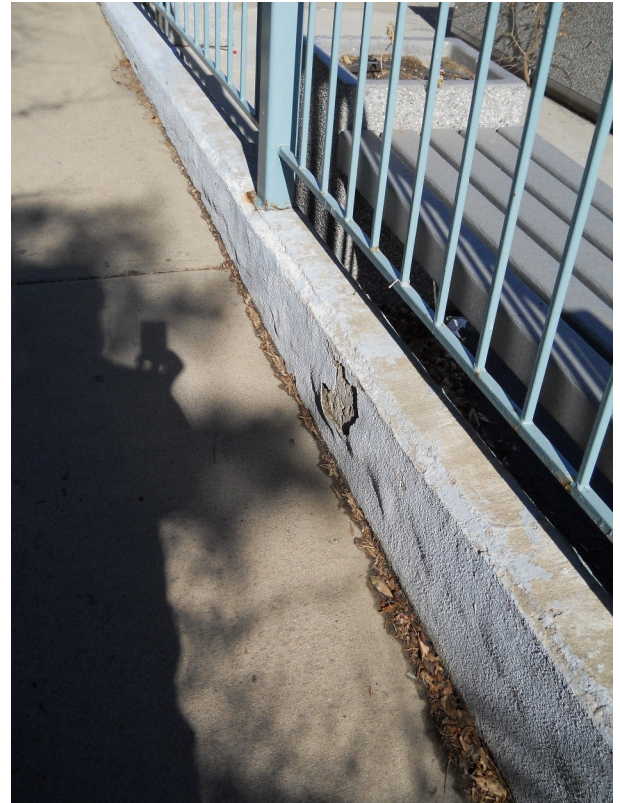
Deteriorated coating at east entry ramp

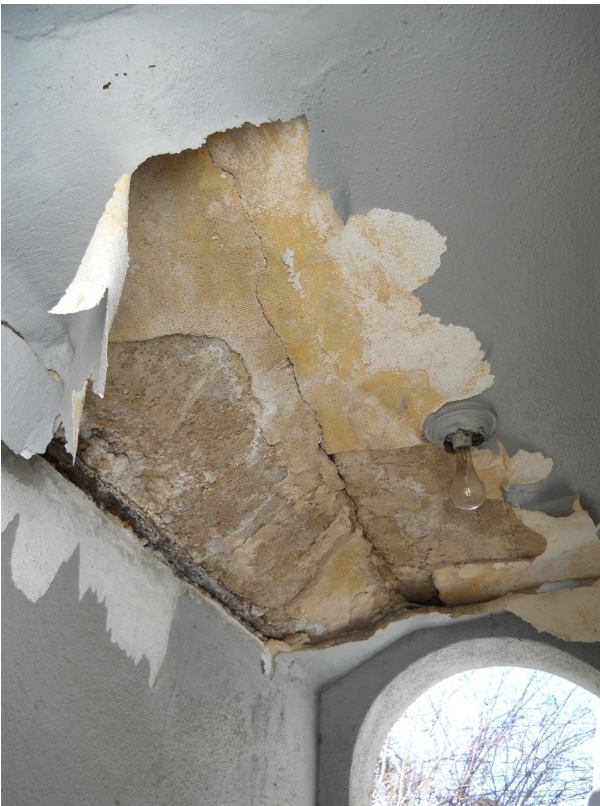
Concrete slab deterioration at south entry landing

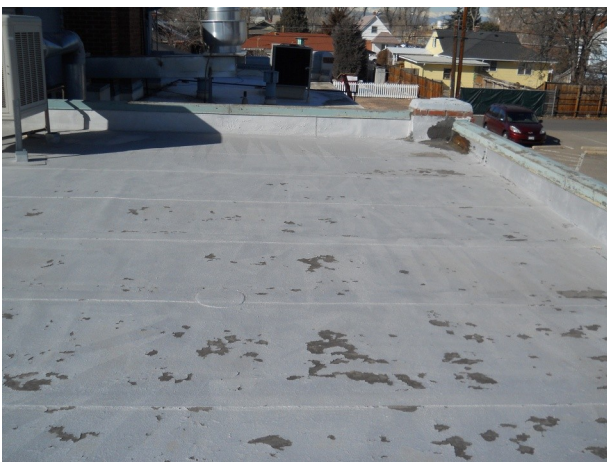
The original building roof is in good condition, although at 23 years old it may be approaching the end of its expected life span. The 1986 roof is in fair to poor condition. The areas around the scuppers in particular are in poor condition. They have been patched repeatedly and pond water. These areas appear to be leaking as active leaks were observed in the area below the scuppers. The scuppers are too small and are higher than the adjacent roof. The remainder of the roof membrane is in fair condition but the coating is failing on the north roof. This roof is at the end of its useful life. The standing seam metal roofs are in good condition.

Failing coating on roof of 1986 addition

- Replace modified bitumen roofs at 1986 addition, including replacing the scuppers with larger units. Due to the leaking, replacement of the underlying insulation should be budgeted.

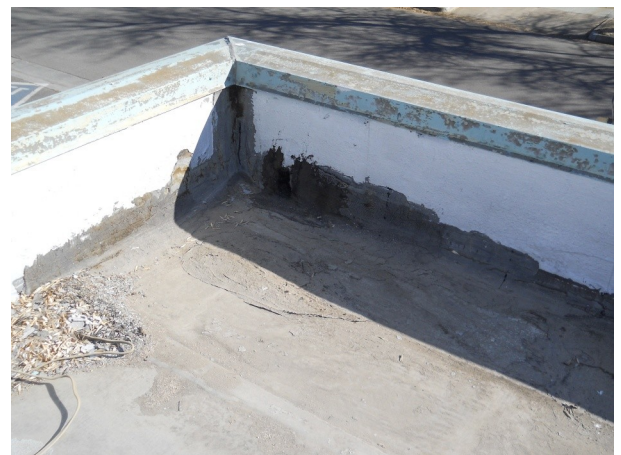
Repeated patching at scupper on 1986 addition

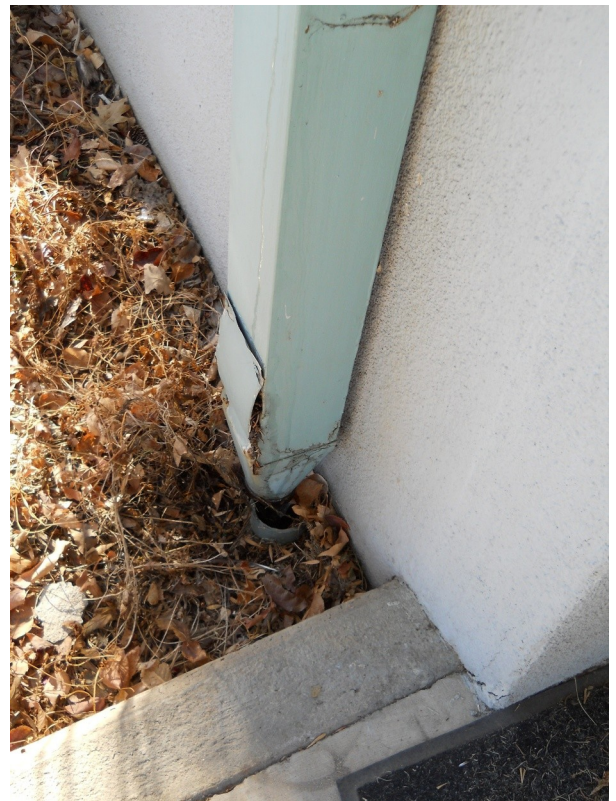
The downspout at the north side of the east entry leaks and its extension is crushed. The downspout at the south side of the east entry doesn't line up with its drain pipe and appears to be clogged as well. The paint is failing on the scuppers and downspouts at the east elevation of the 1986 addition.

Downspout not connected to underground drain

- Replace scupper and downspouts at 1986 addition. Open faced downspouts are recommended.
- Ensure downspouts either are connected to underground drains, or have adequate extensions. Construction of drainage channel and sidewalk chases may be an option.
- Downspouts should be inspected regularly for damage and clogging.

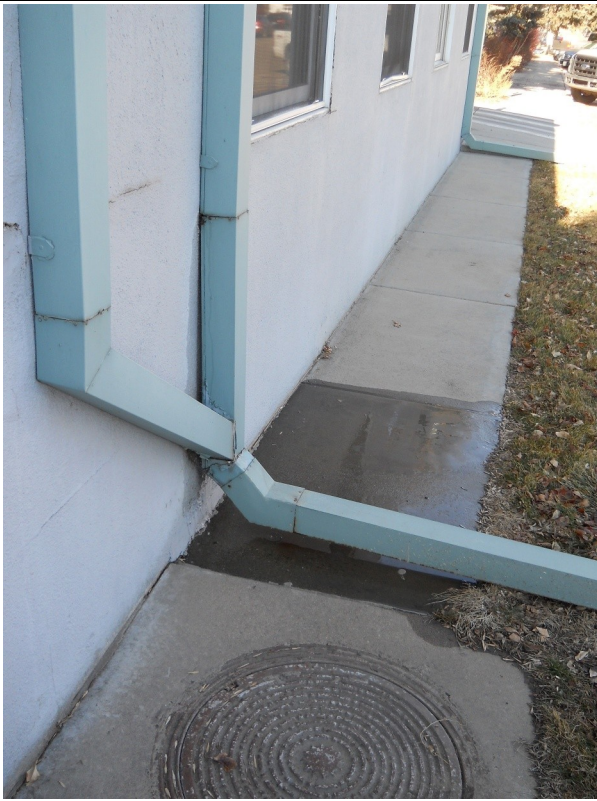
Leaking downspout and ponding water at north side of east entry

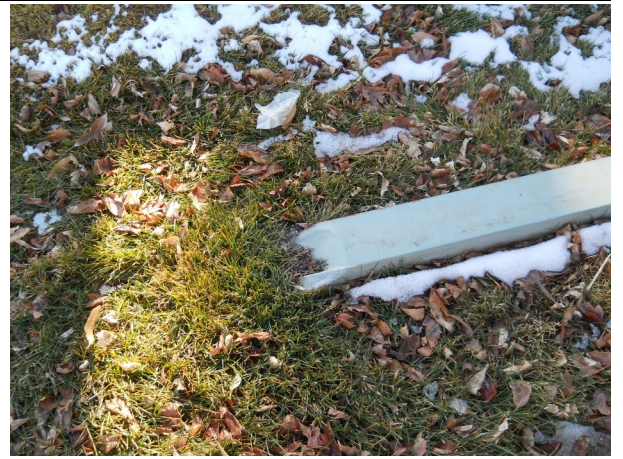
Crushed downspout extension

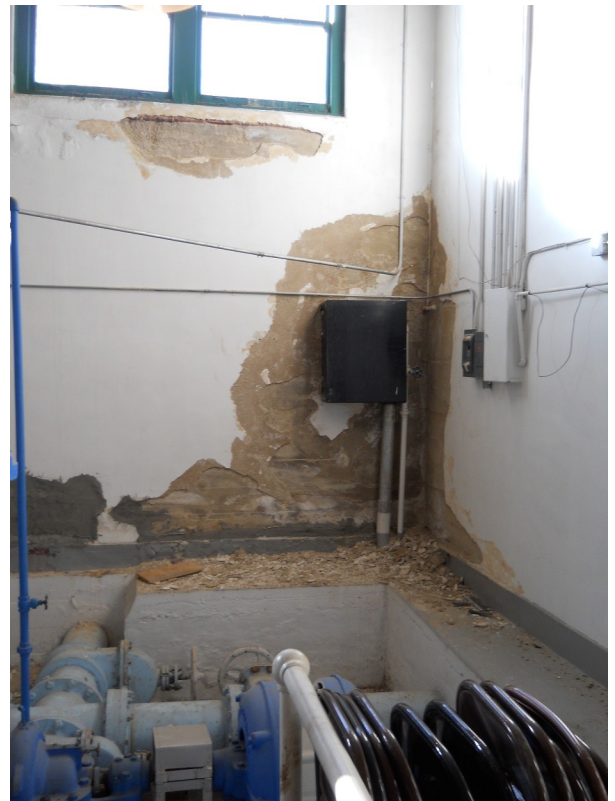
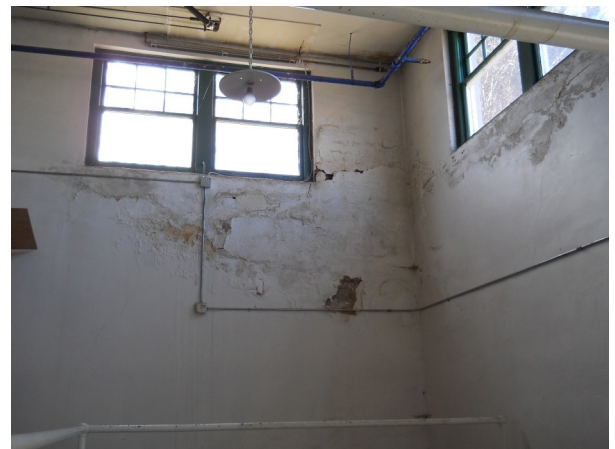
Deteriorated wall finish at basement

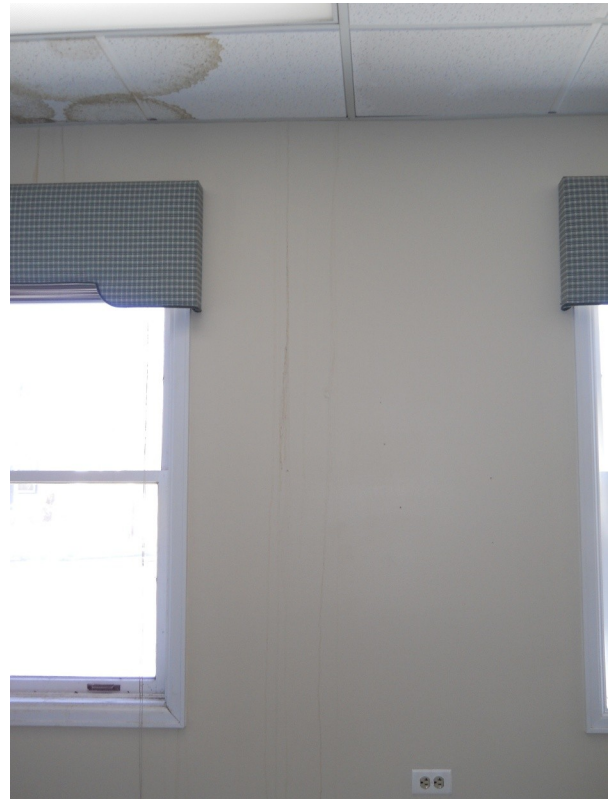
Water stains at dining room walls

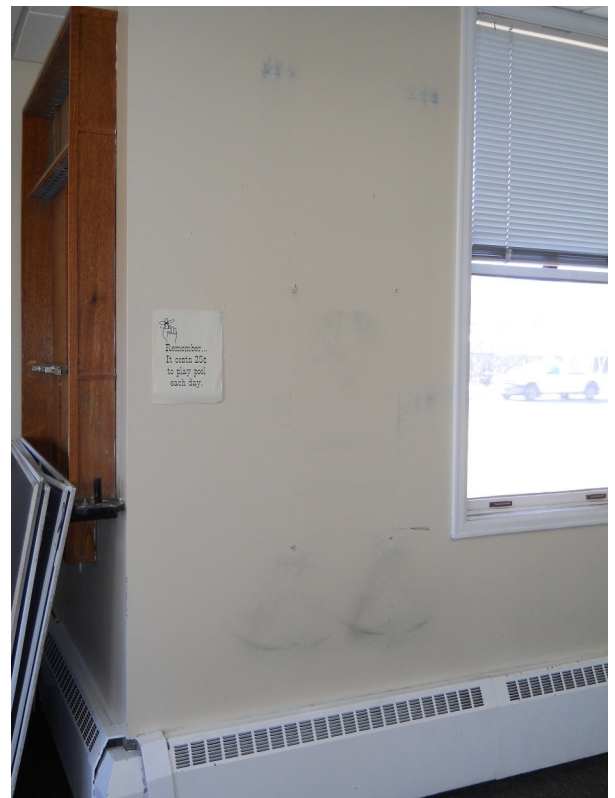
Damaged walls at billiards room

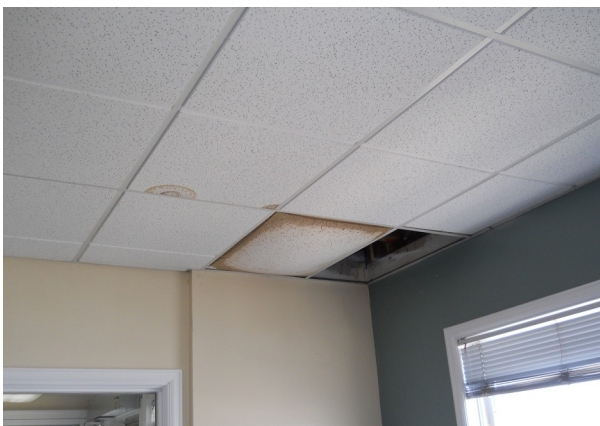
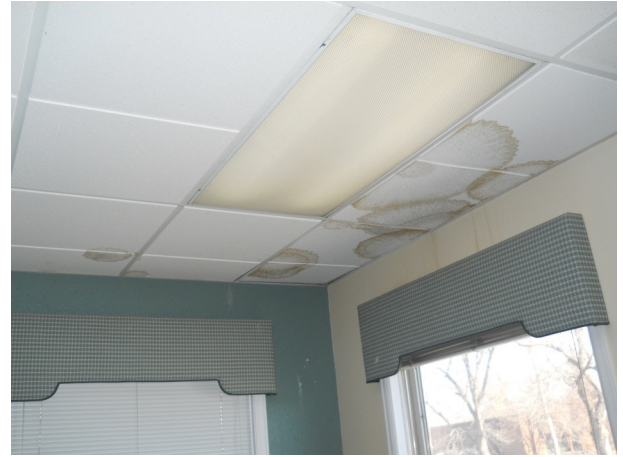
Water damaged ceiling tile

Water damaged ceiling tiles

- Replace stained and damaged ceiling tiles.

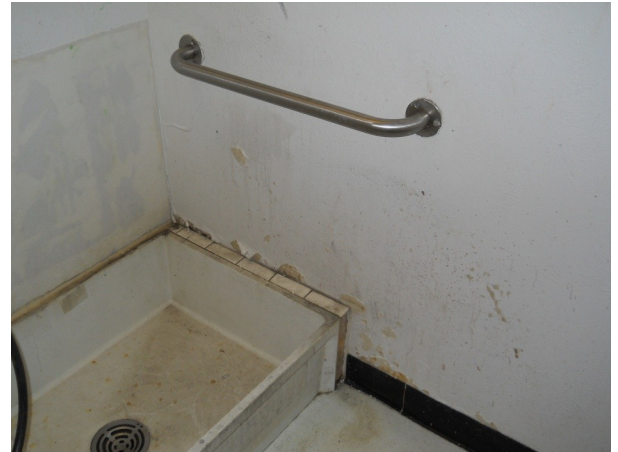
Drywall damage at upper level janitor closet

- Paint and repair walls where needed
- Remove mold-contaminated gypsum board at mop sink (see Hazardous Materials report, Section 4.1)
- Install tile wainscot in restroom.

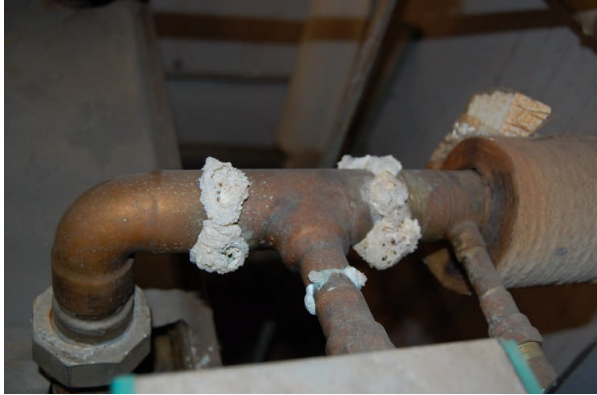
Main level corrosion

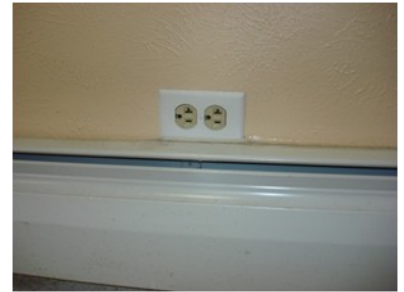
Receptacle Above Baseboard Heater

It is recommended that the building verify with the baseboard heater manufacturer that the installation of power receptacles directly above the heaters is permitted. If the product is not designed to accommodate receptacles installed above a possible fire hazard exists as an electrical cord can be plugged in and exposed to heat from the baseboard heater. It is also recommended that the receptacles that are not GFCI protected as required by NEC as noted above be replaced with GFCI type receptacles. Additionally, it is recommended that weather proof GFCI receptacles be installed within 25 feet of mechanical equipment as required by the NEC. The MC cable routed from the mechanical equipment disconnects should be rerouted to provide code required 3 foot clearance.

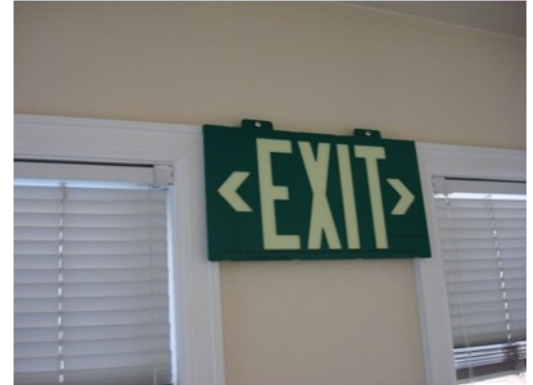
Non-Illuminated Exit Sign

It is recommended that all fluorescent fixtures be retrofitted or replaced from dated T12 technology to current T8 or T5 type lamping. The damaged fixture in the kitchen should also be repaired or replaced. It is recommended that any incandescent fixtures in the building be replaced with fixtures supplied with compact fluorescent lamps. It is recommended that some lighting fixtures be removed or fixtures be replaced with new fixtures with fewer lamps of lesser wattage to satisfy the lighting power density requirements in the International Energy Conservation Code (IECC). The lighting controls in the building should be addressed. The current design does not satisfy the requirements for automatic shut off of lighting fixtures and lighting reduction controls as stated in the IECC. The emergency lighting deficiencies should be addressed in this building as it represents an immediate safety hazard to the occupants. All the emergency battery packs in the existing emergency egress fixtures should be replaced as half are currently not functioning and all are past life expectancy. Additional emergency egress fixtures should be added to the areas that do not have sufficient egress lighting as noted above. Emergency exit discharge fixtures should be added to the areas noted above. All the exit signs in this building should be replaced as the type does not meet current design standards and the internal batteries are all past their life expectancy. Additional exit signs should be added to the areas where they are required as noted above.

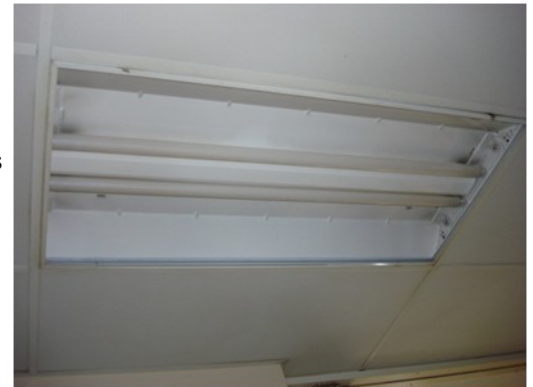
Damaged light fixture in kitchen

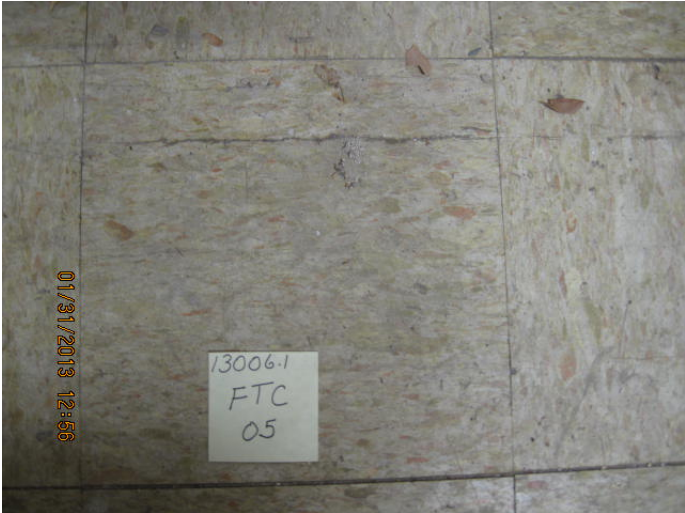
The ACM Floor Tile is considered a non-friable Category I material. Maintained in good condition the material poses minimal risk of fiber release. Avoid activities such as grinding, sanding and cutting which may cause the material to become damaged. Should the materials become damaged, removal should be performed by personnel trained and certified to remove, transport and dispose of asbestos material.

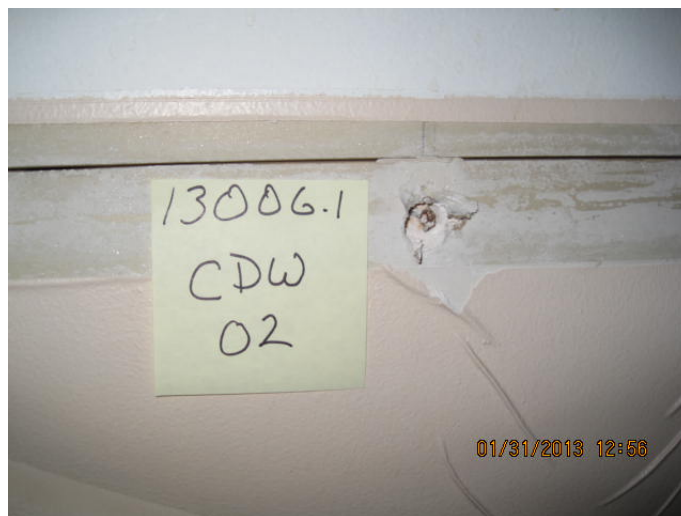
The Drywall Composite material was found to contain asbestos in the joint compound. The Drywall Composite material is present throughout the original building. The EPA and CDPHE do not consider the drywall wall systems (drywall board, tape and joint compound) as an asbestos containing material when composite analysis identifies 1 percent or less asbestos. OSHA considers each layer separately and the drywall joint compound as an asbestos containing materials and requires Class II asbestos worker training, engineering controls and work area containment for drywall wall system interior removal. Therefore, interior activities that may potentially impact ACM Drywall Joint Compound are regulated by OSHA and Schafer recommends that an asbestos abatement contractor perform removal of ACM Drywall Joint Compound.
