OLD BRIGHTON SENIOR CENTER

575 Bush Street
Brighton, Colorado

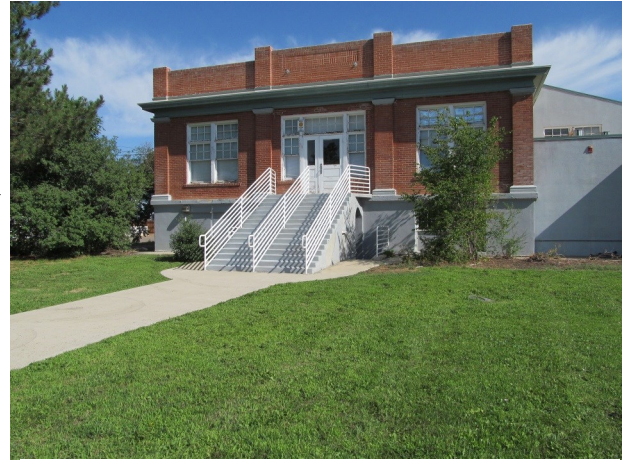
South side of building

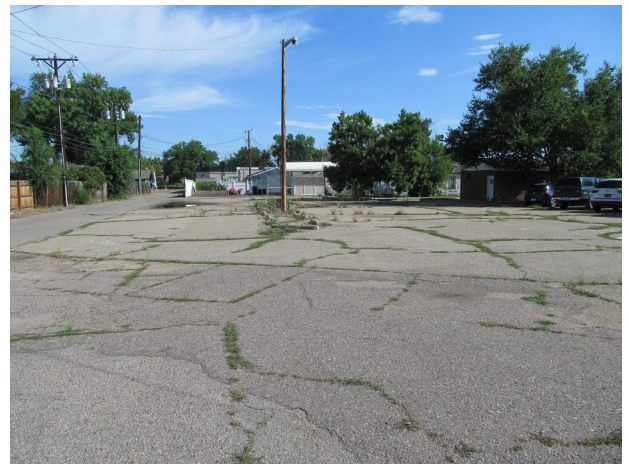
The parking lot is in poor condition. The existing asphalt is cracked and alligating, and is reaching the end of its useful life. There is ponding at the northwest corner of the lot and vegetation in the cracks.

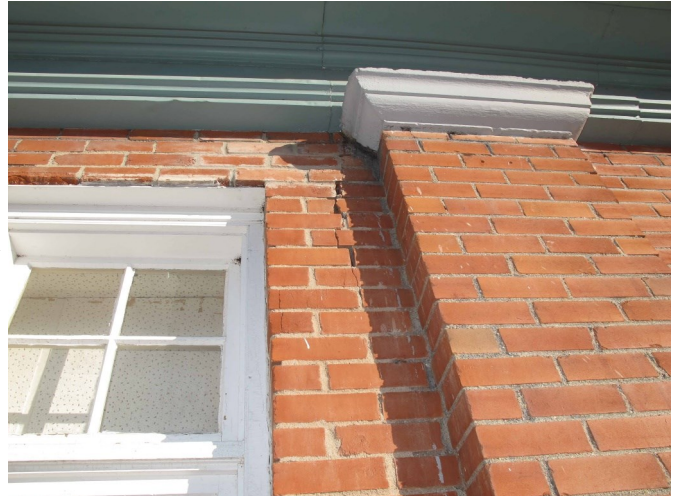
Deterioration of mortar joints

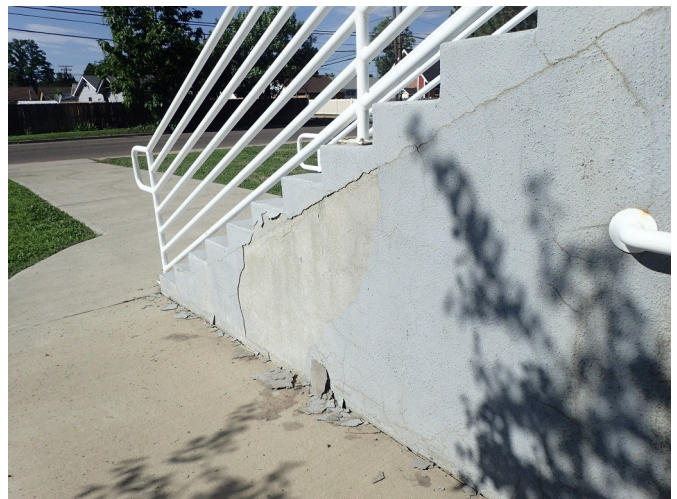
Parge coat at stairs

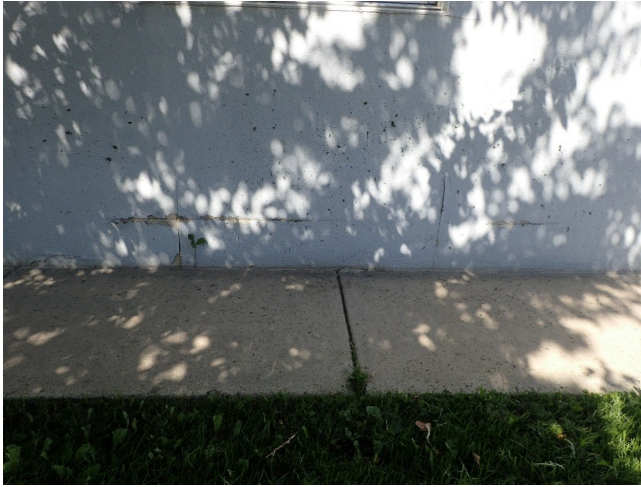
Cracks in exterior stucco

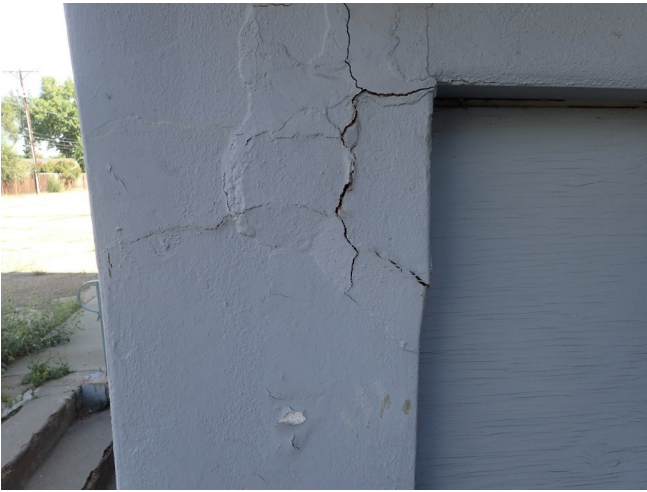
Failing bearing at enclosed balcony

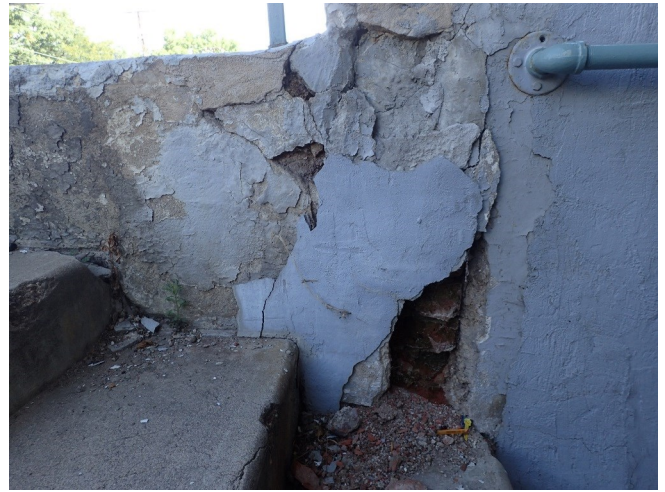
Base of north column at balcony

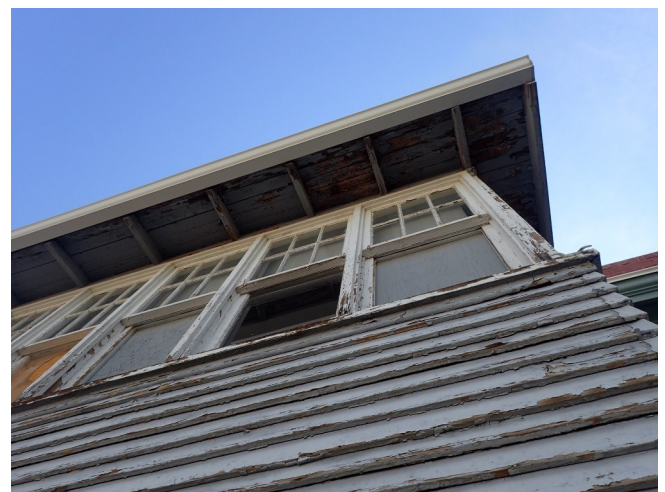
Wood framing at enclosed balcony

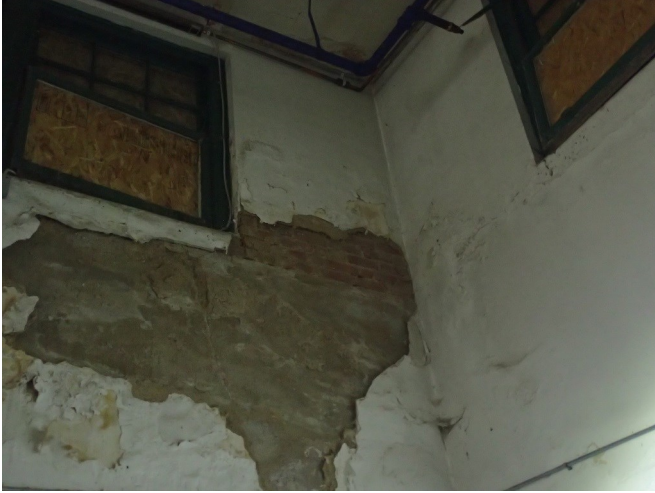
Parge coat at basement wall

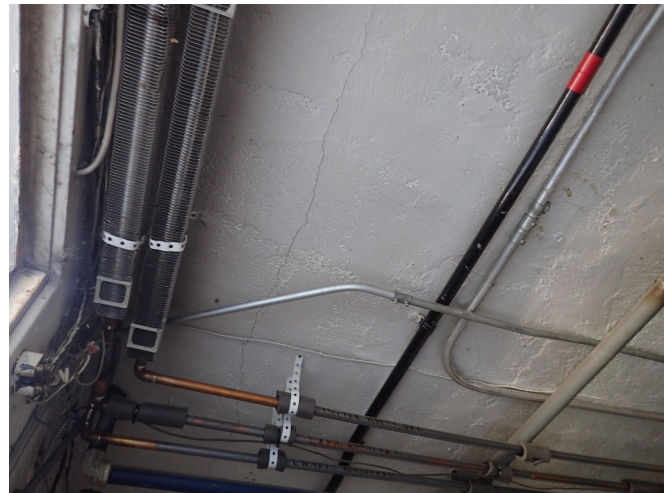
Underside of concrete floor slab

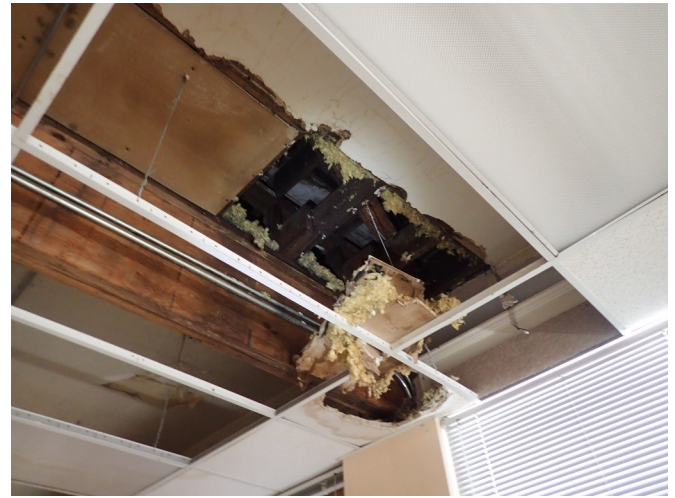
Roof framing at original building

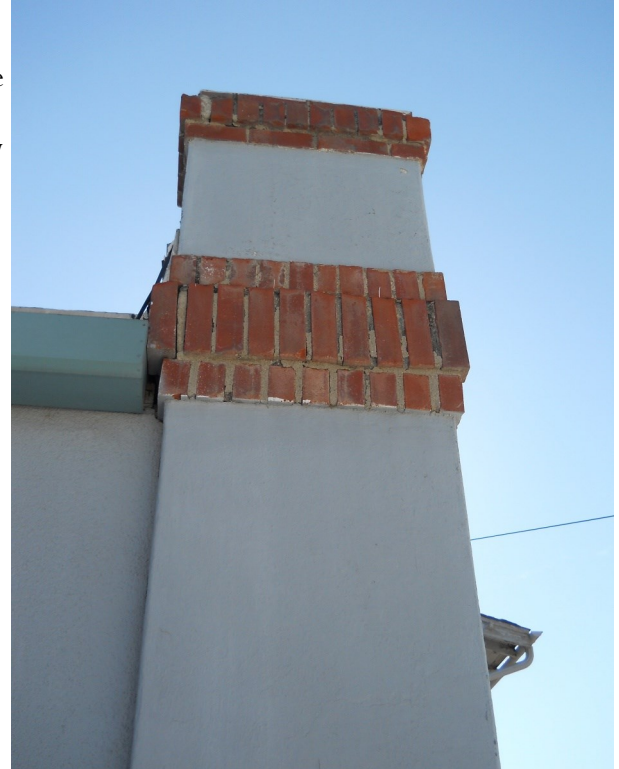
Deteriorated mortar joints and stucco at north wing

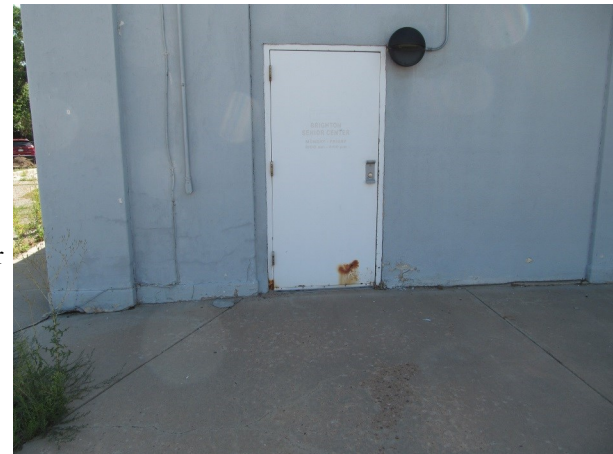
Deteriorated stucco at north wing

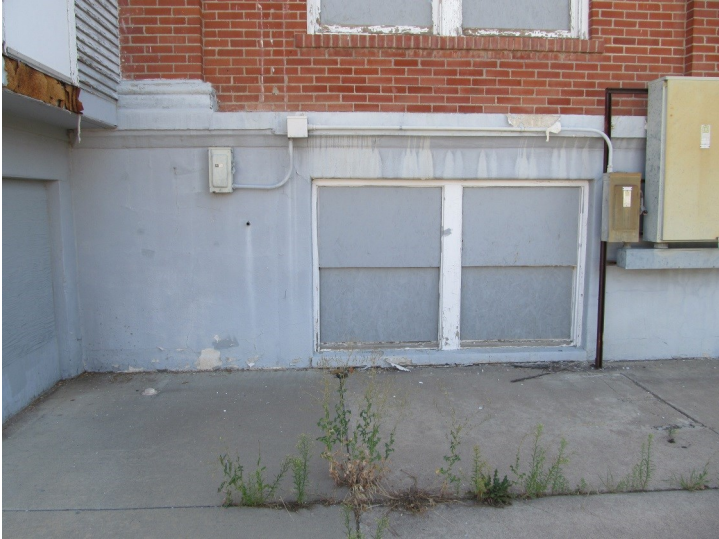
Damaged parge coat at west elevation

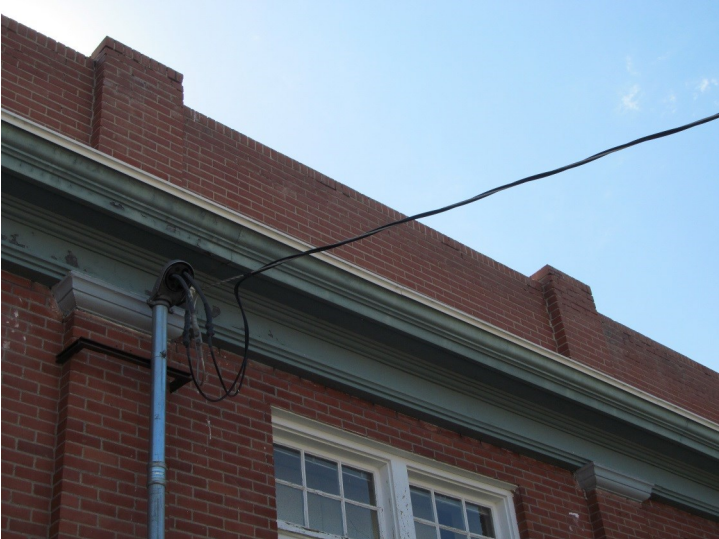
Peeling paint at sheet metal cornice

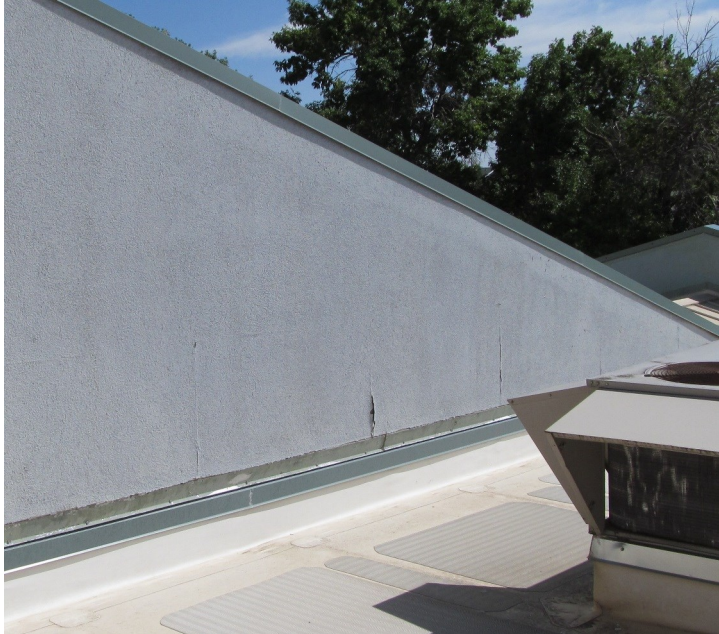
Cracked EIFS on 1986 addition

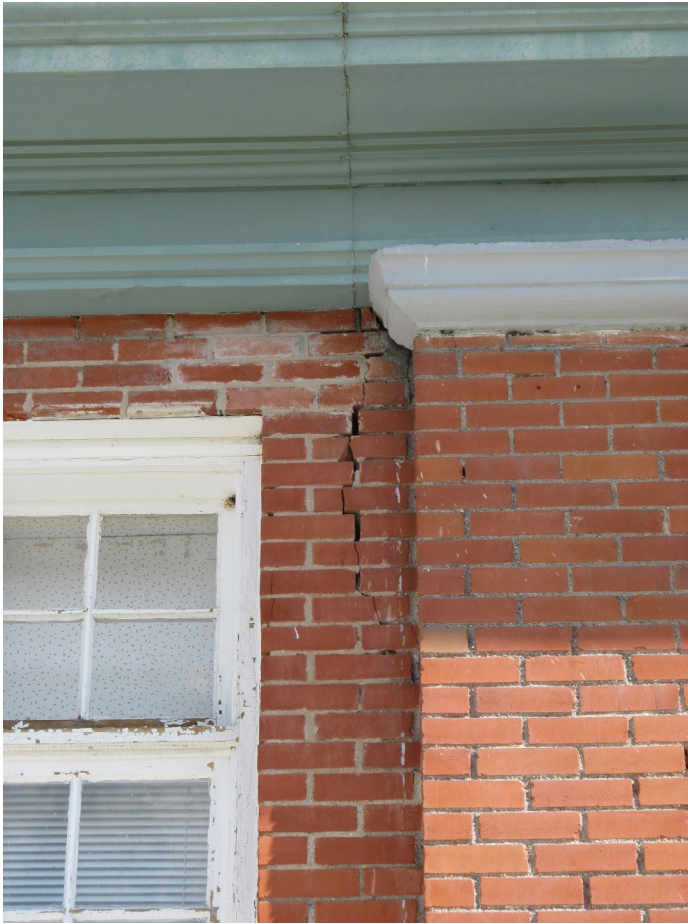
Cracks in brick wall

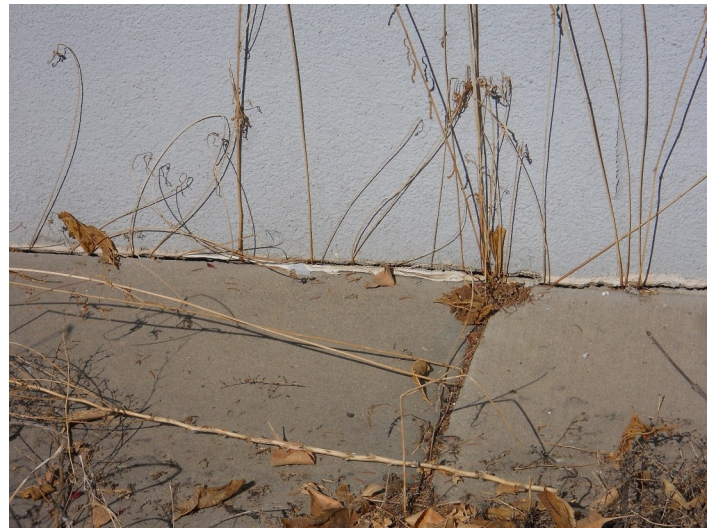
Deteriorated sealant joint at grade/base of wall

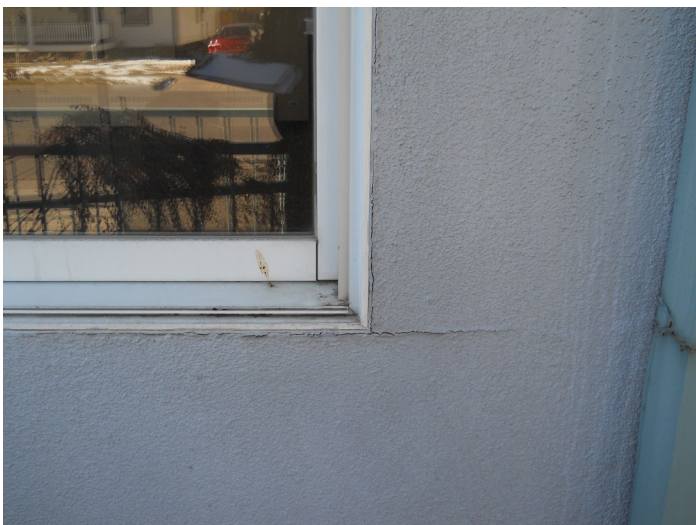
Cracks in EIFS at 1986 addition

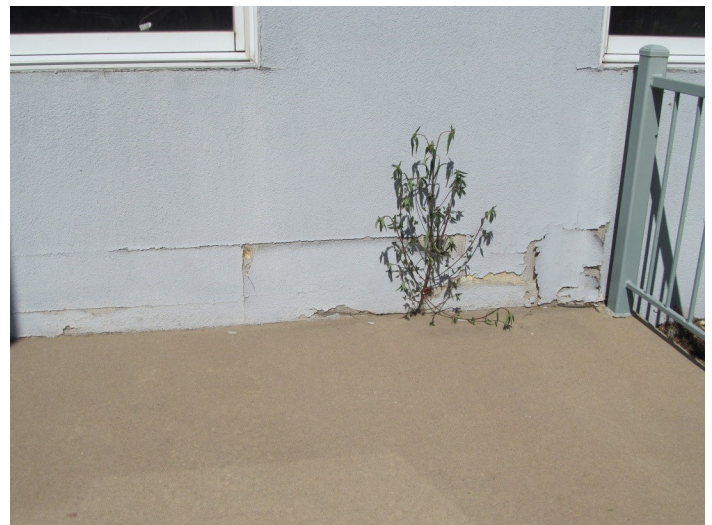
Cracks in EIFS at 1986 addition

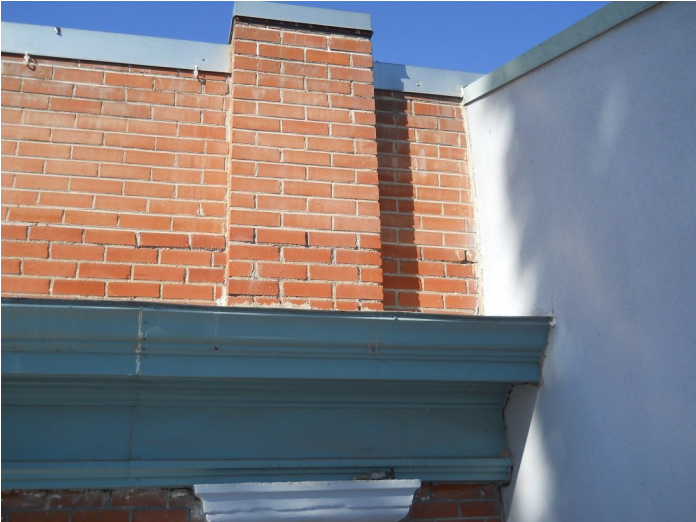
Deteriorated mortar at original building

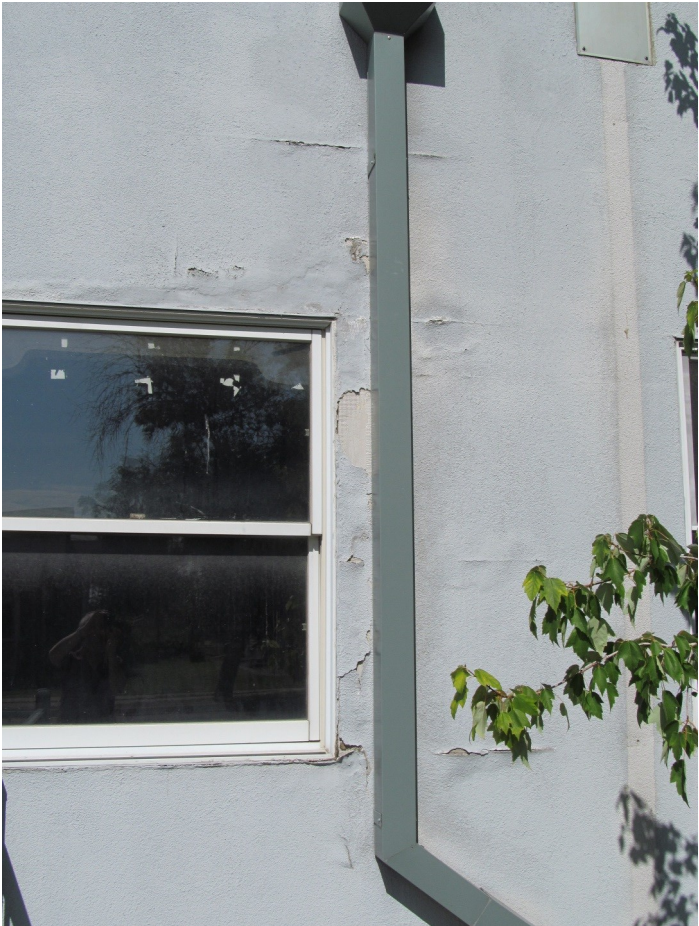
Cracks in EIFS at 1986 addition

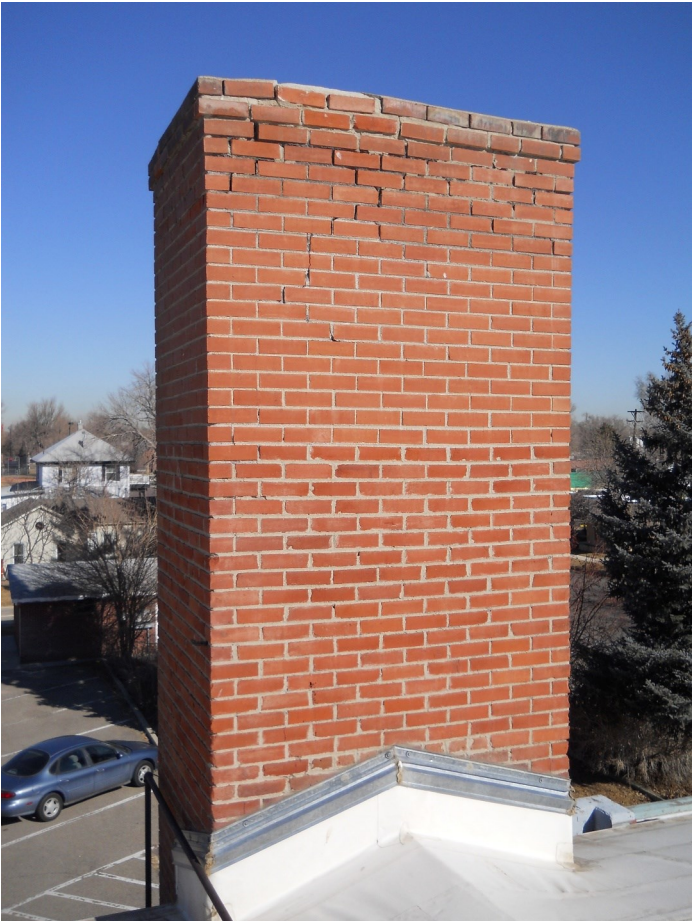
Chimney at original building

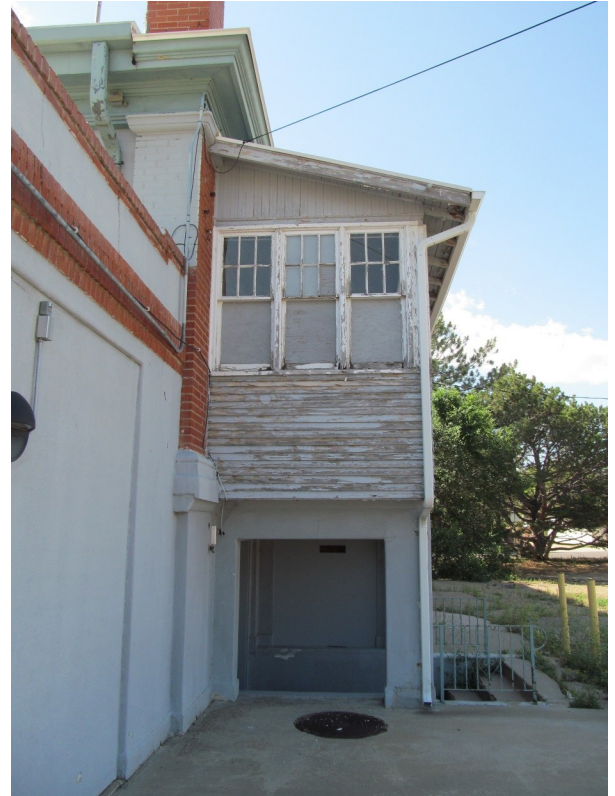
- Repair traffic coating at south stairs.
- Repair deteriorated wood including exposed sheathing and rafters at west porch. Repaint.
- Repair EIFS at east entry porch.
- Replace coating on ramp at east entry.
- Repaint handrails on ramp.
- Replace flashing at top of north vestibule roof.
- Repair and repaint soffit at north vestibule.

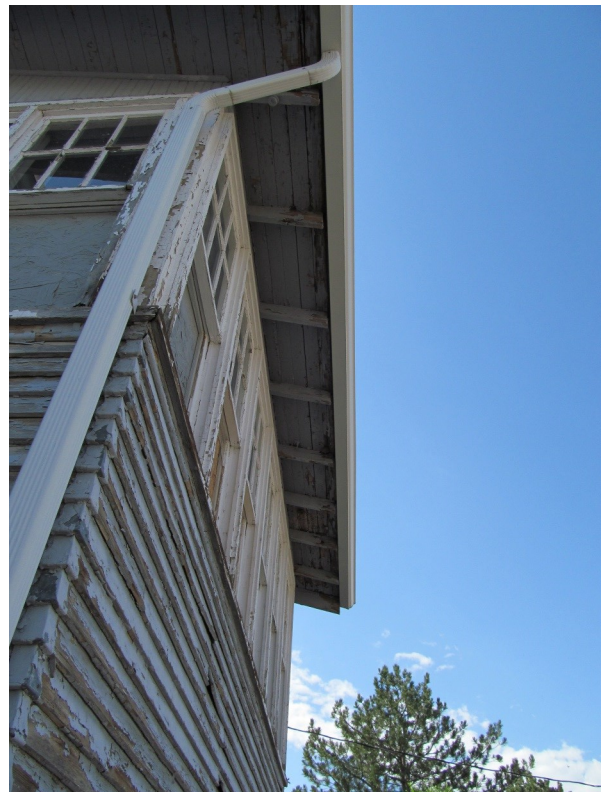
Deteriorated sheathing and rafters at west porch

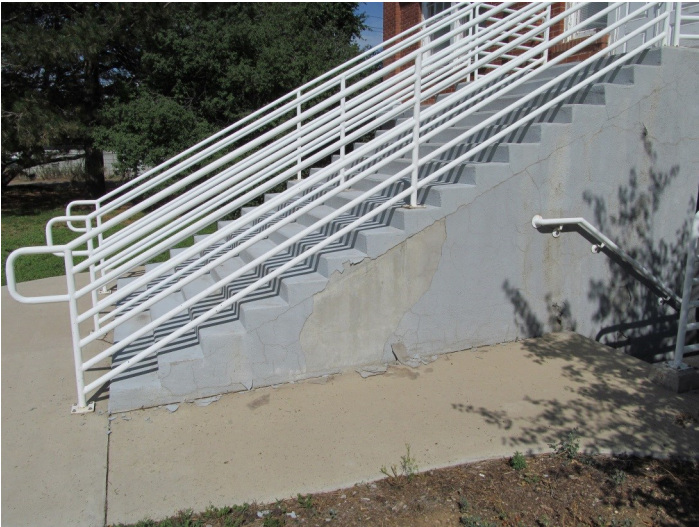
Delaminating parge coat at south stairs

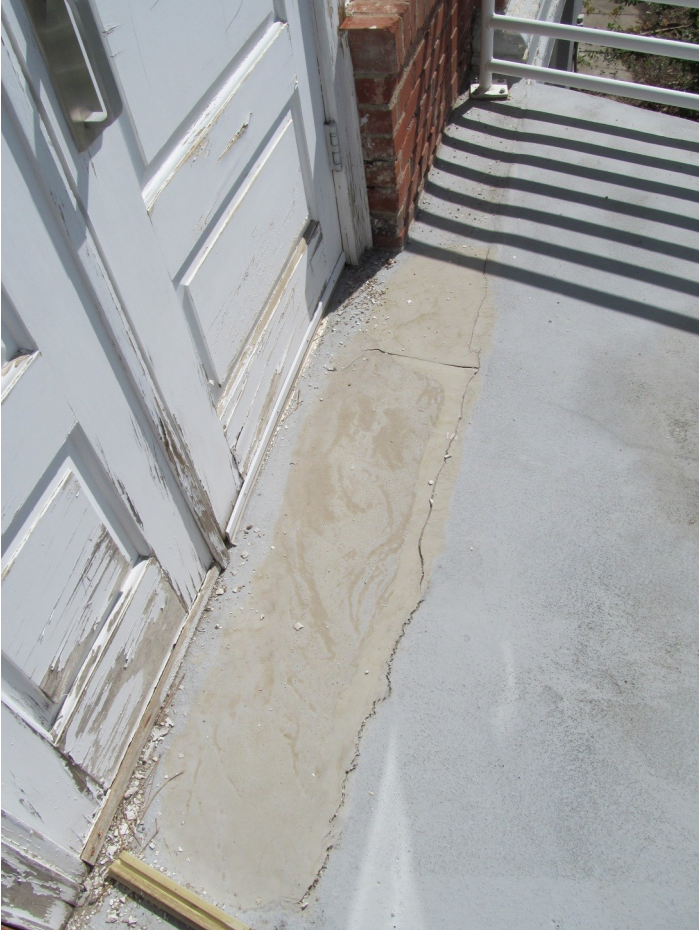
Cracks at south landing

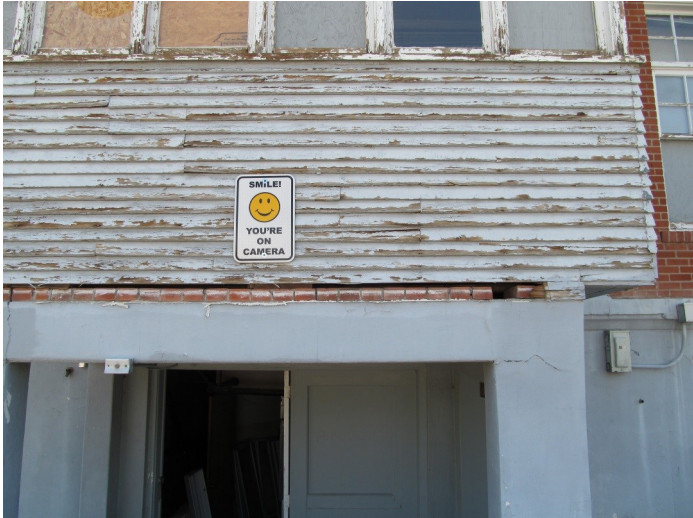
Deteriorated paint on siding at west porch

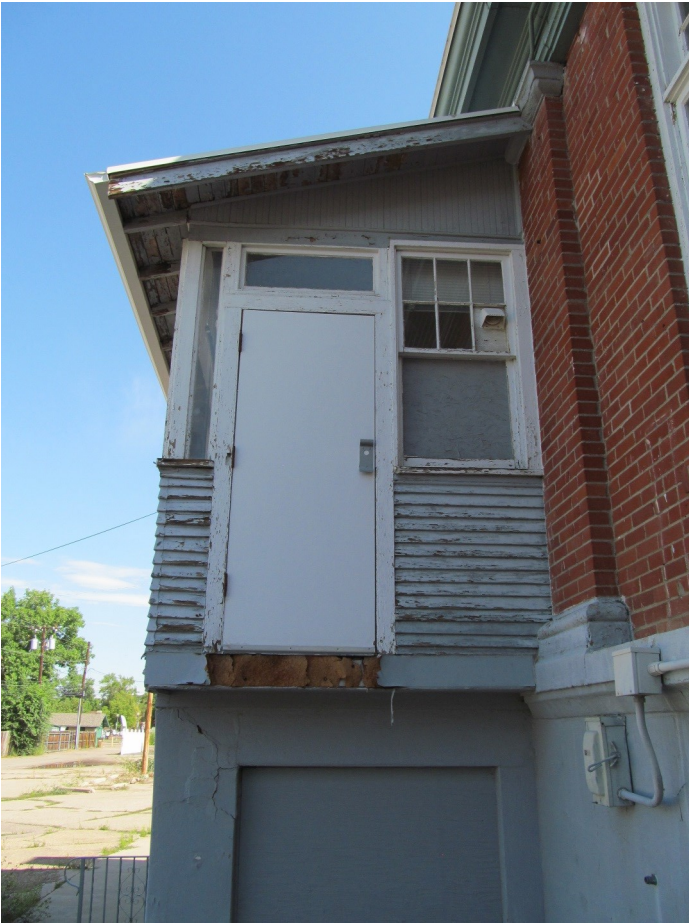
Damaged trim at west porch

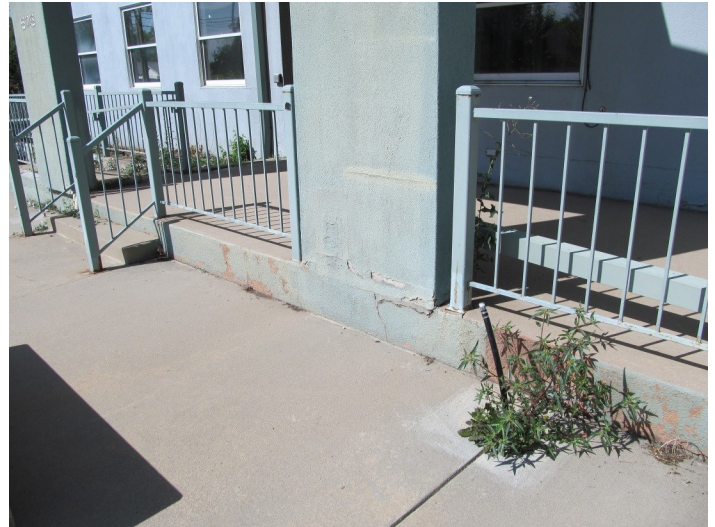
Deteriorated EIFS at east porch

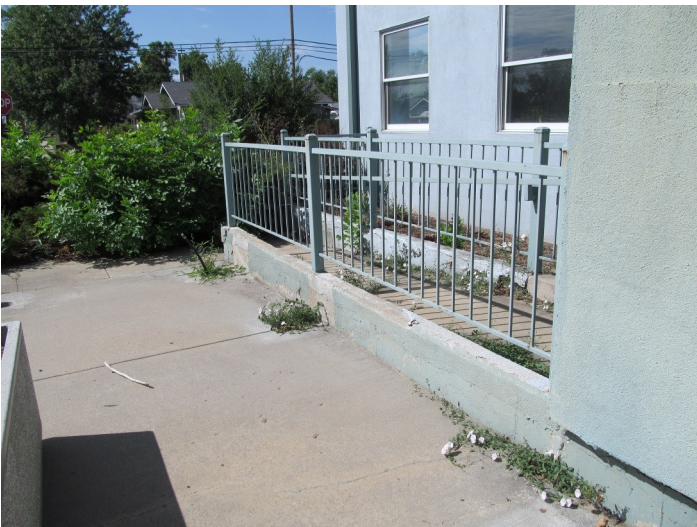
Deteriorated coating at east entry ramp

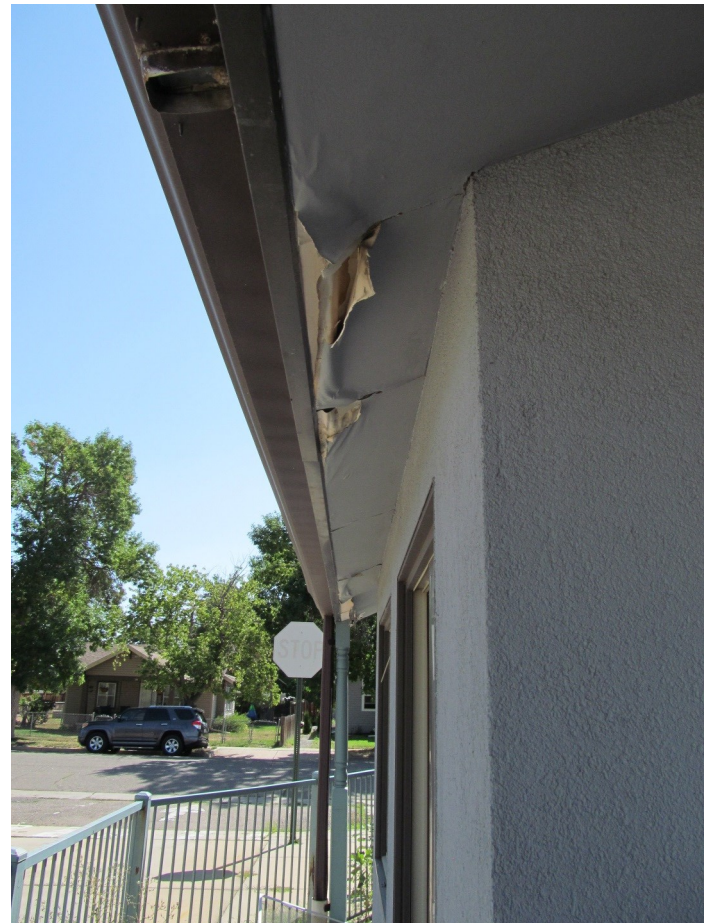
Water damage at soffit on north entry

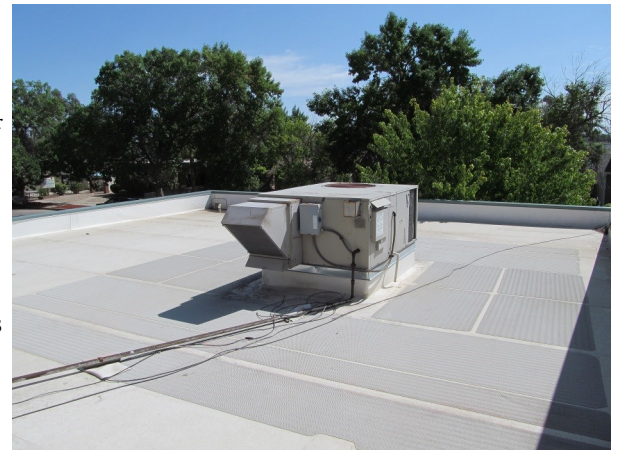
North roof at 1986 addition

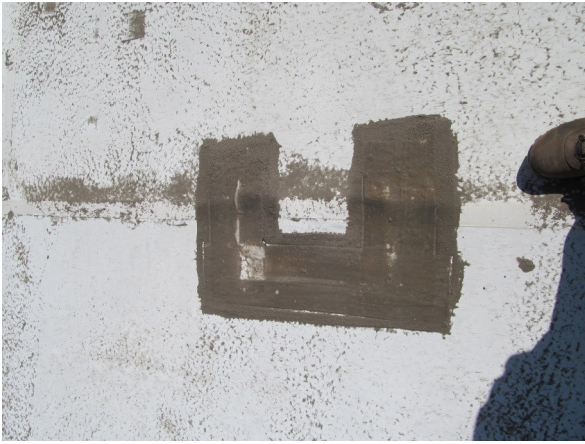
Defective patch at original building roof

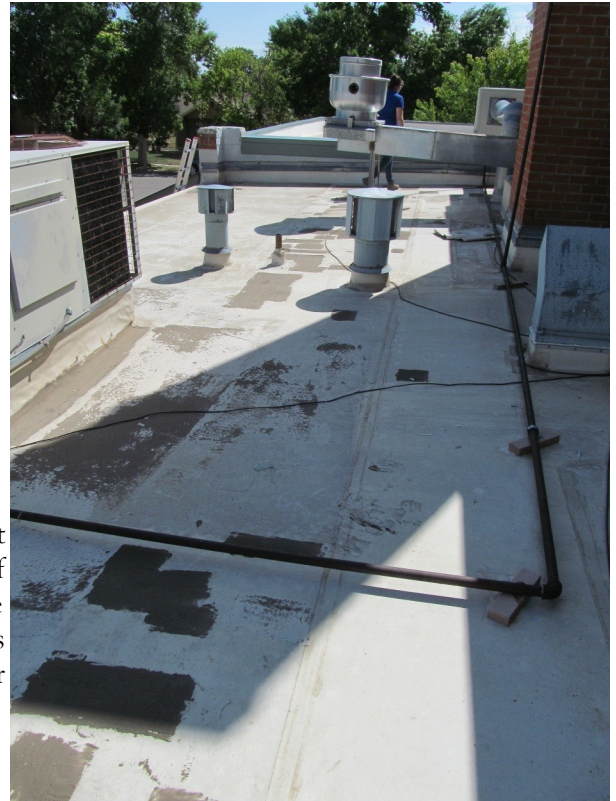
Roof of north addition

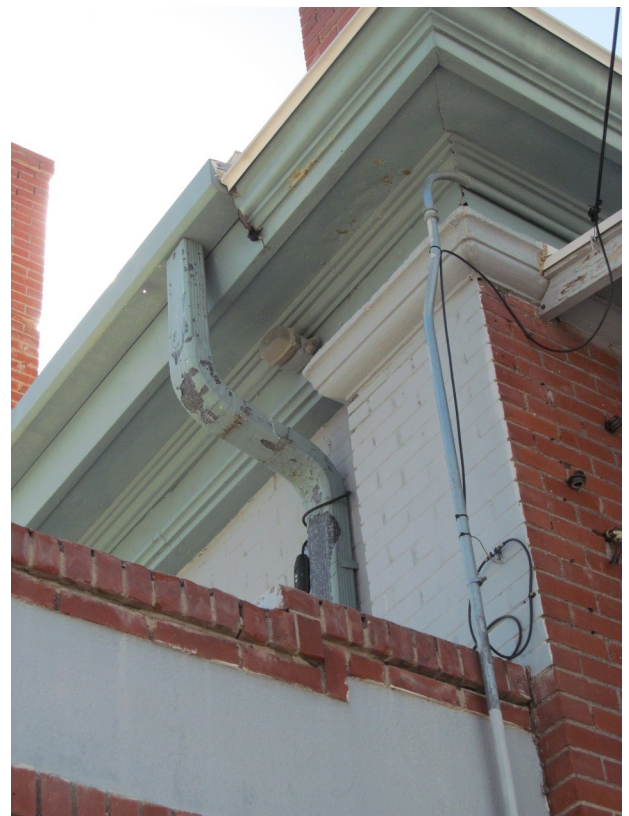
Downspout at original building

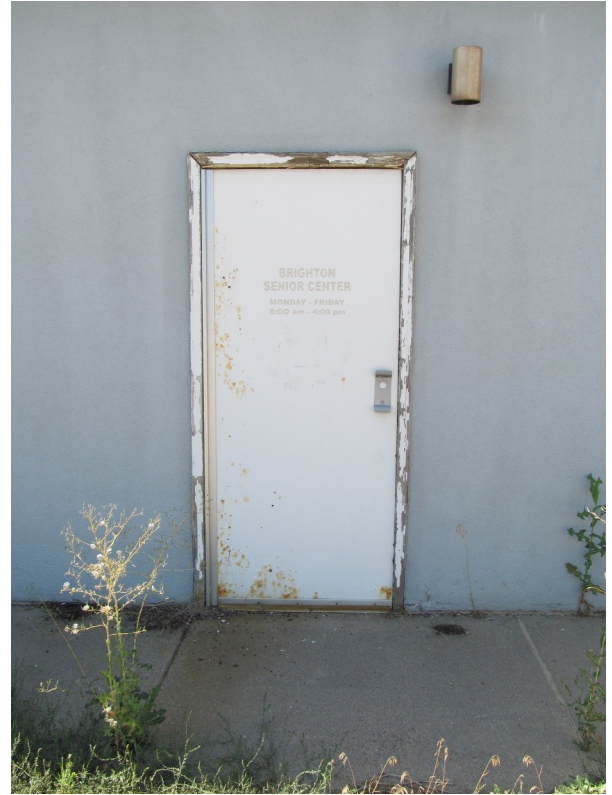
North kitchen entry door

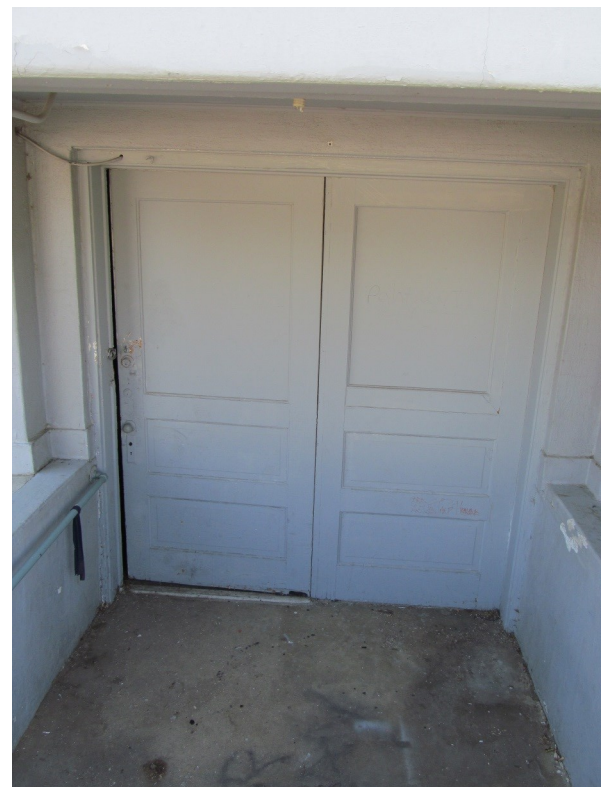
West entry to basement

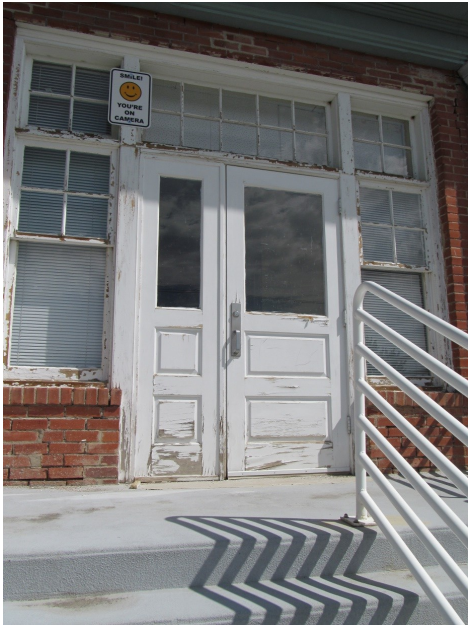
- Rehabilitate wood door, sidelights, and transom at south entry. Existing configuration to remain.
- Replace lockset at east vestibule door with exit device.
- Repair damaged interior doors.
- Replace missing doors and hardware.
- Repaint west and north kitchen doors.
- Repaint basement exterior doors

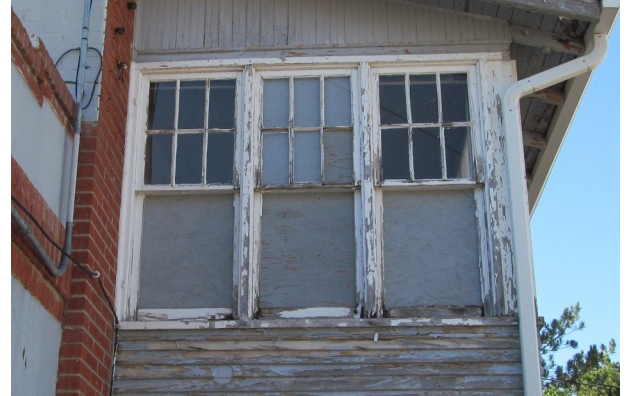
Windows at west porch

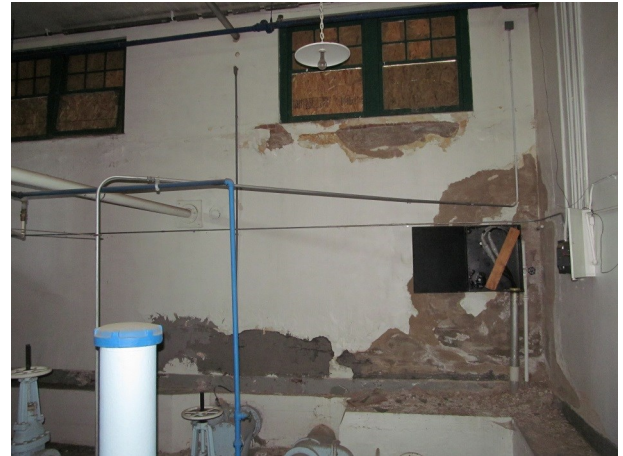
Deteriorated wall finish at basement

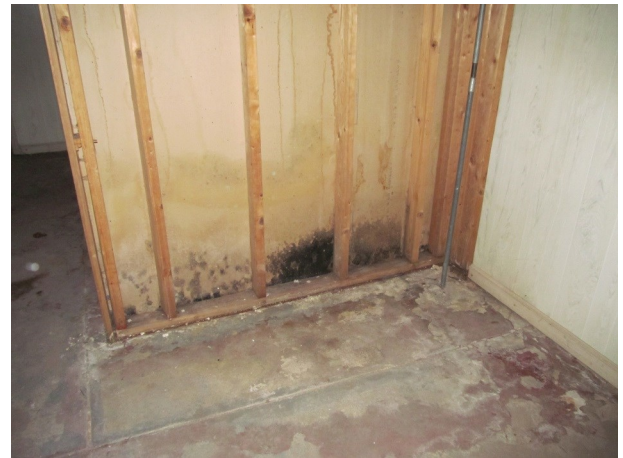
Suspected mold in basement

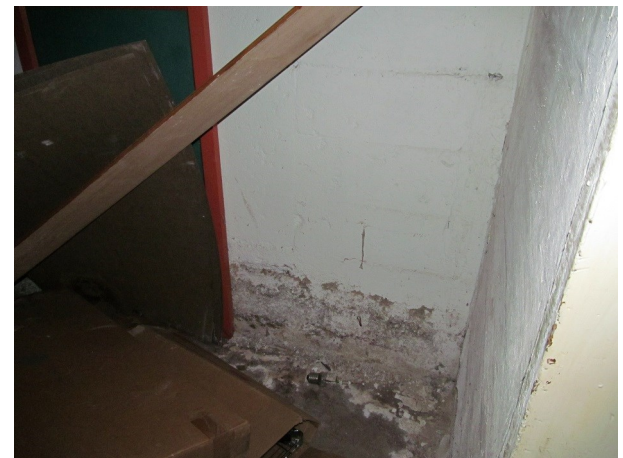
Water damage at basement storeroom

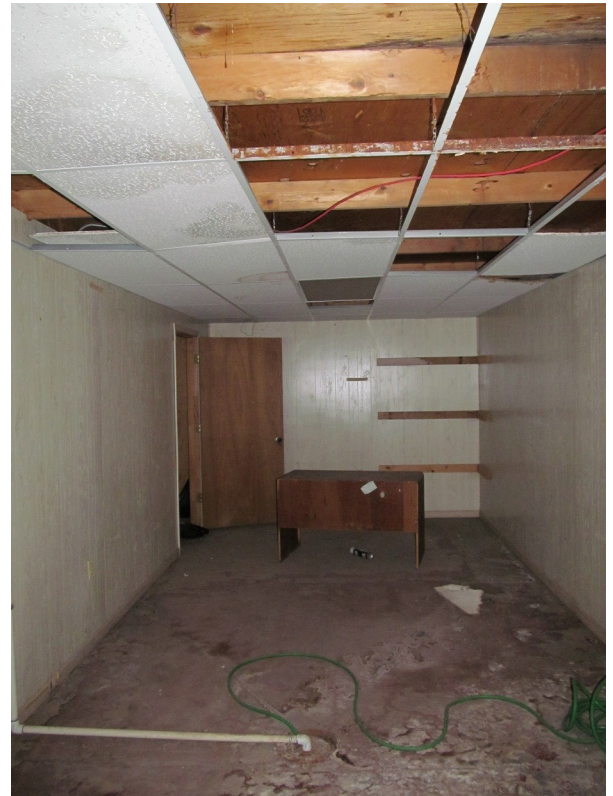
Water damaged ceiling at basement

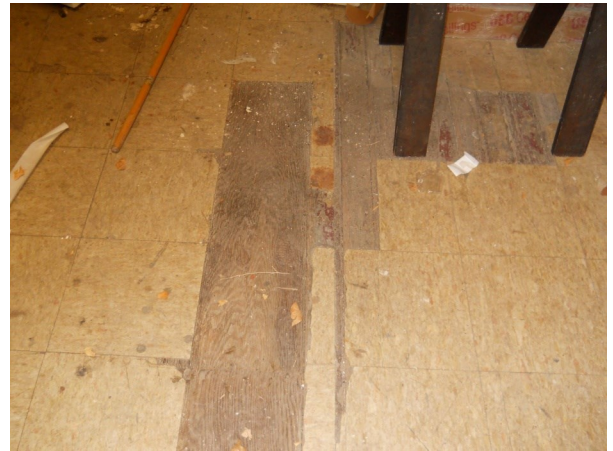
VCT floor at basement entry

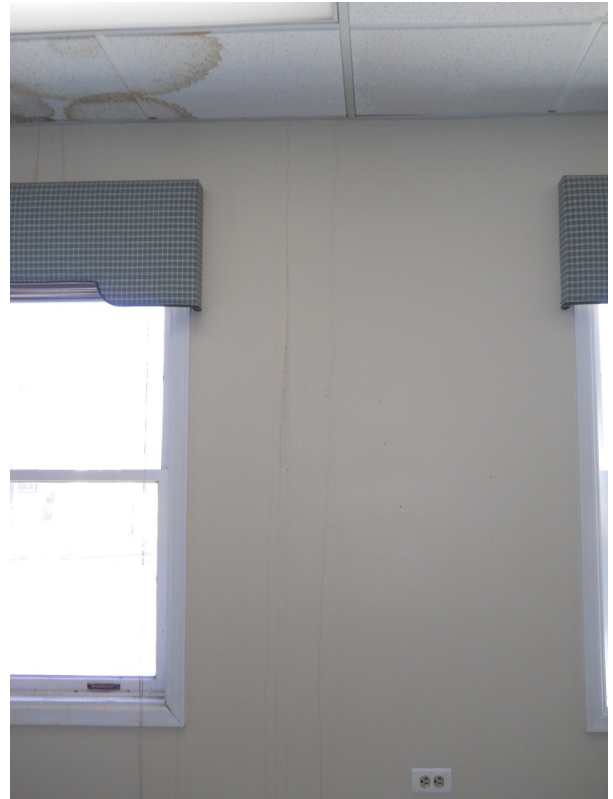
Water damage at dining room wall

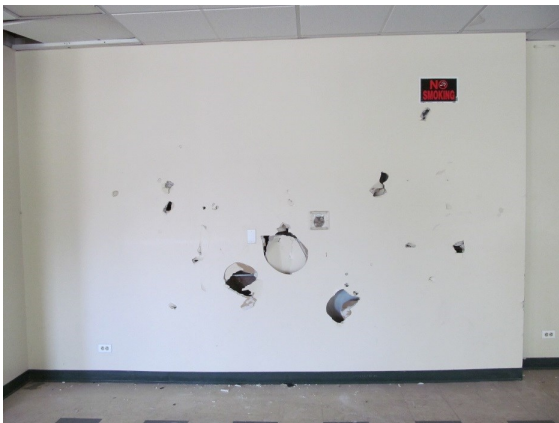
Vandalism damage at dining room wall

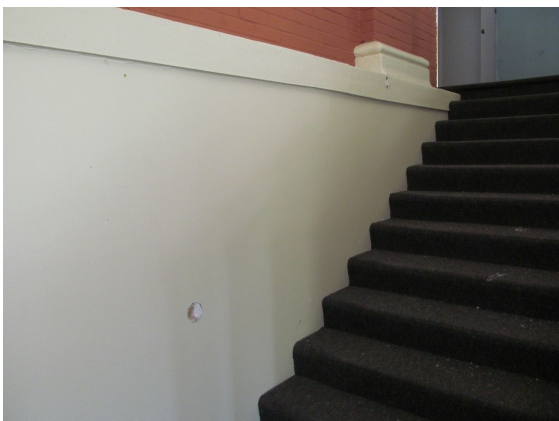
Missing handrails at stairs

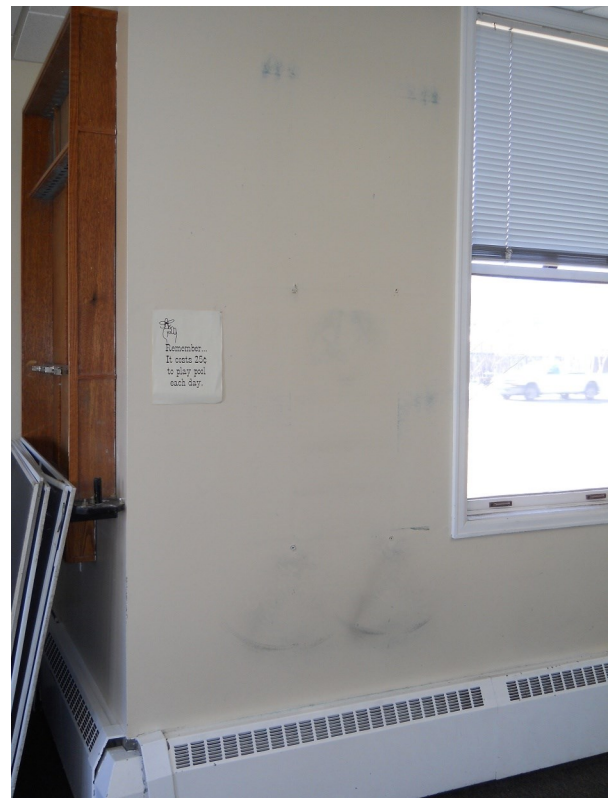
Damaged walls at billiards room

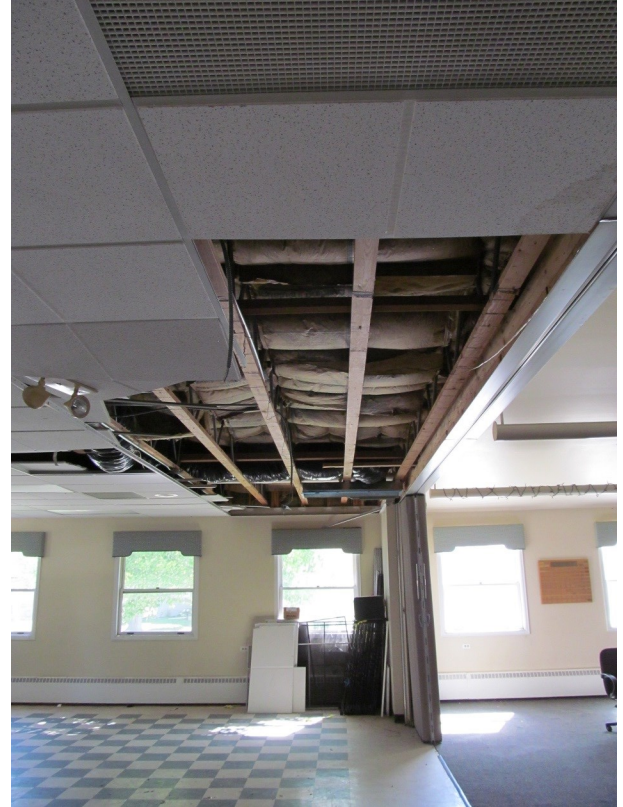
Ceiling damage at dining room

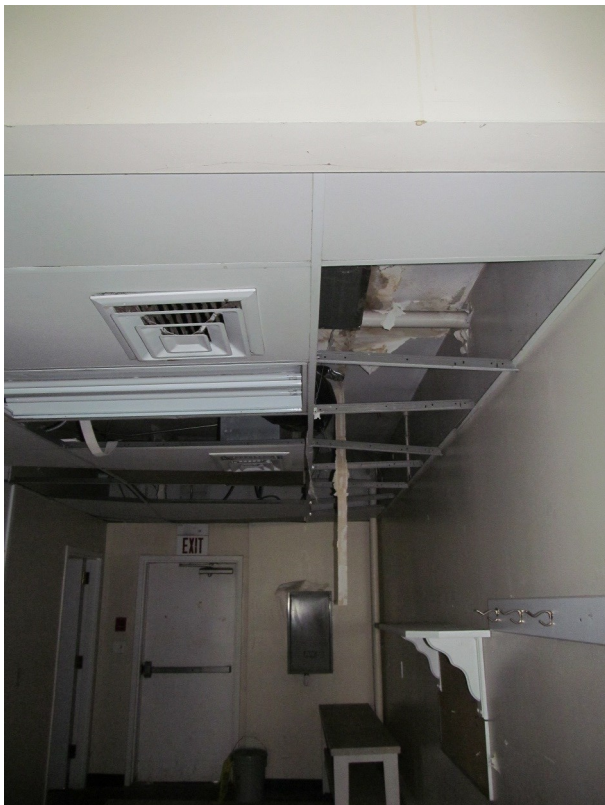
Water-damaged ceiling tiles at kitchen

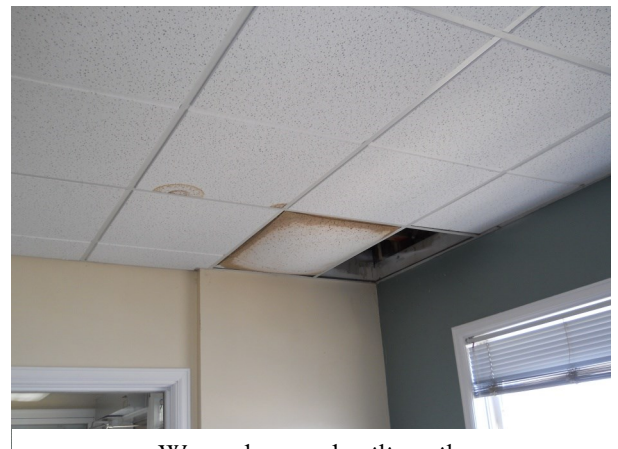
Water-damaged ceiling tile

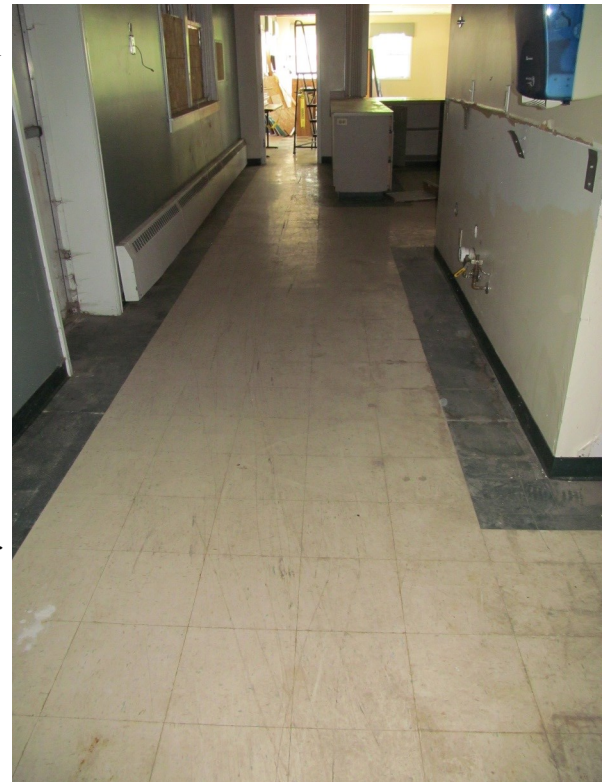
VCT flooring at kitchen

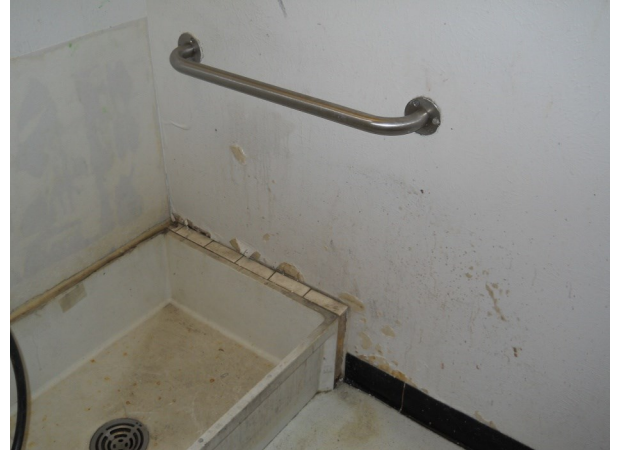
Drywall damage at upper level janitor closet

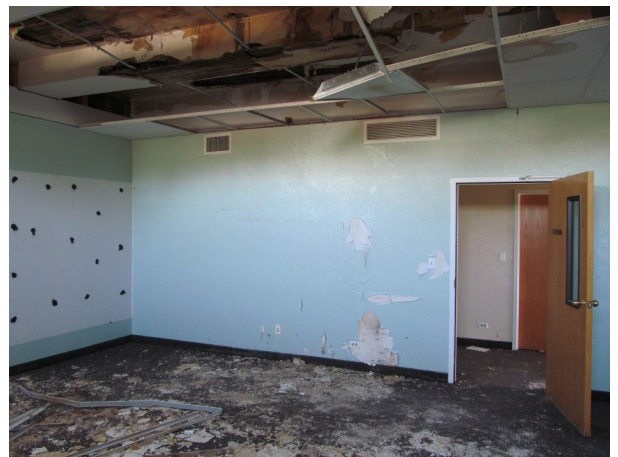
Drywall damage at upper level

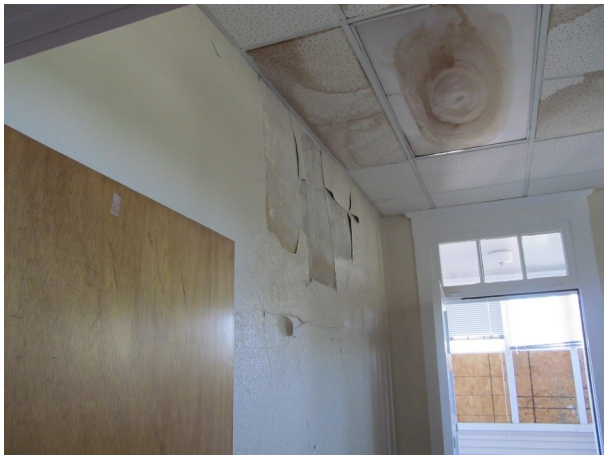
Drywall damage at upper level

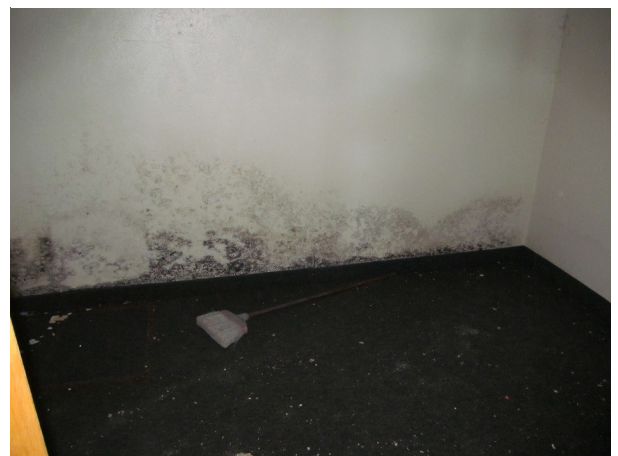
Suspected mold at upper level

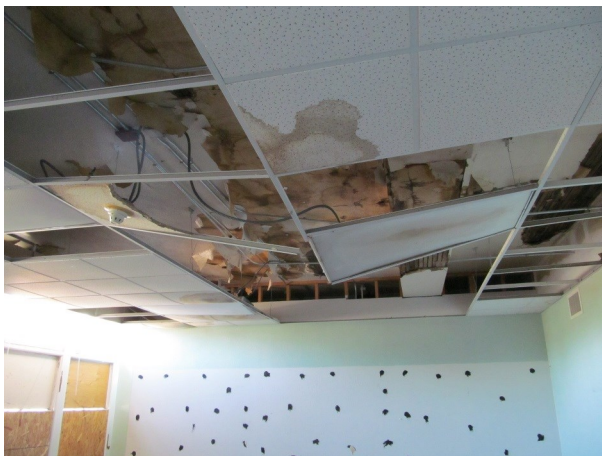
Ceiling damage at upper level
