OLD BRIGHTON SENIOR CENTER

575 Bush Street
Brighton, Colorado

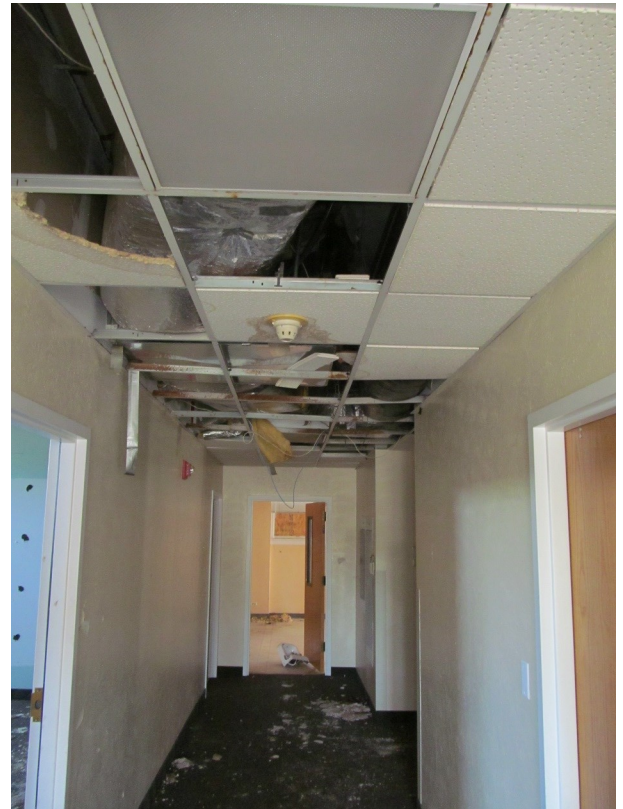
Ceiling damage at upper level

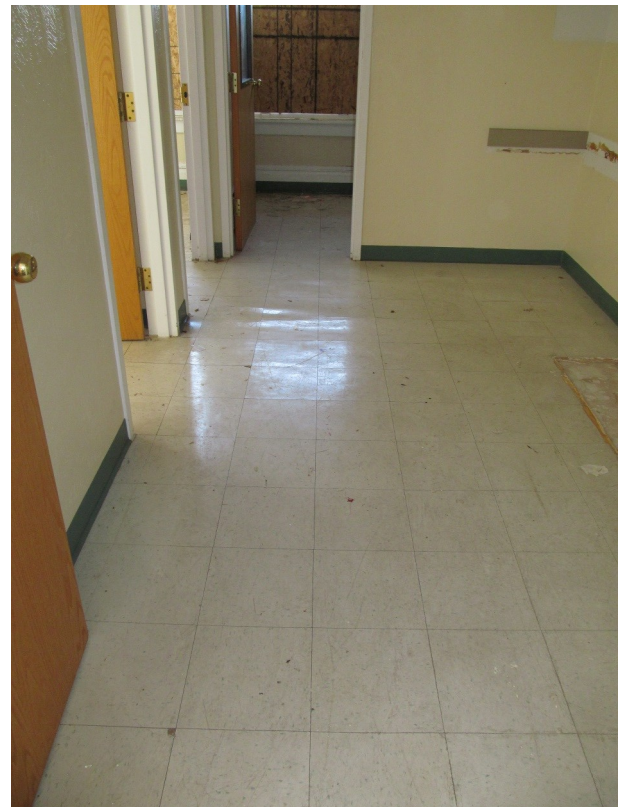
- Replace VCT in clinic, providing new underlayment to prevent the telegraphing of substrate flaws.
- Replace sheet vinyl.
- Replace carpet at upper level.

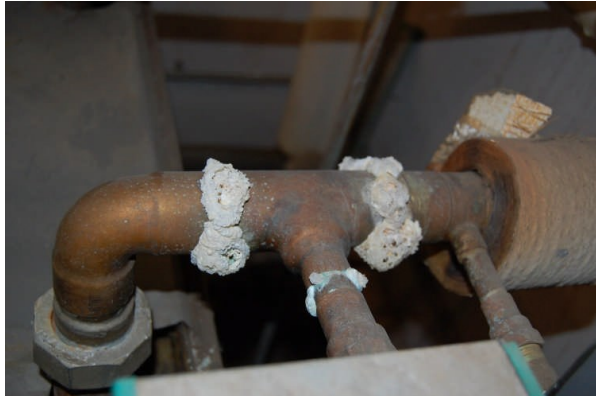
Main level corrosion in 2013

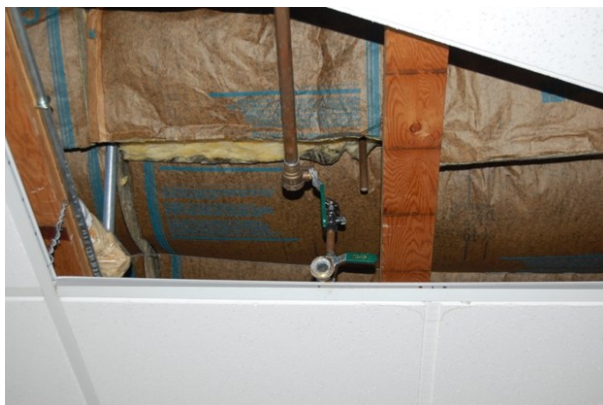
Main level piping in 2024

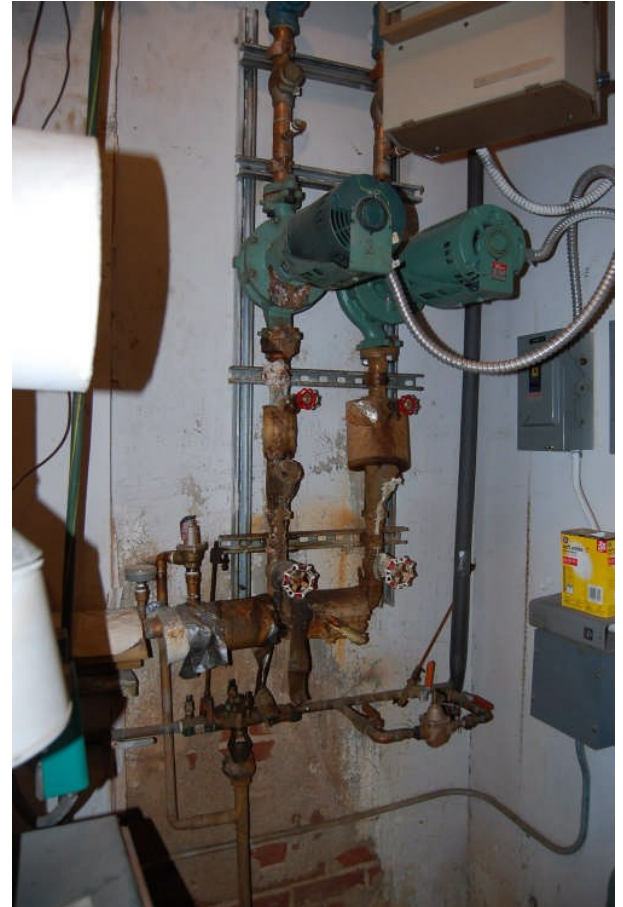
Main level pumps in 2013

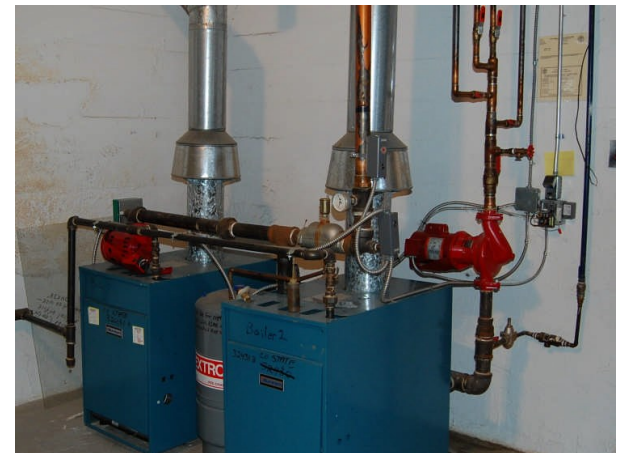
Basement boilers, pump, and air scoop in 2013

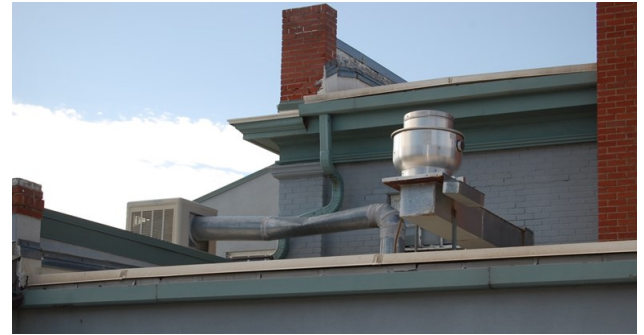
Kitchen hood exhaust and make-up system in 2024

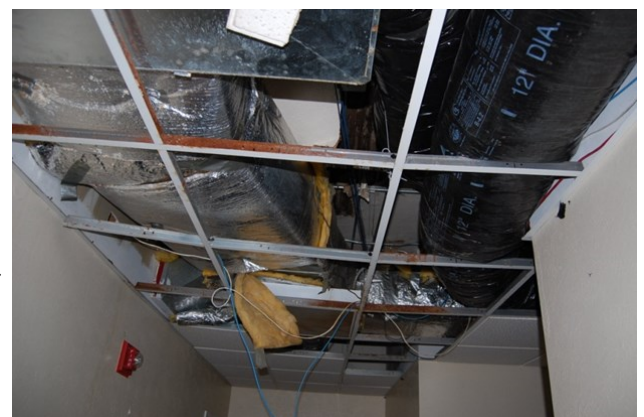
Interior ductwork in 2024

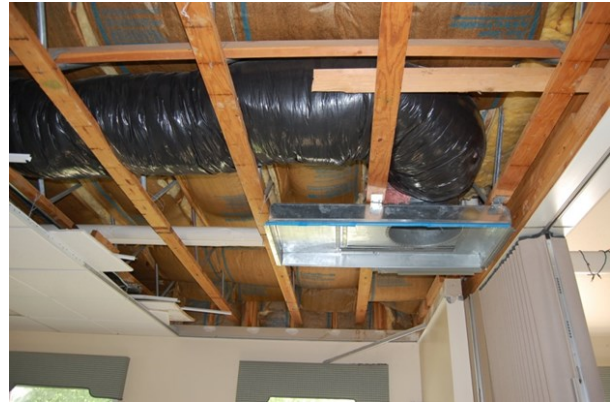
Interior ductwork in 2024

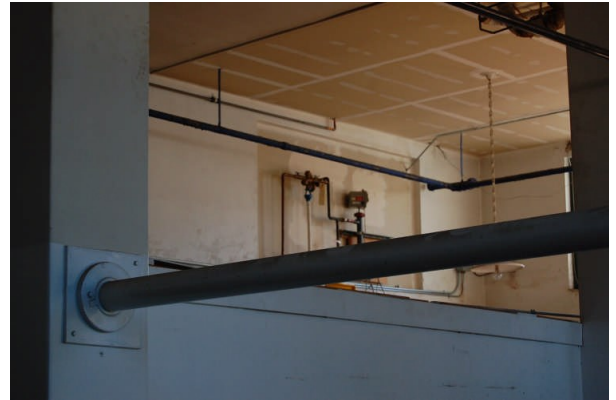
Domestic water backflow device in 2013

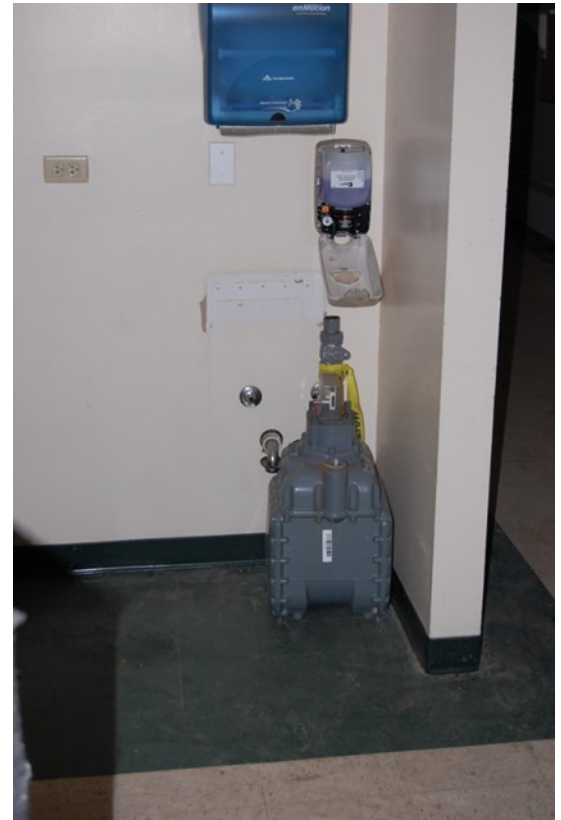
Plumbing fixture in 2024

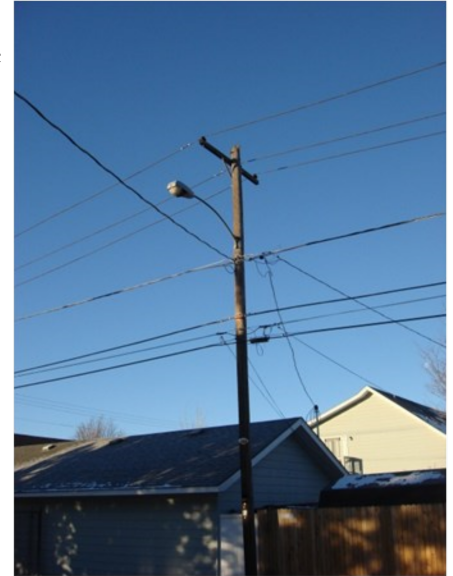
Overhead electrical service

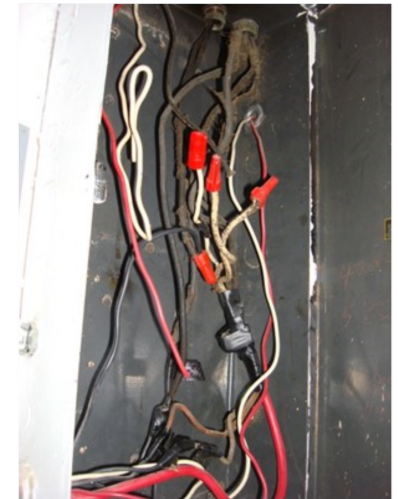
Basement branch circuit wiring

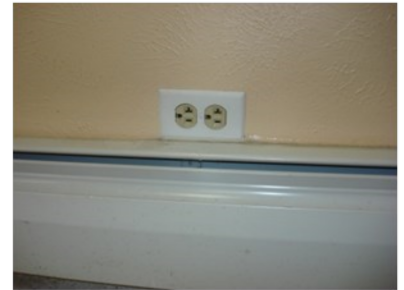
Receptacle above baseboard heater

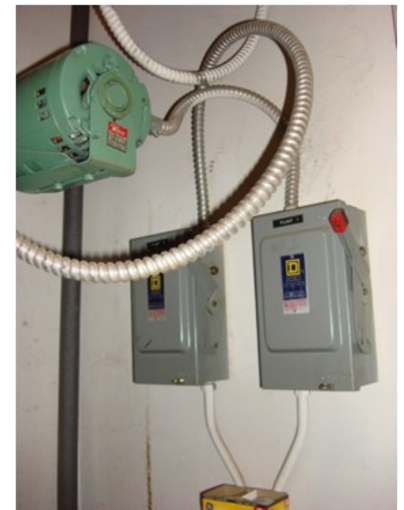
Mechanical equipment disconnects – kitchen mechanical room

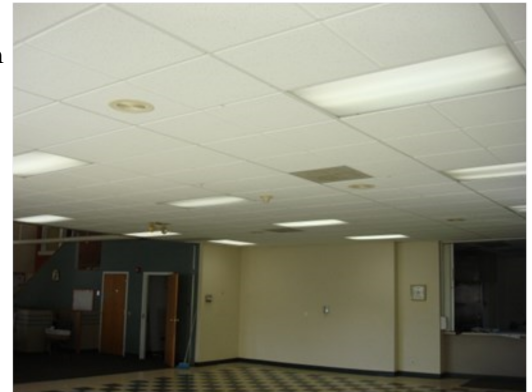
Typical fluorescent fixtures

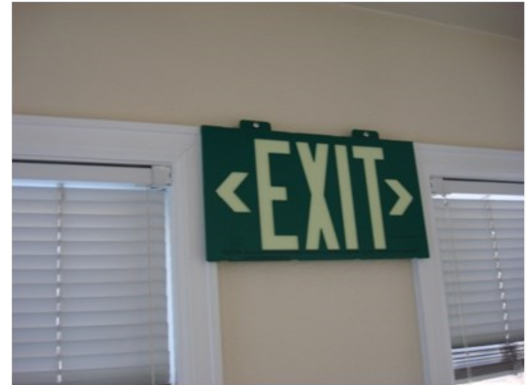
Non-illuminated exit sign

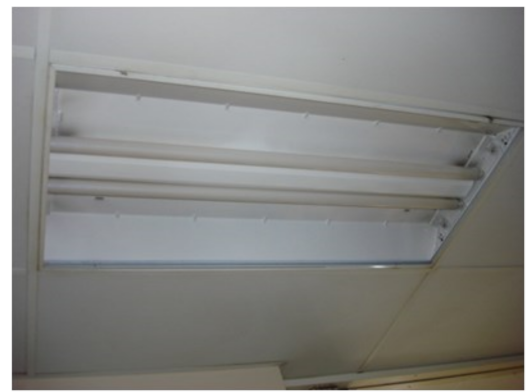
Damaged light fixture in kitchen

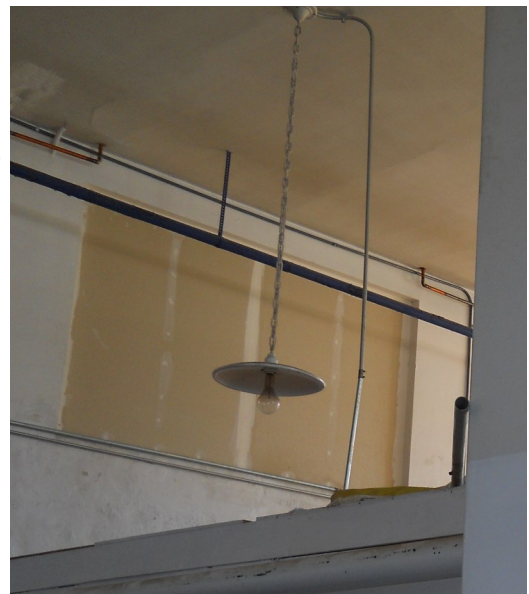
Basement light fixture

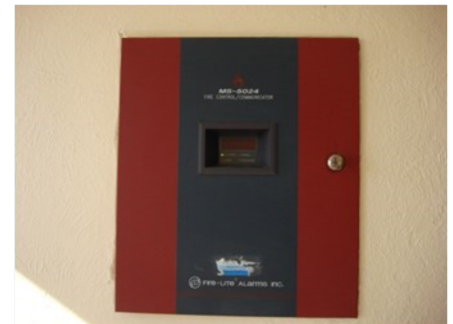
Fire alarm control panel
