# 2019 Guardrail Treatment Safety Improvements

Public Works Department

Brighton Guardrail Inspection Report  
City of Brighton, CO

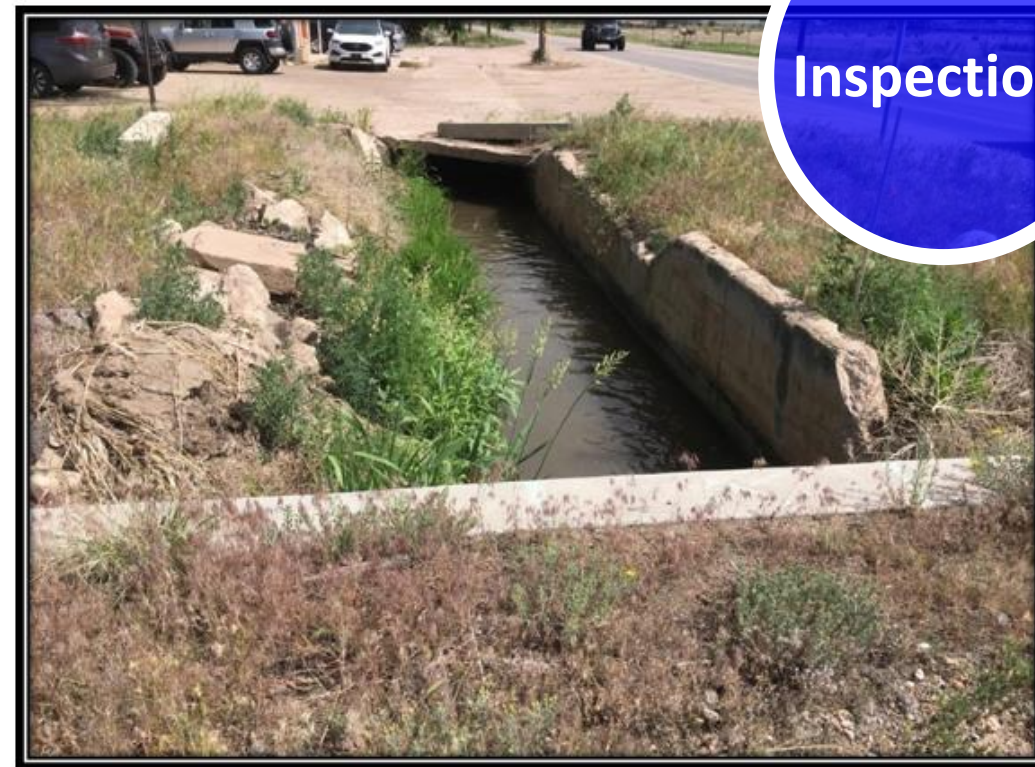
No guardrail is in place; slab is about 22 feet. Priority 1

FIGURE 13: VIEWING NORTH ON THE WESTBOUND SIDE OF THE DITCH

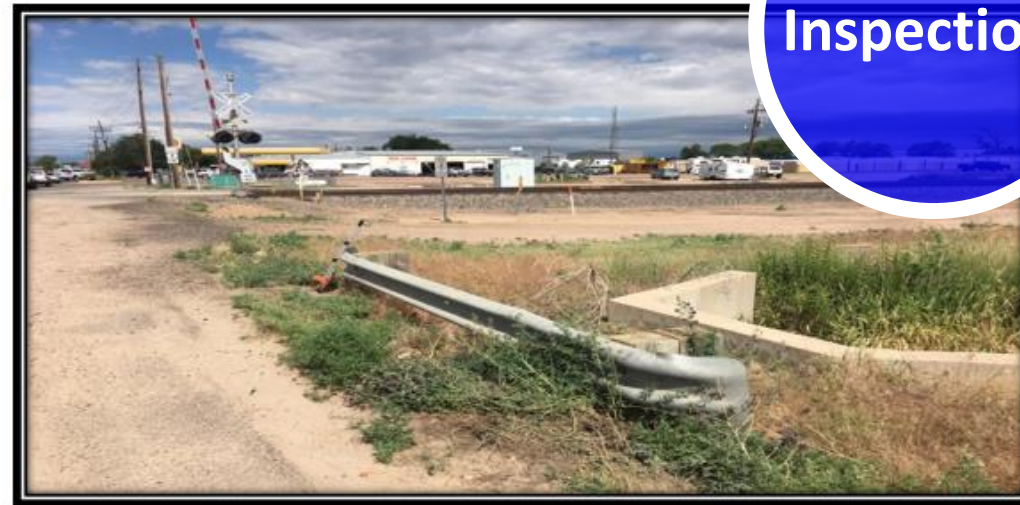
FIGURE 22: VIEWING GUARDRAIL FROM THE EAST IN THE WESTBOUND DIRECTION APPROACHING MAIN STREET (CR27)

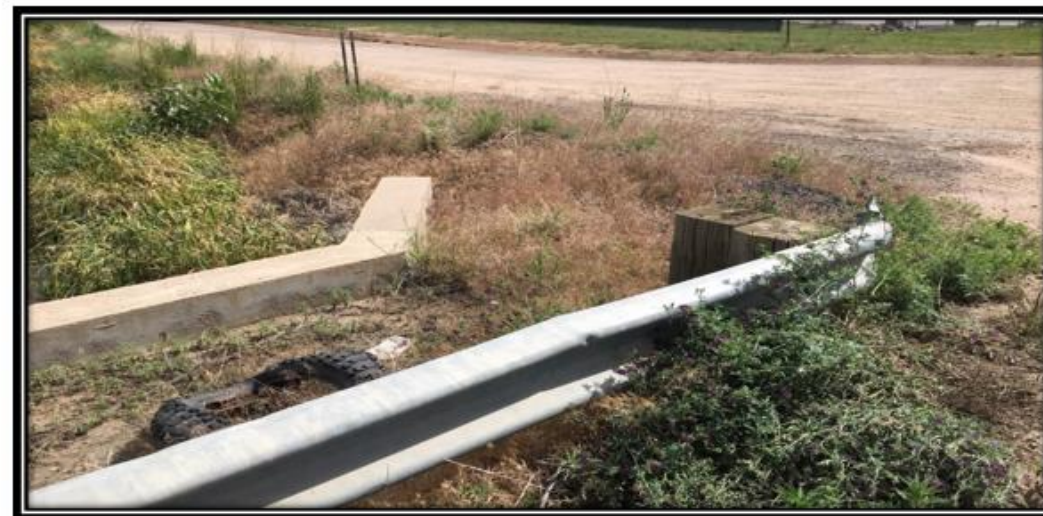
| Minor westbound damage but guardrail remains operational. Priority 5 |

FIGURE 23: MINOR BEND TO GUARDRAIL IN THE WESTBOUND SIDE

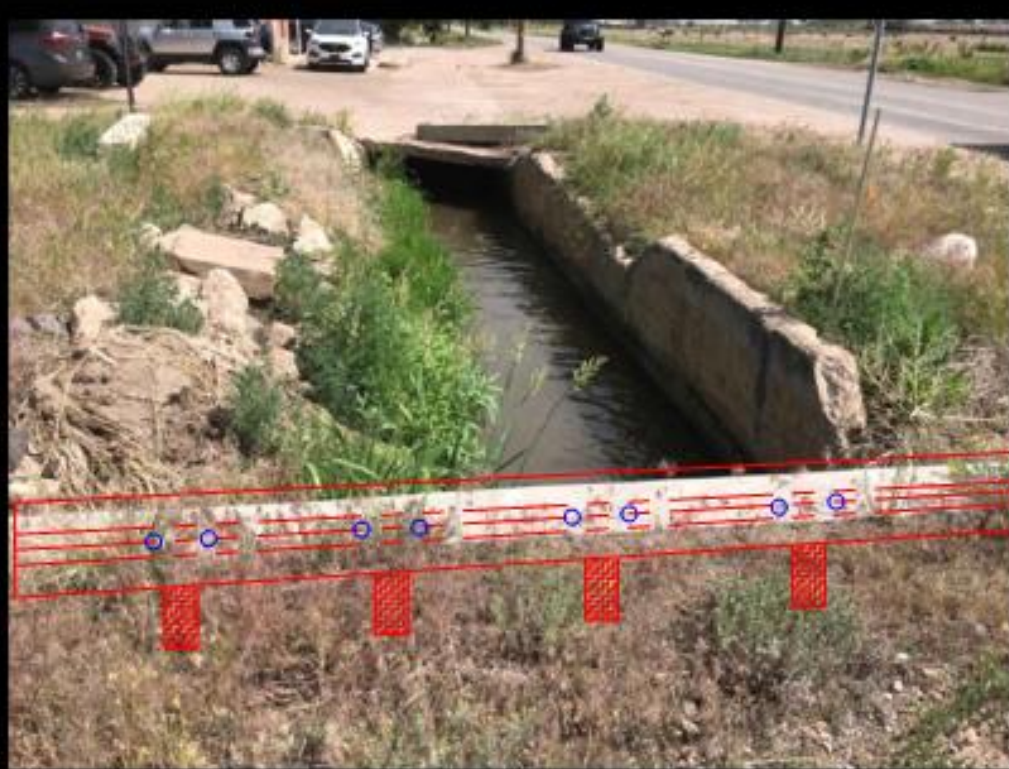
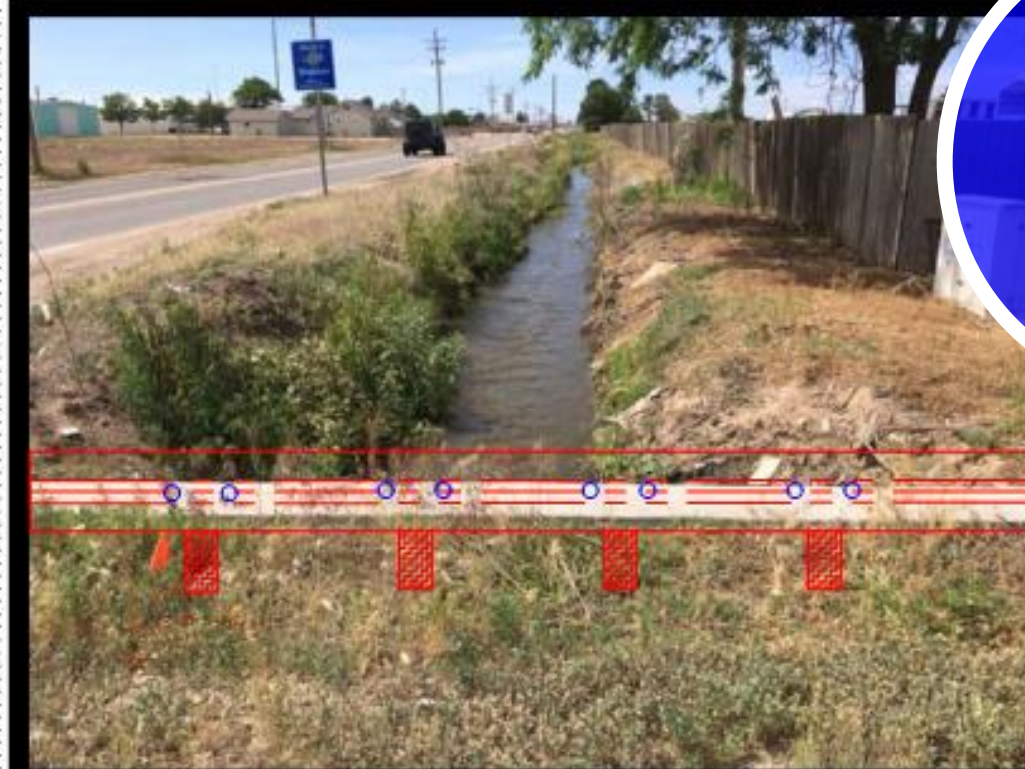
NOTE: FOR ILLUSTRATION PURPOSES ONLY ACTUAL GUARDRAIL TO VARY

1. APPROXIMATELY 30 LINEAR FEET OF NEW GUARDRAIL ON EACH SIDE OF THE DITCH STRUCTURE
2. TWO (2) FLARED END TREATMENTS WILL BE REQUIRED FOR A TOTAL OF 4
3. BOTH MASH AND CDOT STANDARDS AND SPECIFICATION WILL GOVERN
