COLORADO CULTURAL RESOURCE SURVEY

Architectural Inventory Form

1. Resource number: 5AM.23
2. Temporary resource number: N/A
Parcel Number: 0156907106011
3. County: Adams
4. City: Brighton
5. Historic building name:
Brighton Municipal Building/Town Hall;
Brighton Water Utility Building
Brighton Senior Center
6. Current building name:
Old Brighton Senior Center
7. Building address: 575 Bush Street
8. Owner name and address:
City of Brighton
500 S. 4th Ave.; Brighton, CO 80601

47. Photograph numbers: 5AM23-01 through 5AM23-05
Negatives filed at: City of Brighton, 500 S. 4th Ave., Brighton, CO 80601
48. Report title: Brighton Historic Resources Survey: Phase 1 (Certified Local Grant # CO-13-012)
49. Date(s): January 2014
50. Recorder(s): Deon Wolfenbarger
51. Organization: Three Gables Preservation
52. Address: 320 Pine Glade Road; Nederland, CO 80466
53. Phone number(s): 303-258-3136

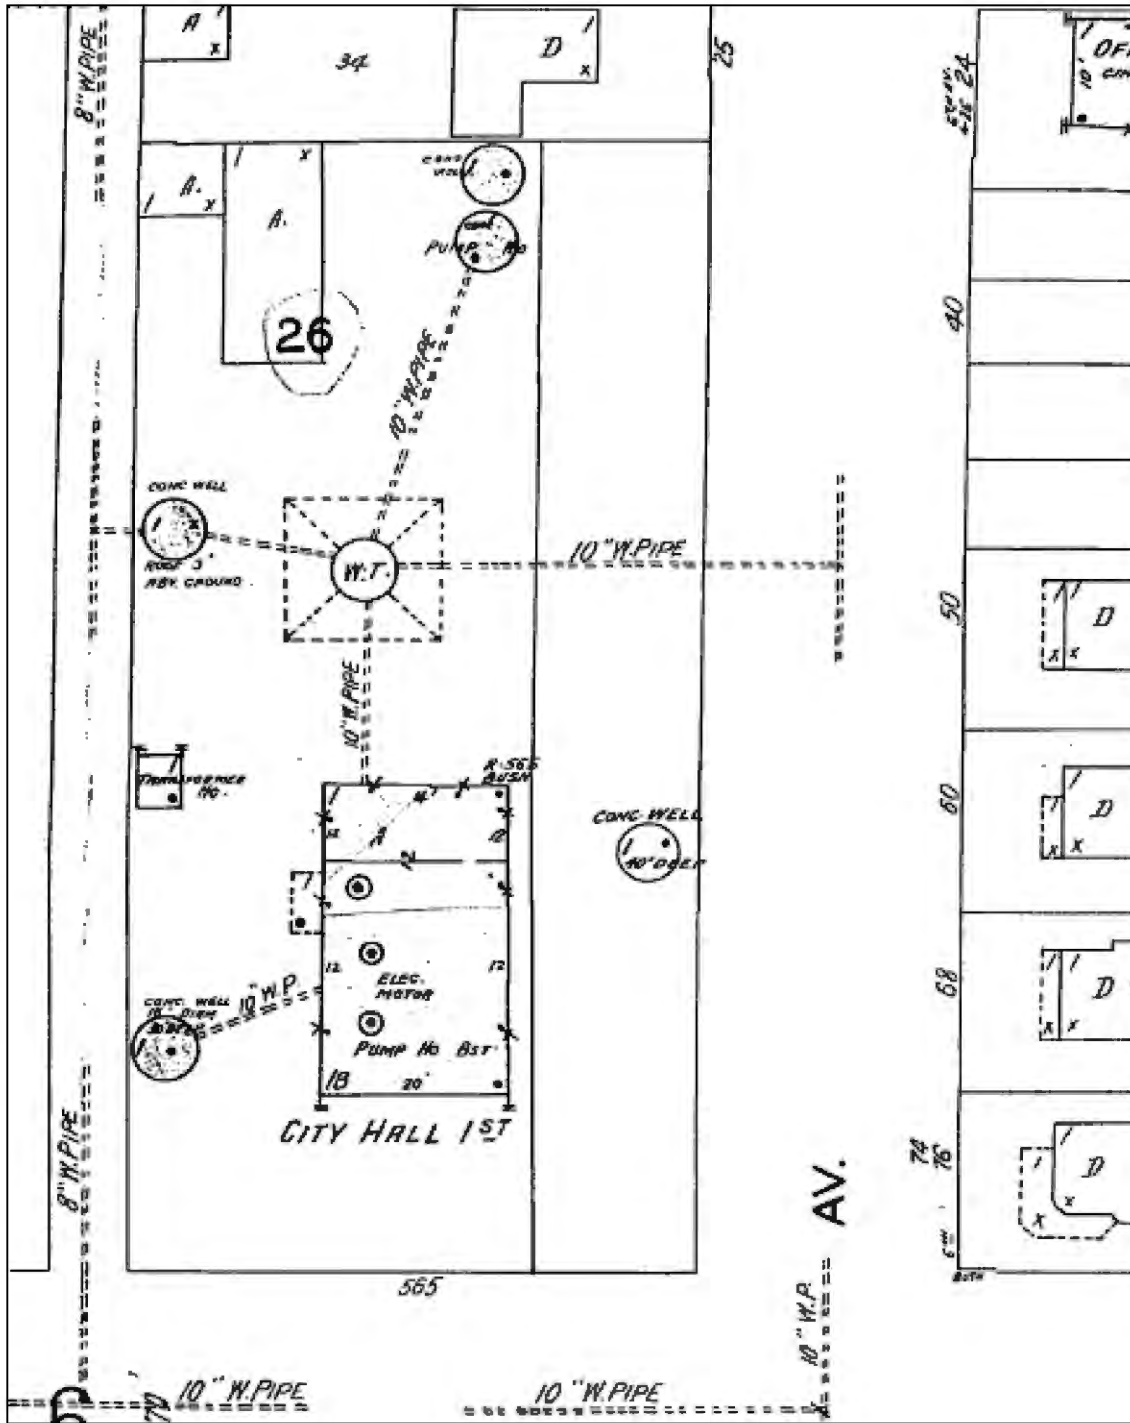
Figure 2. By the time of the 1948 Sanborn map, additional features related to the waterworks had been added, but the first floor still served as the City Hall.

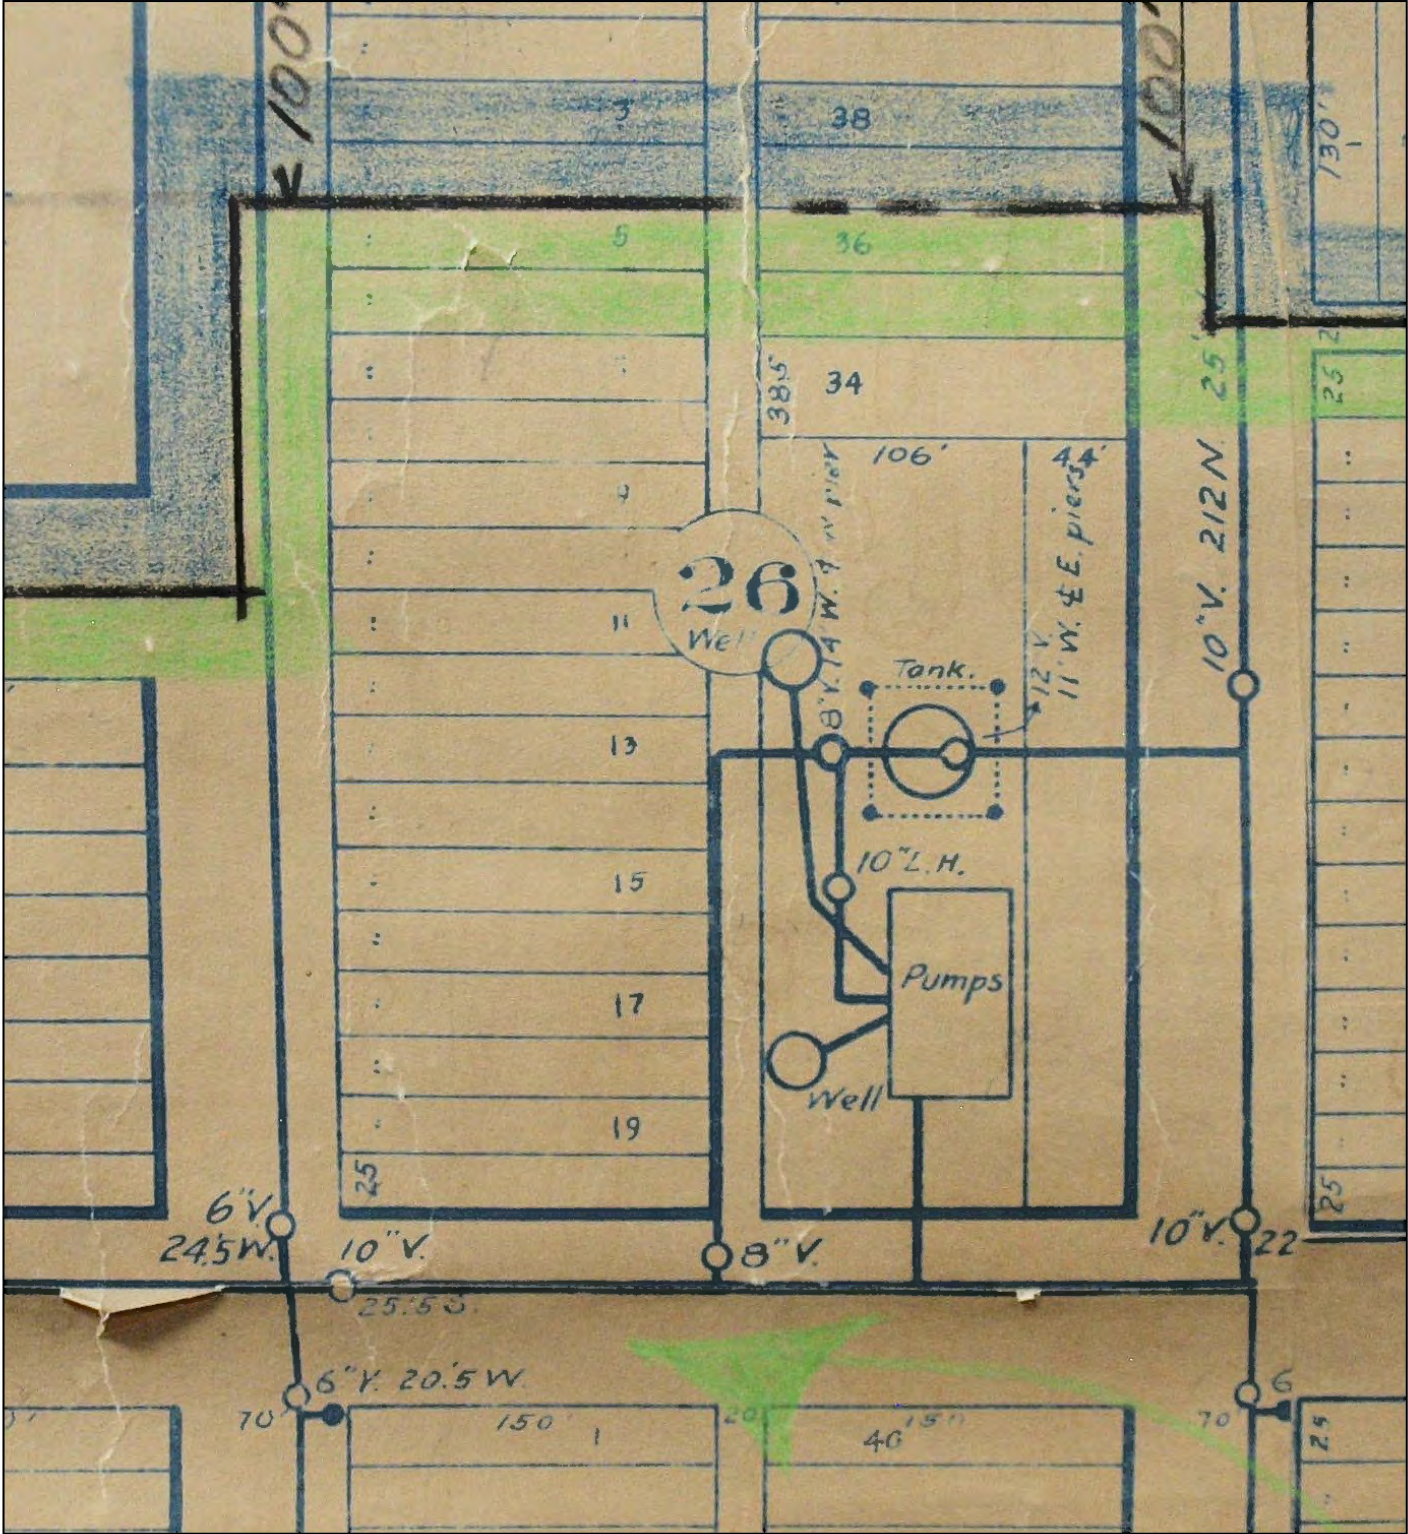
Figure 3. This early twentieth century zoning map shows the extent of the piping system that connected to the waterworks plant. Source: City of Brighton.

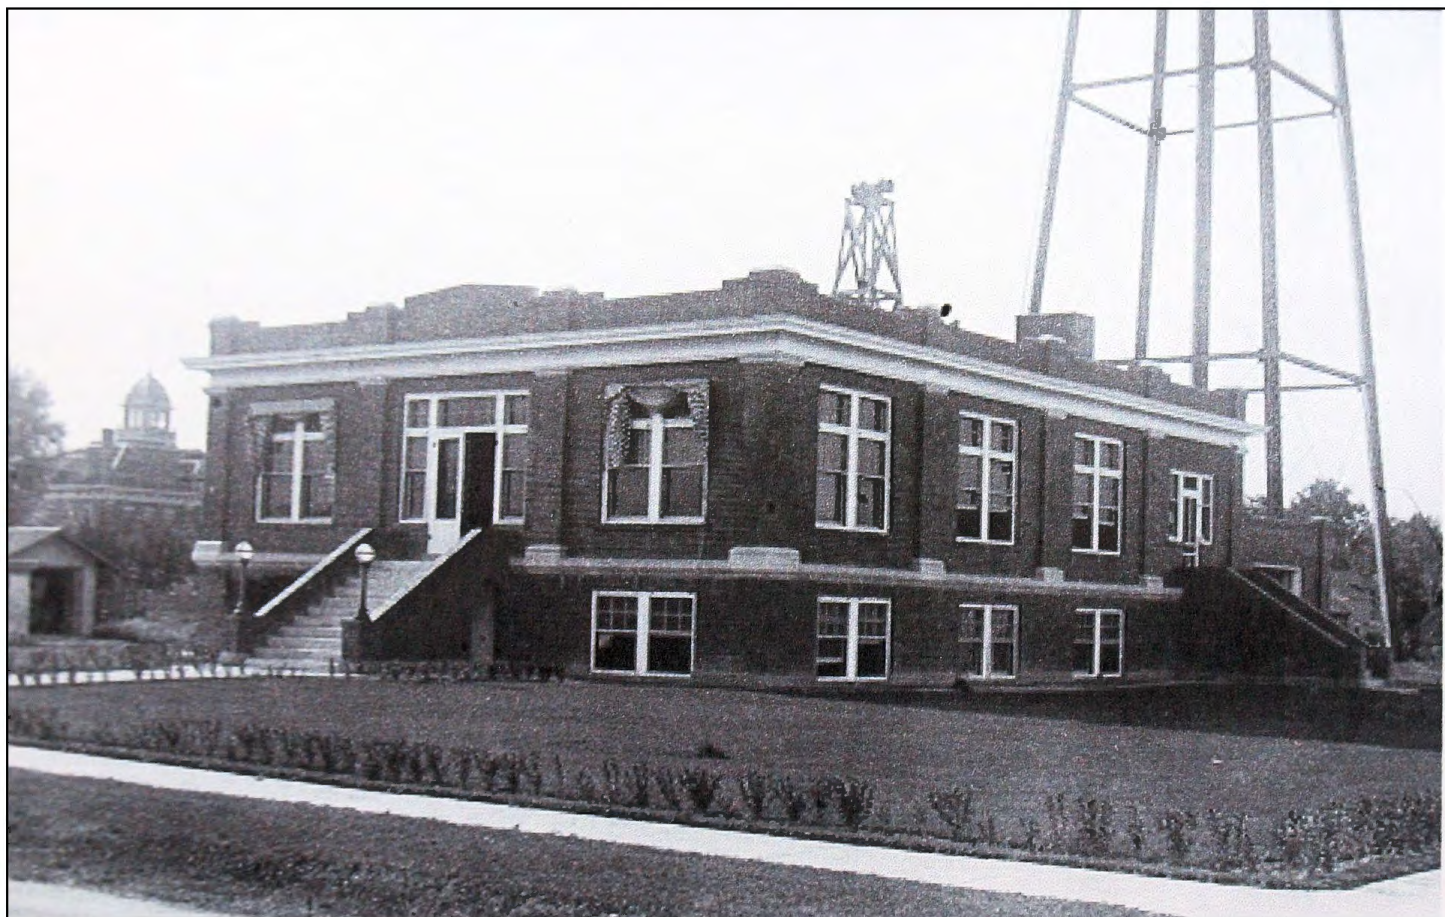
Figure 4. Historic view of Brighton City Hall/waterworks building, with water tower at the rear (no longer extant).
Source: Pat Reither collection.

35. Historical background: The building was designed by the architectural firm of William Redding & Son. The plans refer to the building as the "Municipal Pump House & Town Hall." The engineer for the pump house was Peter O'Brien, and the consulting engineer was R. D. Salisbury. The building cost \$16,922 to construct. It was the first building designed and built solely for the growing municipality of Brighton. As such, it was designed to serve multiple purposes. The mayor's and clerk's offices were located in the front (south end) of the building. Behind these offices was a 20' x 44' room that was used for council meetings and assembly hall. The assembly hall could be rented for youth dances for a \$15 rental fee. At the rear were four rooms and a bath that served as living quarters for the pump man that was required to be on-call for 24 hours a day. The basement contained the boiler, pump, coal rooms and machinery necessary for the water works. To adequately house the machinery, the basement had 18' tall ceilings. The lower rear addition housed the fire equipment for Brighton. In 1946, the city's public library moved into the building; they remained in these quarters until 1972. In 1976, the building was converted to a Senior Center with a federal grant. Another federal grant in 1985 was used to build an addition on the east side, adding a kitchen, cafeteria and community room. The architects for this addition were Ron Abo Architects. Historically, the site also contained a water tower, but this was removed in 1993 and replaced with a parking lot.

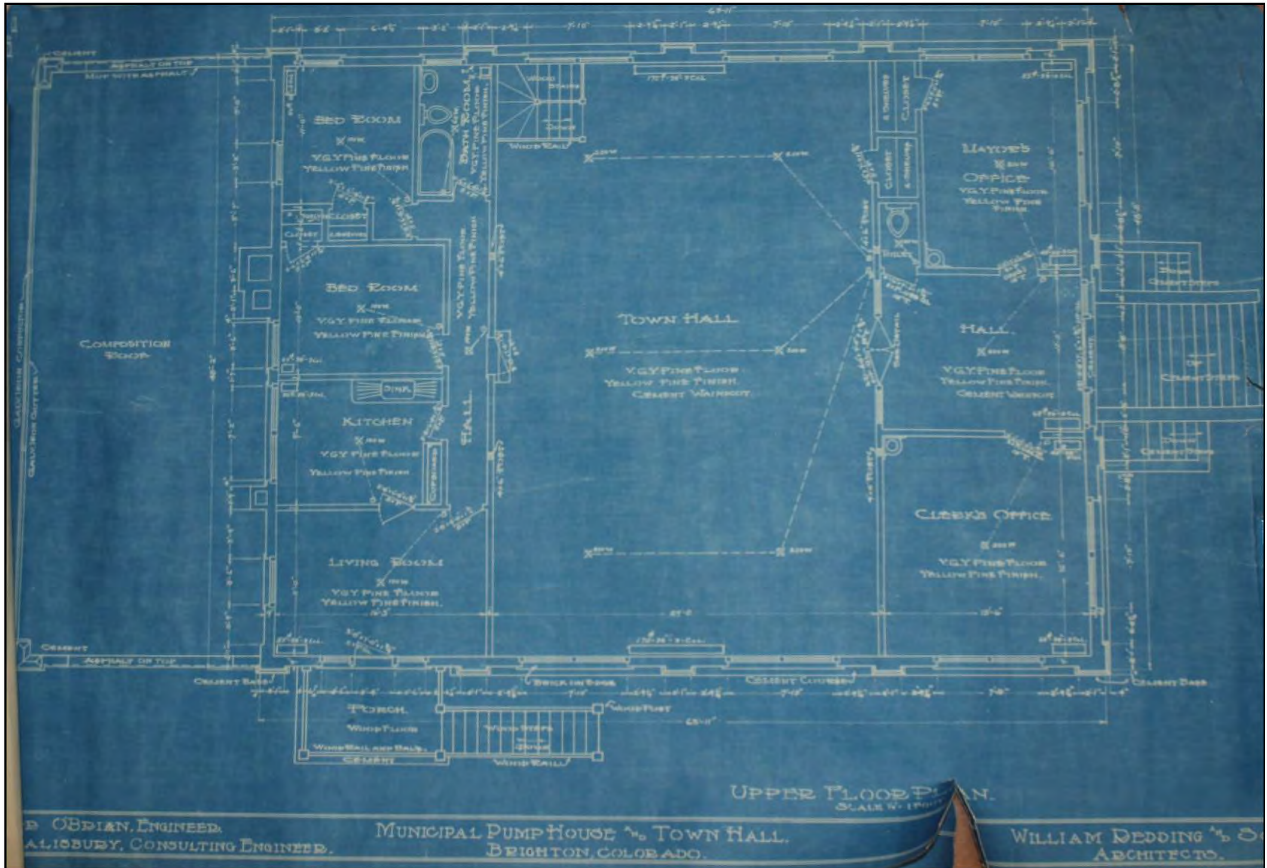
Figure 5. "Upper Floor Plan," 1918 blueprints, William Redding & Son, Architects. Source: City of Brighton, Historic Preservation Commission.

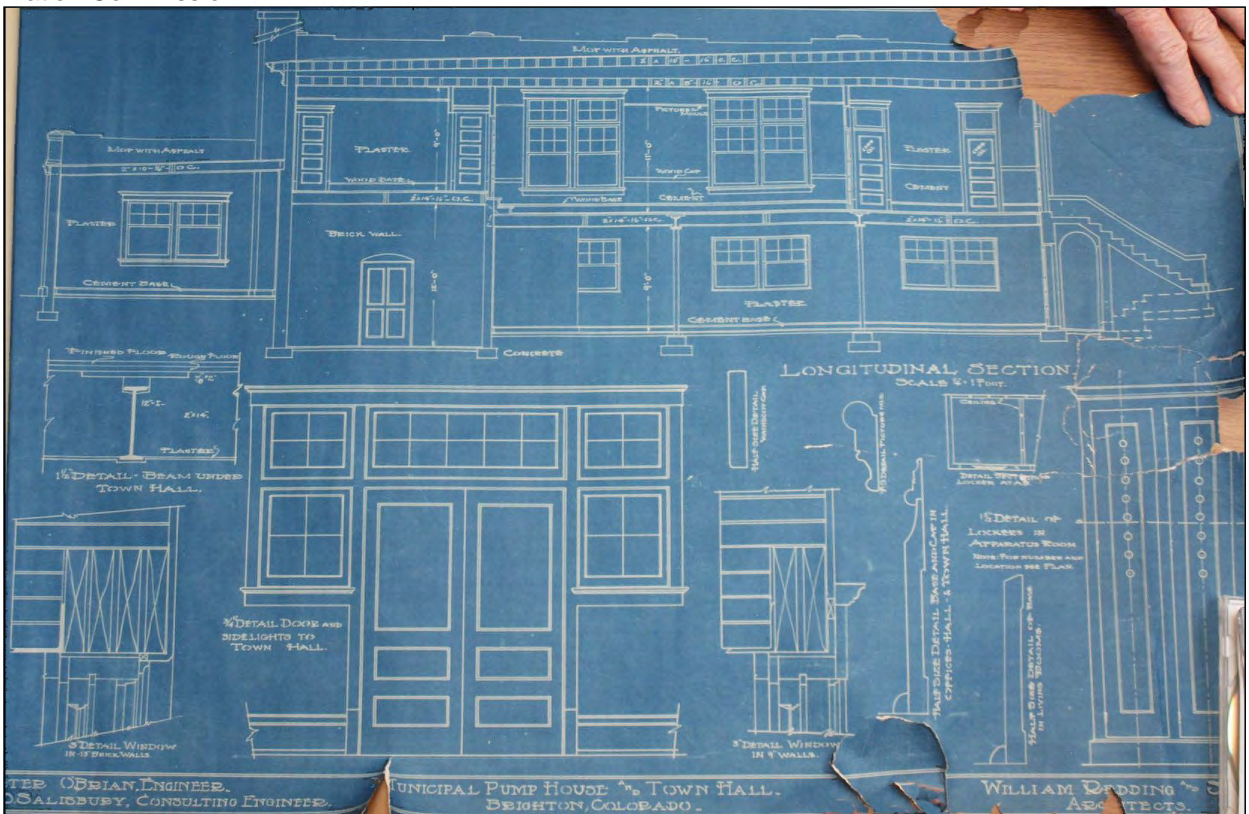
Figure 5. Elevation and details, 1918 blueprints, William Redding & Son, Architects. Source: City of Brighton, Historic Preservation Commission
