Supportive, Sustainable Infrastructure

Brighton Guardrail Inspection Report City of Brighton, CO

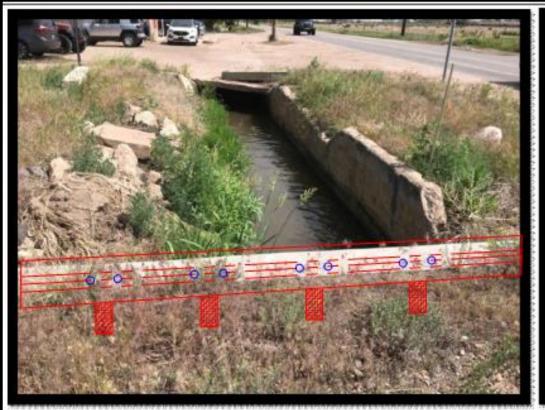
- APPROXIMATELY 30 LINEAR FEET OF NEW GUARDRAIL ON EACH SIDE OF THE DITCH STRUCTURE
- TWO (2) FLARED END TREATMENTS WILL BE REQUIRED FOR A TOTAL OF 4
- BOTH MASH AND COOT STANDARDS AND SPECIFICATION 3. WILL GOVERN
