Pre-Demolition Asbestos Building Inspection

575 Bush St.

Brighton, CO 80601

Prepared for The City of Brighton

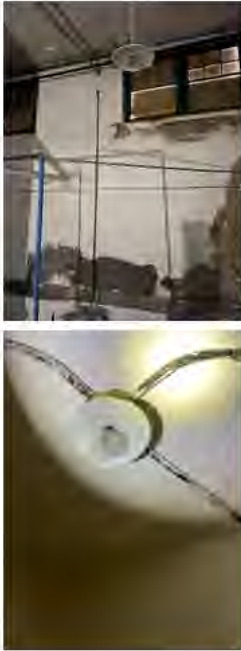
97	Gasket in Pipe and Valve	No Sample- Located in basement	Assumed ACM	No
-

98	Light heat shield	No sample - located in basement lights on ceiling	Assumed ACM	No
-

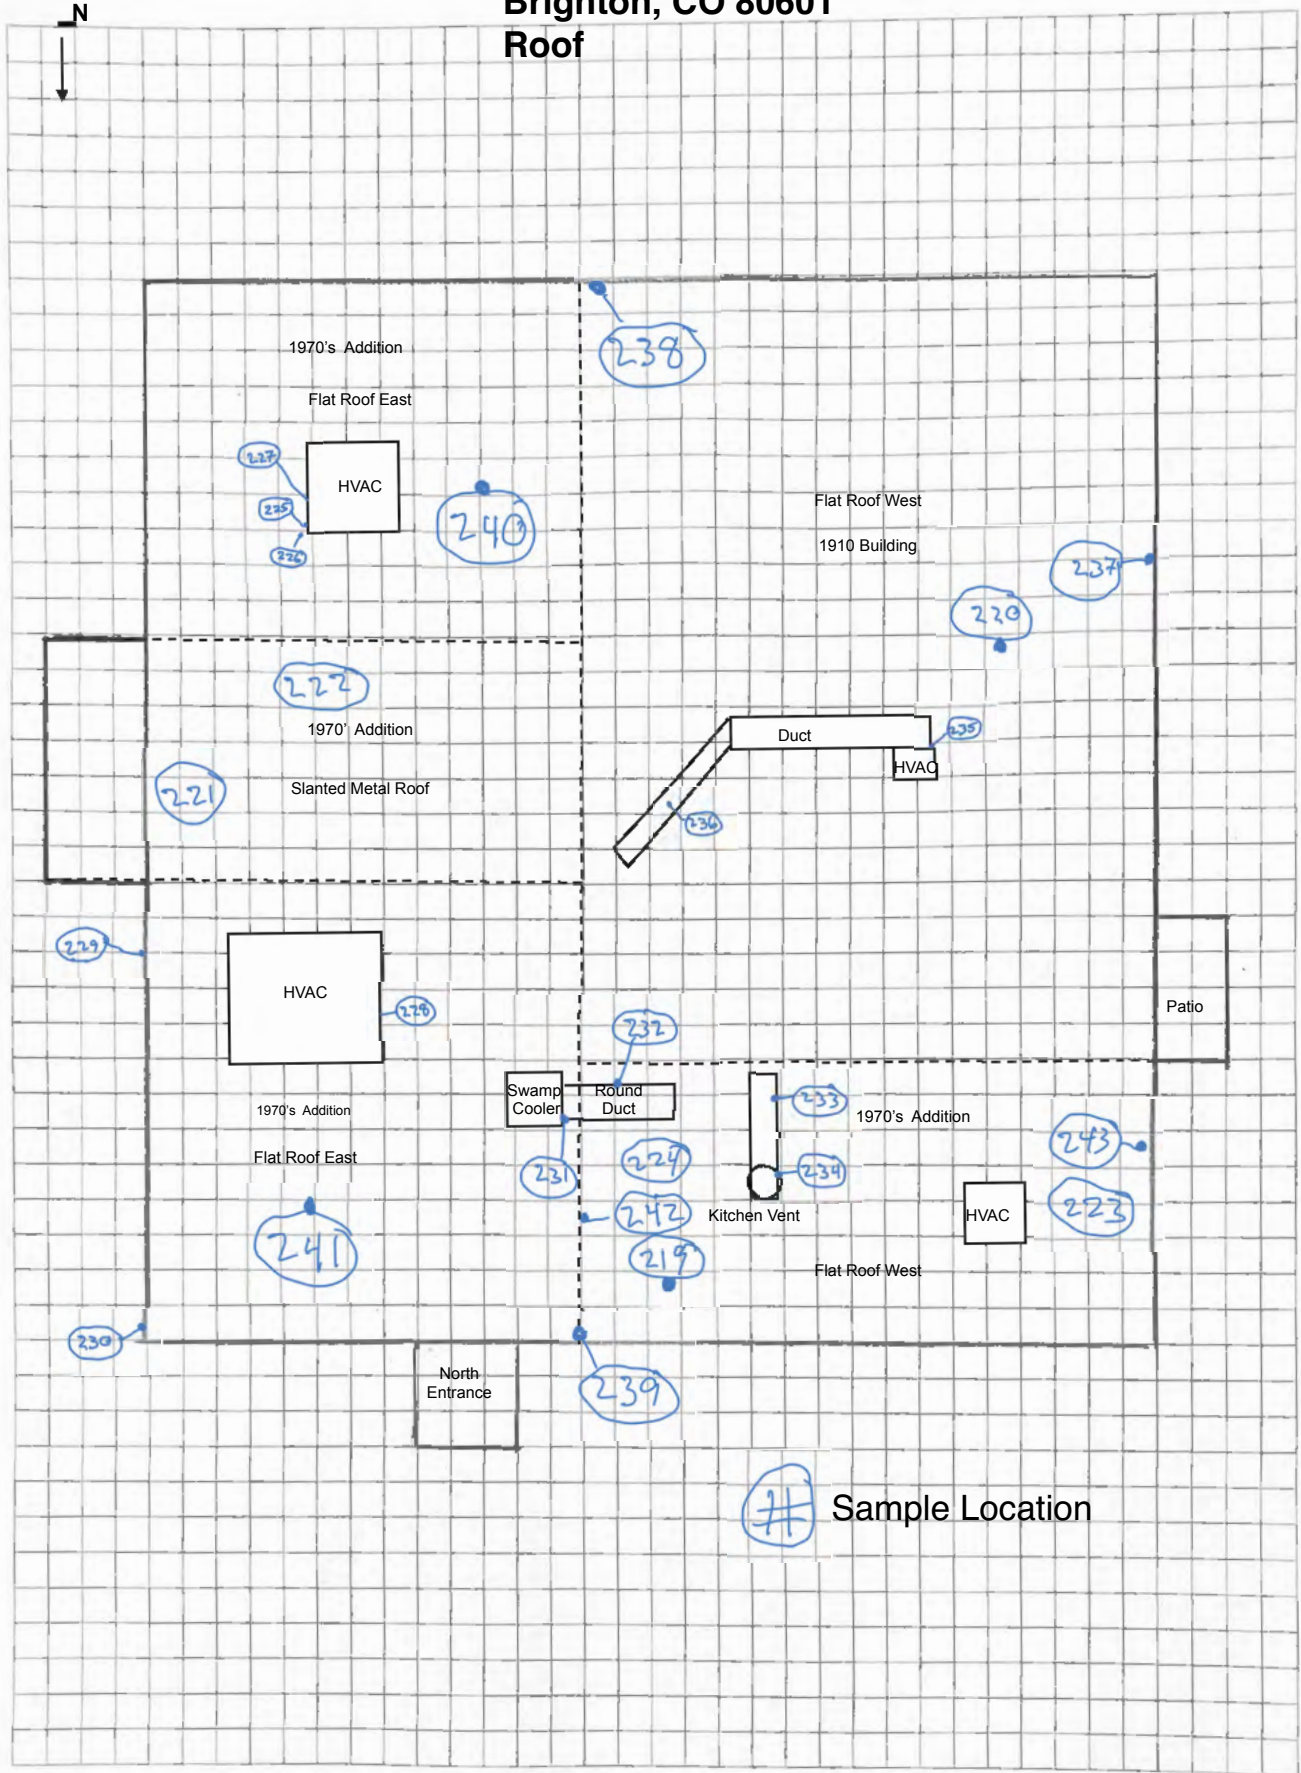
575 Bush St.
Brighton, CO 80601
Roof

86. HA86 -approx. 1370 sq ft of Metal Roof Coating located on the slanted metal roof on the east side of the building. Samples 221-222
87. HA87 -approx. 30 sq ft of Flat Roof Patch found on the roof of the Flat Roof West portion of the roof on the 1970's addition. Samples 223-224

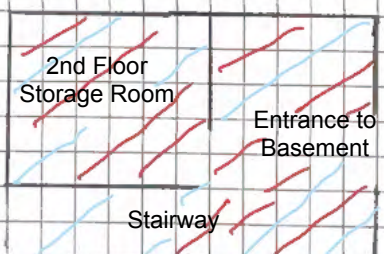
575 Bush St
 Brighton, CO 80601
 Basement

HA 97 Assumed Asbestos containing
 HA 98 Assumed Asbestos containing
 HA 99 Assumed Asbestos containing
