# OLD BRIGHTON SENIOR CENTER

575 Bush Street  
Brighton, Colorado

## IMPROVEMENT ASSESSMENT

Revised Draft April 24, 2013

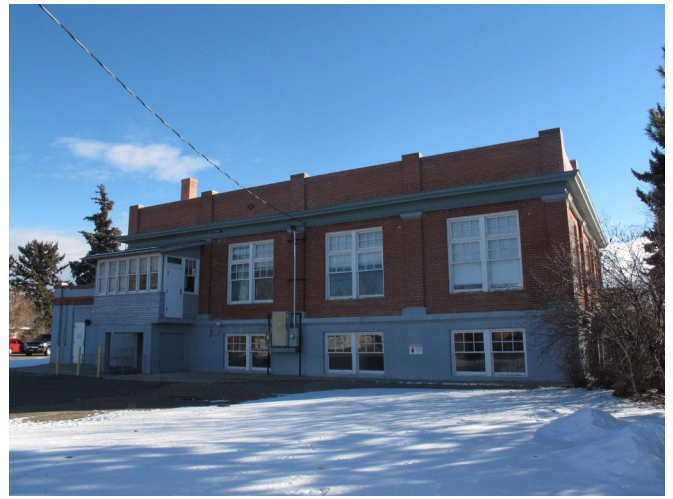
The lack of positive drainage away from the building is allowing water to build up adjacent to the structure which can lead to foundation issues or permeate into the building as noted above. Also, there are no drains observed at the base of the exterior stairs to the basement located on the south and west walls. Ponding was observed adjacent to the east side of the building around the downspouts.

Site lacks positive drainage away from the building

- Remove all landscaping and irrigation systems located within 5 feet of the structure.
- Install drains at below grade stairs.
- Replace apron at east side of 1986 addition to slope away from building.
- Installation of below-grade waterproofing and a perimeter drainage system should be considered.

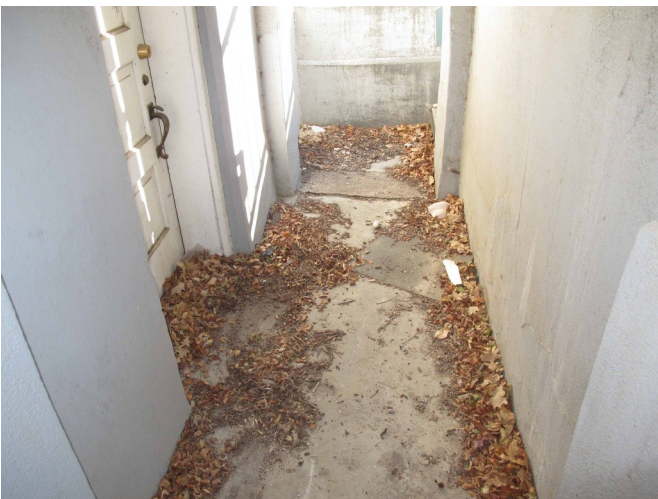
South exterior stairwell lacks an area drain.

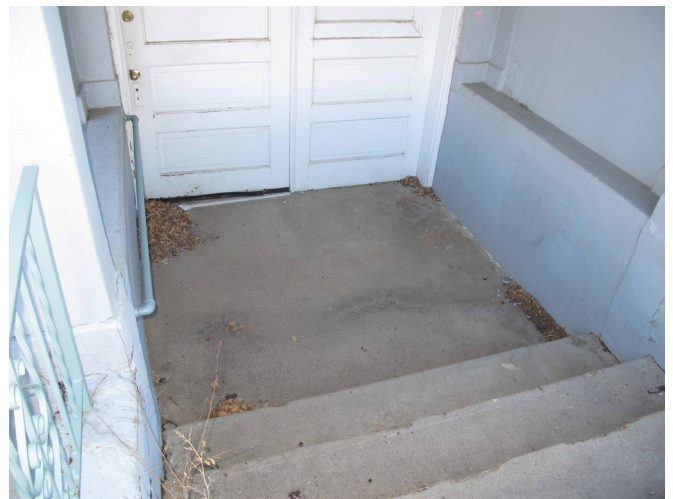
West exterior stairwell lacks an area drain.

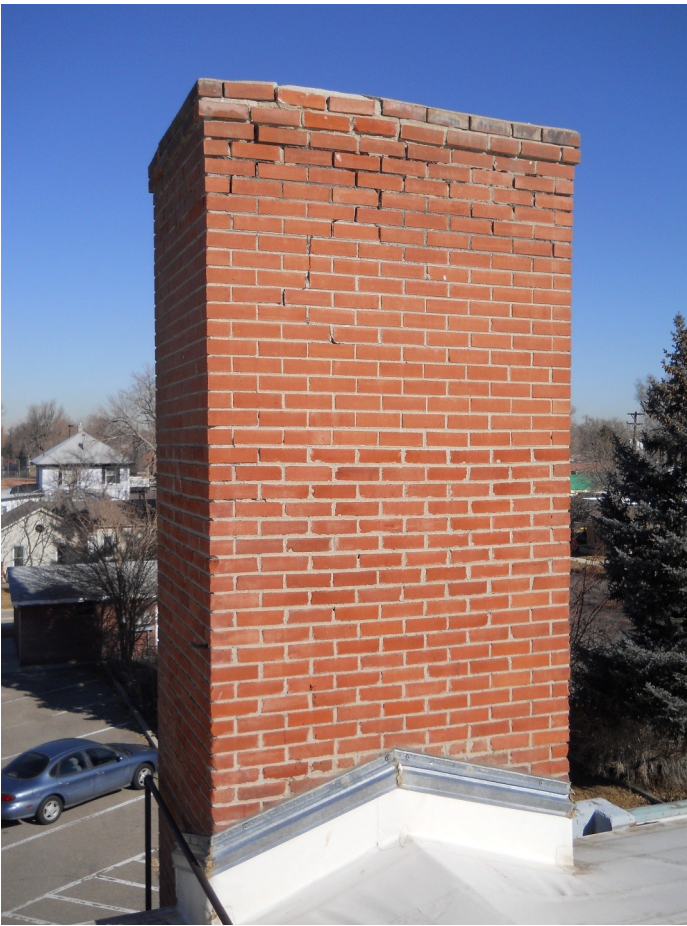
The brick on the original building needs repointing. In particular there are cracked bricks in the header of the south entry and adjacent to the pilaster east of the entry. The brick is deteriorated at the chimneys on the original building.

Chimney at original building

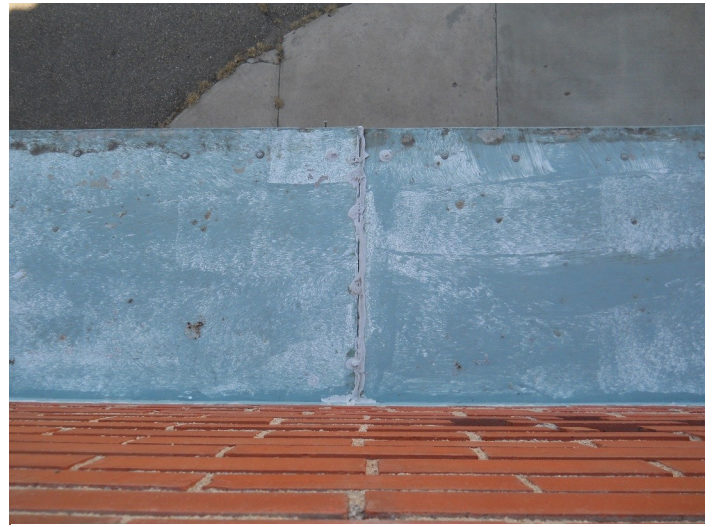
The sheet metal cornice is in generally good condition, but some on the top joints are in need of recaulking, and the top surface needs to be repainted.

Joint on top of sheet metal cornice

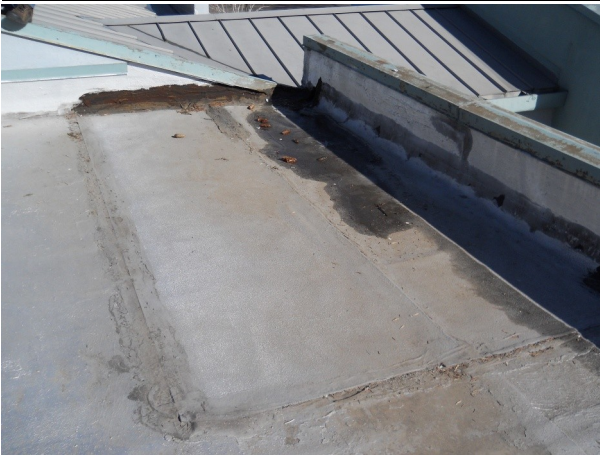
Ponding at scupper on 1986 addition

- Replace modified bitumen roofs at 1986 addition, including replacing the scuppers with larger units. Due to the leaking, replacement of the underlying insulation should be budgeted.

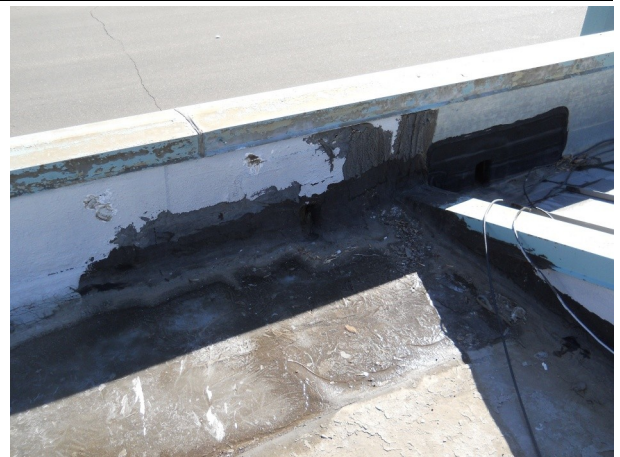
Repeated patching at scupper on 1986 addition

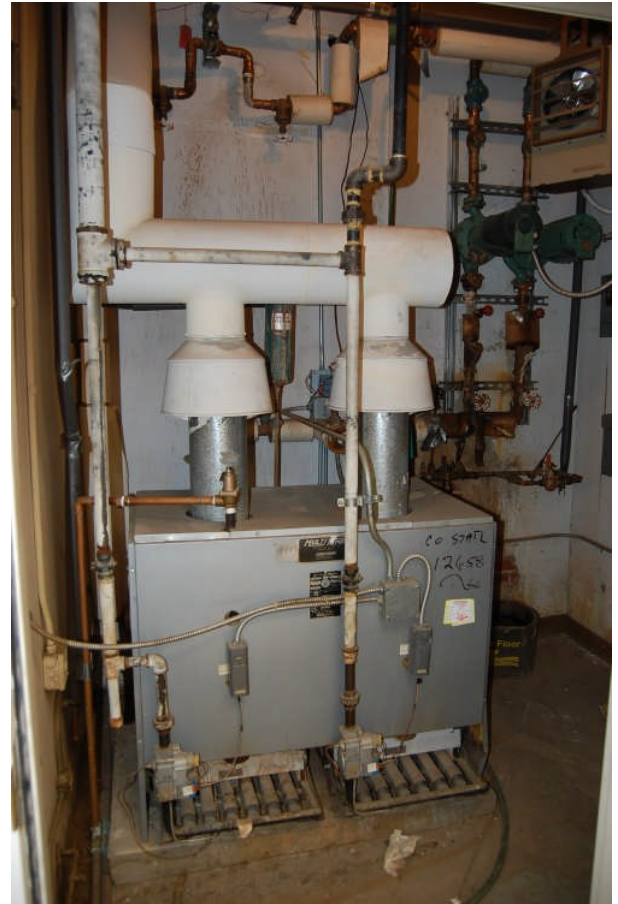
Main Level Boiler System

All three boilers contain the code required safety devices. These devices consist of a temperature controller, low water cut off and flame safety control. However, none of the boiler rooms contain the code required emergency shut down

switch. An emergency power off (EPO) switch is required at a boiler room door to shut off all power and gas to a boiler in the event of an emergency.

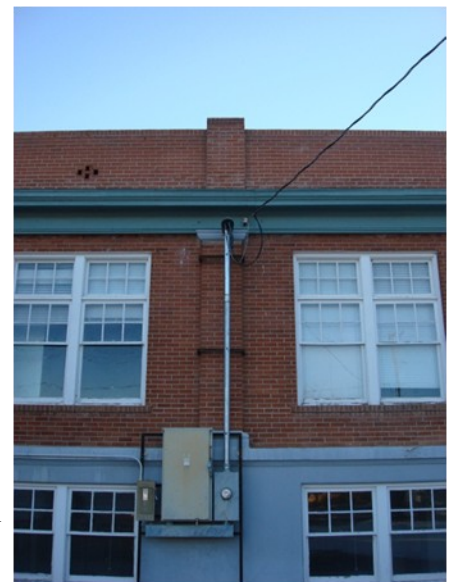
Building Weatherhead

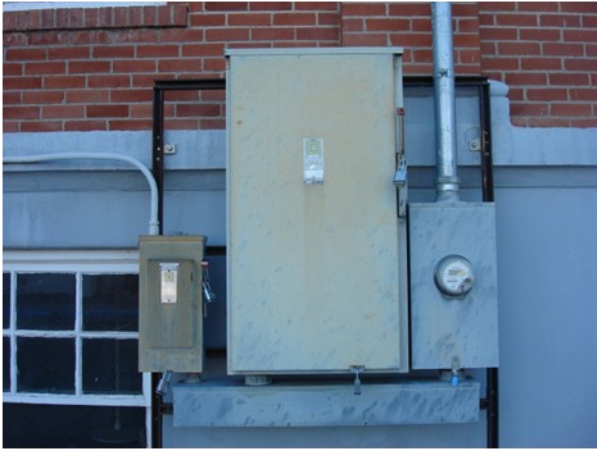
Wireway, Meter and Disconnects

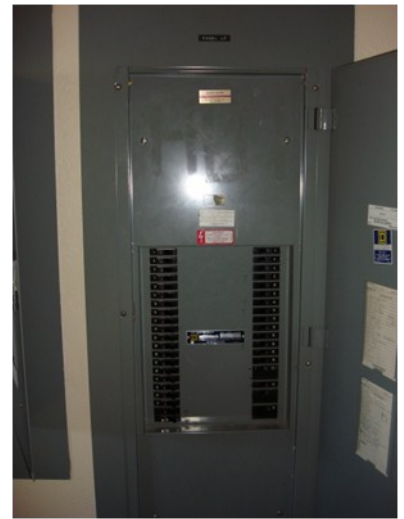
400A Panelboard 'LP'

The branch circuits fed out of electrical panelboards 'LP' and 'LP1' are not clearly labeled. The circuit directories have been hand modified and some circuits are labeled with marker on the metal housing of the panel. The labels in marker and the hand modified circuit directories do not match. It is recommended that the branch circuits be traced to determine the load on the circuit breakers and the directories should be updated accordingly.

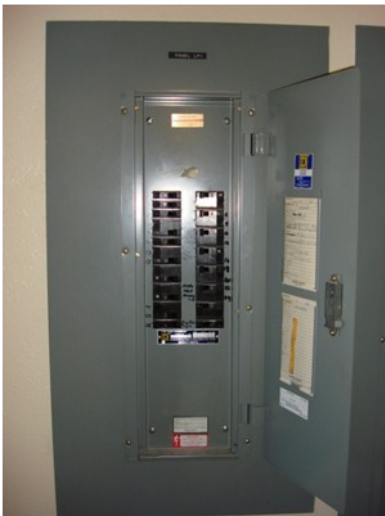
100A Panelboard 'LP1'

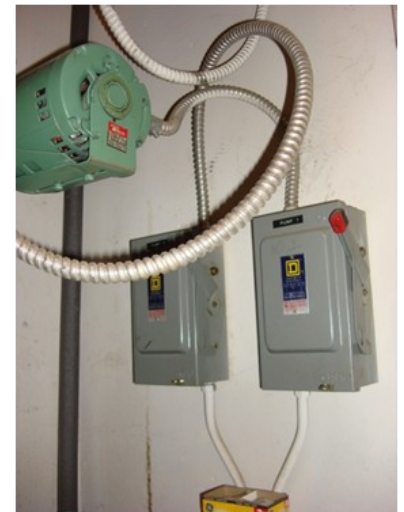
Mechanical Equipment Disconnects – Kitchen Mechanical room

It is recommended that the building verify with the baseboard heater manufacturer that the installation of power receptacles directly above the heaters is permitted. If the product is not designed to accommodate receptacles installed above a possible fire hazard exists as an electrical cord can be plugged in and exposed to heat from the baseboard heater. It is also recommended that the receptacles that are not GFCI protected as required by NEC as noted above be replaced with GFCI type receptacles. Additionally, it is recommended that weather proof GFCI receptacles be installed within 25 feet of mechanical equipment as required by the NEC. The MC cable routed from the mechanical equipment disconnects should be rerouted to provide code required 3 foot clearance.

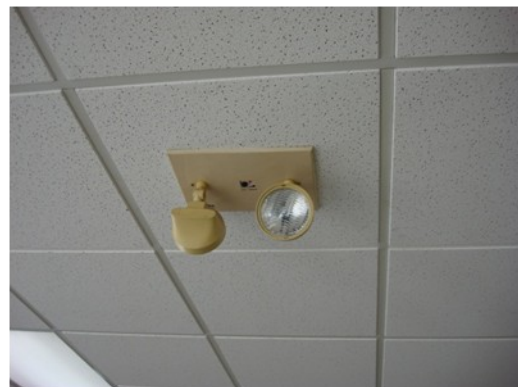
Emergency egress lighting levels appear to be insufficient in this building. International building code (IBC) section 1006.4 requires 1 foot-candle (FC) average and 0.1 FC of minimum illumination on the floor at any point along the path of egress. Emergency egress lighting is achieved through emergency battery powered 'frog-eye' type fixtures. The emergency batteries integral to existing emergency egress lighting fixtures were tested and roughly half of them were no longer operational. It appears as if the following areas do not have sufficient emergency lighting:

Typical EM Egress fixture

It is recommended that all fluorescent fixtures be retrofitted or replaced from dated T12 technology to current T8 or T5 type lamping. The damaged fixture in the kitchen should also be repaired or replaced. It is recommended that any incandescent fixtures in the building be replaced with fixtures supplied with compact fluorescent lamps. It is recommended that some lighting fixtures be removed or fixtures be replaced with new fixtures with fewer lamps of lesser wattage to satisfy the lighting power density requirements in the International Energy Conservation Code (IECC). The lighting controls in the building should be addressed. The current design does not satisfy the requirements for automatic shut off of lighting fixtures and lighting reduction controls as stated in the IECC. The emergency lighting deficiencies should be addressed in this building as it represents an immediate safety hazard to the occupants. All the emergency battery packs in the existing emergency egress fixtures should be replaced as half are currently not functioning and all are past life expectancy. Additional emergency egress fixtures should be added to the areas that do not have sufficient egress lighting as noted above. Emergency exit discharge fixtures should be added to the areas noted above. All the exit signs in this building should be replaced as the type does not meet current design standards and the internal batteries are all past their life expectancy. Additional exit signs should be added to the areas where they are required as noted above.

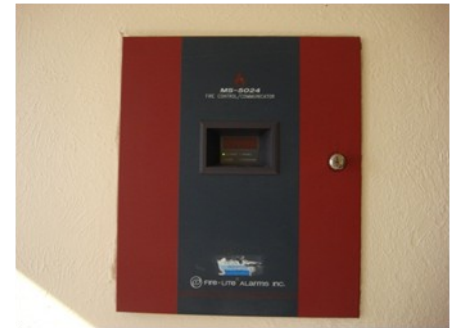
Fire Alarm Control Panel

It is recommended that additional detection and notification devices be added to the basement of the building as it does not appear that the coverage is adequate. It is also recommended that the fire alarm system be tested and inspected by the fire department with jurisdiction prior to the turnover of the facility to insure proper operation.

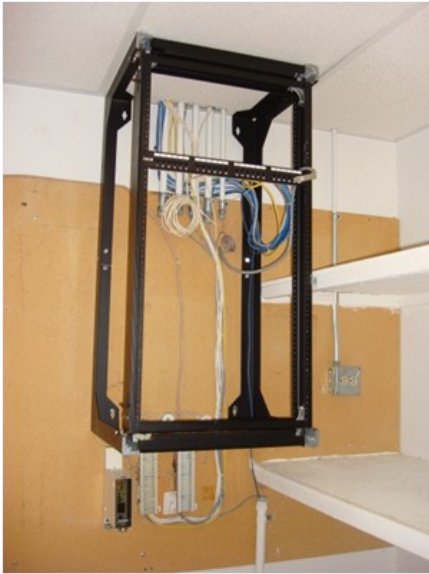
Generally the telephone and data systems are adequate by current design standards. The wall mounted 4-post equipment rack is adequate infrastructure for data equipment to serve the needs of the building. Office workstations are equipped with adequate cabling to support computer and telephone usage.

Equipment Rack

It is recommended that an old abandoned telephone head-end cabinet located in the kitchen prep area is demolished and removed as it appears that it is no longer in use. In order to utilize telephone and data in the building a service provider will need to install head-end equipment in this equipment rack and provide necessary programming. Infrastructure is in place to adequately support the telecommunications needs of the building.

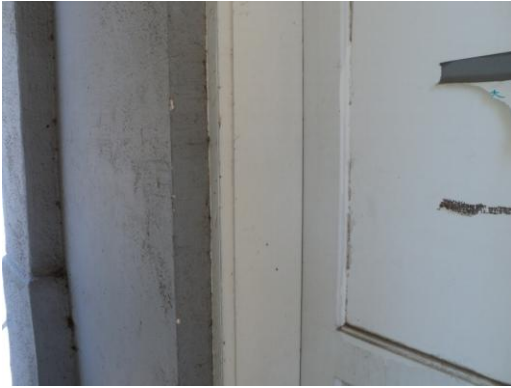
**#13 Exterior Side 2 Lower Door**

Room Type	Room #	Wall #	Component	Substrate	Condition	Color	Kgrade Pb Content mg/cm <sup>2</sup>	Lgrade
Exterior	1	2	Lower Door Molding	Wood	Good	White	16.8	1.79
Exterior	1	*	Stair Handrail	Metal	Good	Green	-0.01	0.85
Exterior	1	*	Stair Handrail	Metal	Good	White	0.57	0.74
Exterior	1	2	Door	Wood	Good	White	0.04	0.49
Exterior	1	2	Lower Window 2 Pane	Wood	Good	White	13.36	1.68
Exterior	1	2	Lower Window 2 Trim	Wood	Good	White	5.33	0.84
Exterior	1	2	Lower Window 2 Sill	Wood	Good	White	1.26	0.45
Exterior	1	2	Lower Window 2 Jamb	Wood	Good	White	-0.55	0.76
Exterior	1	2	Crown Molding	Metal	Good	Green	-0.09	0.46
Exterior	1	3	Wall	Masonry	Good	Gray	-2.28	-0.06
Exterior	1	2	Window Pane	Wood	Satisfactory	White	12.12	1.78
Exterior	1	2	Window Jamb	Wood	Satisfactory	White	10.03	1.67
Exterior	1	2	Window Trim	Wood	Satisfactory	White	14.68	1.98
Exterior	1	3	Wall	Wood	Poor	Gray	2.18	0.7
Exterior	1	*	Soffit	Wood	Good	Gray	7.96	0.13
