# Greensand Filter Effluent Line Repair Project

Presenting: Michael Woodruff, Director of Infrastructure  
Project Manager: Jake Hebert, Project Engineer

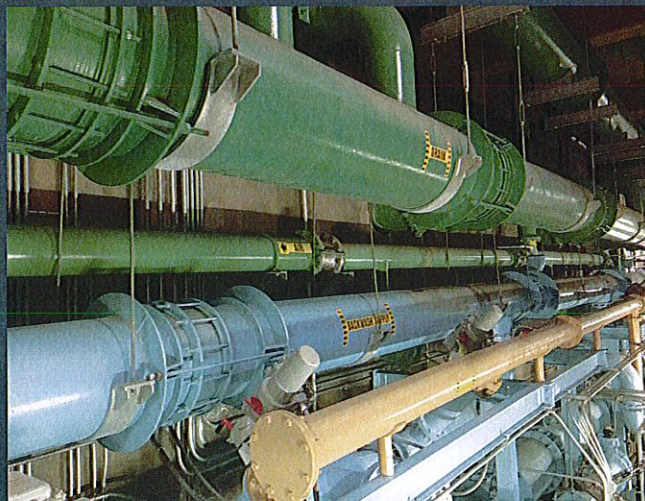
Greensand Pipe Gallery

- ◆ The 4 filter effluent lines are currently leaking at the wall penetrations in the Greensand Water Treatment Plant
- ◆ Leaking is occurring from the Victaulic couplings and between the concrete and the pipe at the wall penetration
- ◆ The leaking has become so prominent that water plant staff is concerned there is a chance the effluent lines could entirely fail at any time
- ◆ Loss of the Greensand Plant would be detrimental, as the City would not have adequate water supply for its citizens during the summer months

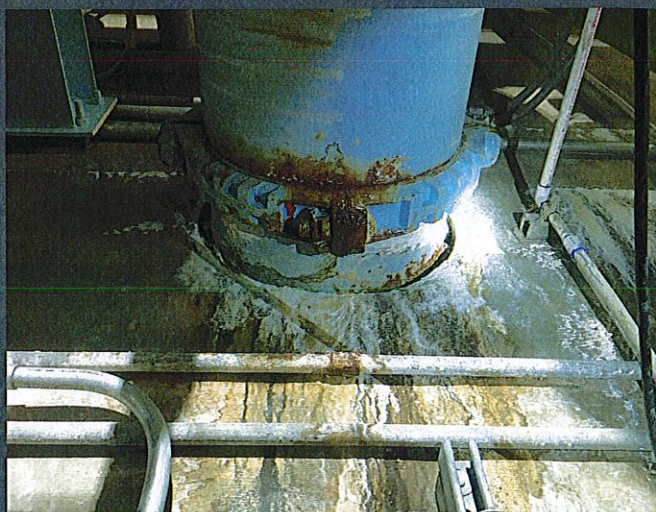
- ◇ Scope of work
  - ◇ Design/build services for identifying and repairing leakages on all 4 effluent lines
